05V-252

TECHNICAL SERVICE BULLETIN

Victory Motorcycle

SUBJECT: CAMSHAFT CHAIN DRIVE SPROCKET INSPECTION

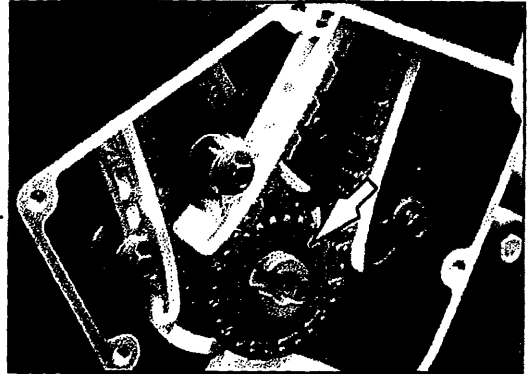
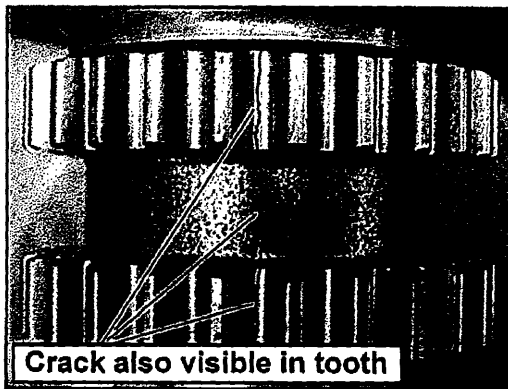
1. Remove the lower cam chain drive sprocket cover.
2. Carefully inspect the entire surface of the sprocket for cracks.

If the sprocket is NOT CRACKED, proceed to Step 3.

If the sprocket is cracked, proceed to REPAIR PROCEDURE.

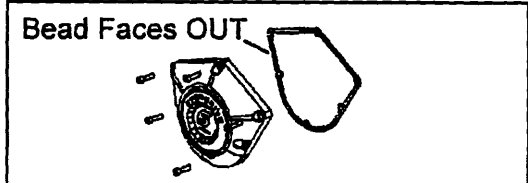
3. Clean gasket surface and install new gasket with sealant bead facing OUT (toward cover). Torque screws in a cross pattern to 85 in. lbs. (9.6 Nm).

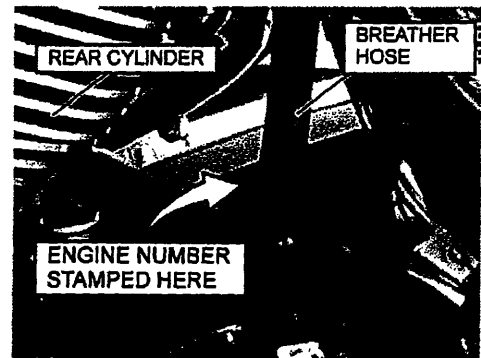
- Engine Serial Number (See photo at below right for location)
 - Engine Color (Silver or Black)
2. Return shipping instructions will be included with the engine. Save the shipping container from the new engine and follow the instructions to return the original engine (shipping is pre-paid by Victory). You **MUST** return the defective engine. Engines not received within 60 days of the replacement engine's shipping date will be charged back to your dealership at replacement value of \$16,000.00 (U.S. funds).
