# SPECIAL SERVICE CAMPAIGN 70A (NON-COMPLIANCE RECALL)

## 2003 THROUGH MID-2005 MODEL YEAR 'TUNDRA ACCESS CAB CHILD RESTRAINT ANCHORAGE CAUTION LABEL

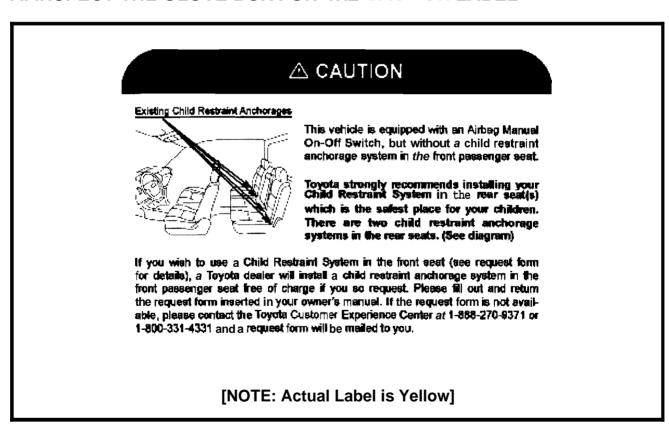
#### A. INSPECT THE GLOVE BOX FOR THE CAUTION LABEL

1) Is the label already installed?
