Winnebago Industries, Inc. has started three recall campaigns.

**SUBJECT: Campaign #97 – Fuel Tank Strap Fastener**

## Instructions to Perform Campaign 97 Fuel Tank Strap Fastener

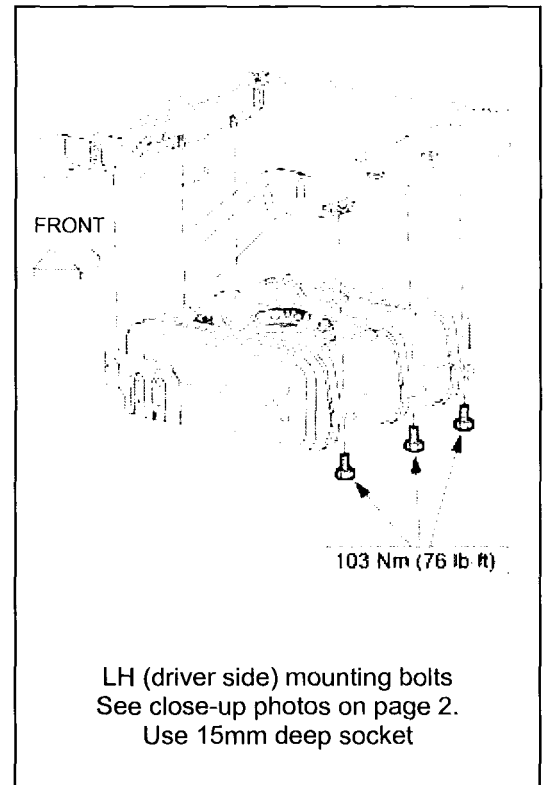
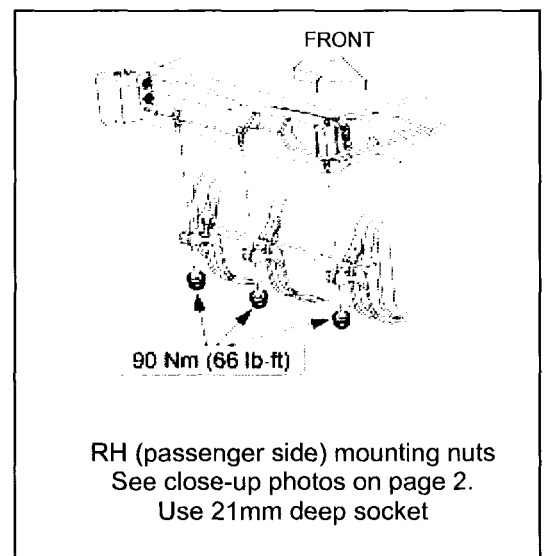
1. Beneath the rear of the vehicle, locate the appropriate fuel tank strap mounting bolts and nuts as shown in the figures at right.
2. See close-up photos on page 2 to identify specific bolts and nuts included in this procedure.
3. Tighten each affected bolt or nut to the specified torque.

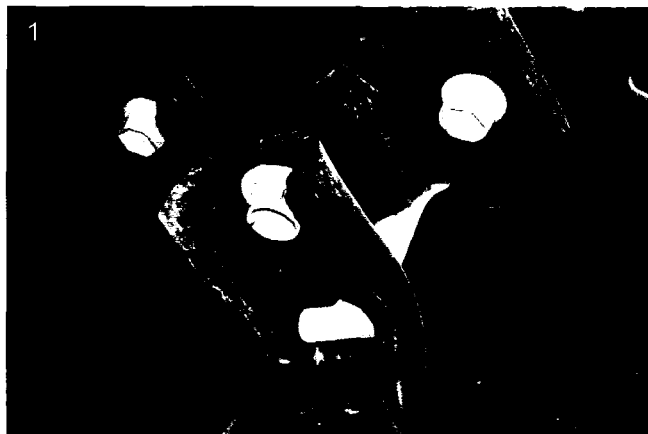
Photo 1  
LH Side Front  
Fuel Tank Strap Mounting Bolts  
Use 15mm deep socket  
Torque 76 ft/lb

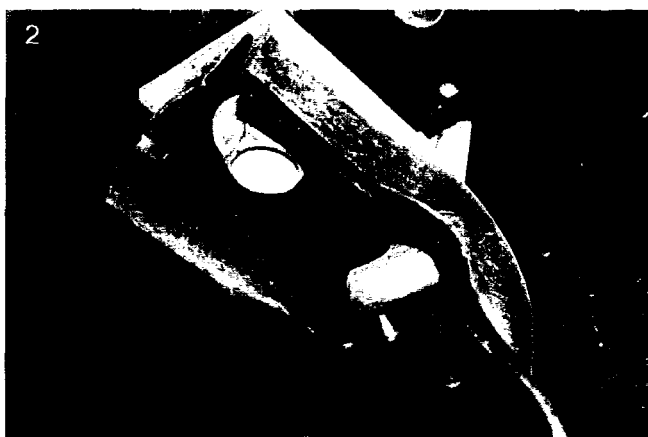
Photo2  
LH Side Mid and Rear  
Fuel Tank Strap Mounting Bolts  
Use 15mm deep socket  
Torque 76 ft/lb

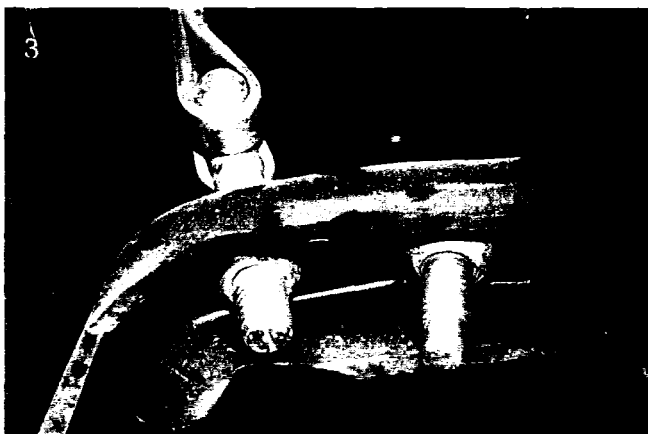
Photo 3  
RH Side  
Fuel Tank Strap Mounting Nuts  
Use 21mm deep socket  
Torque 66 ft/lb
