Subject: 2003-04 G35 - 2003-06 FX45/35 Fuel Hose Recall Campaign Update #2

INTERIM REPAIR INSTRUCTIONS FX FUEL HOSES

(Revised 1/20/06)

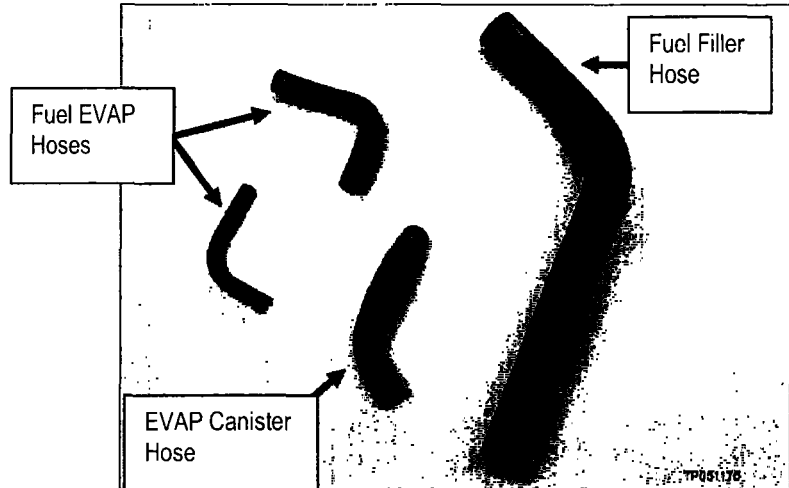
Figure 1a

- Fuel hose kit (see Figure 1a)

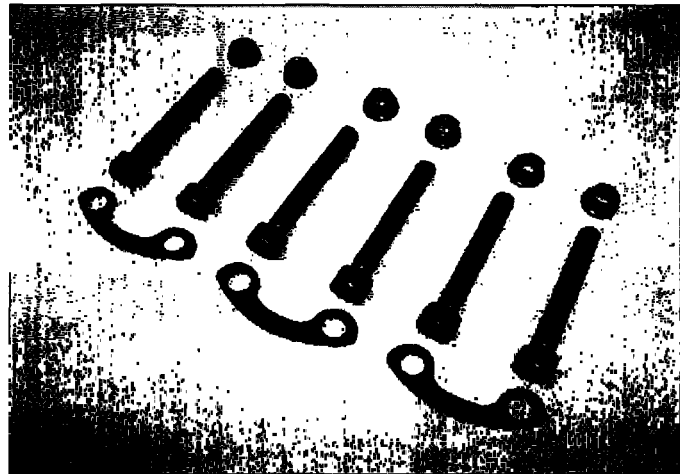
Figure 1b

- Propeller shaft bolt kit (see Figure 1b)

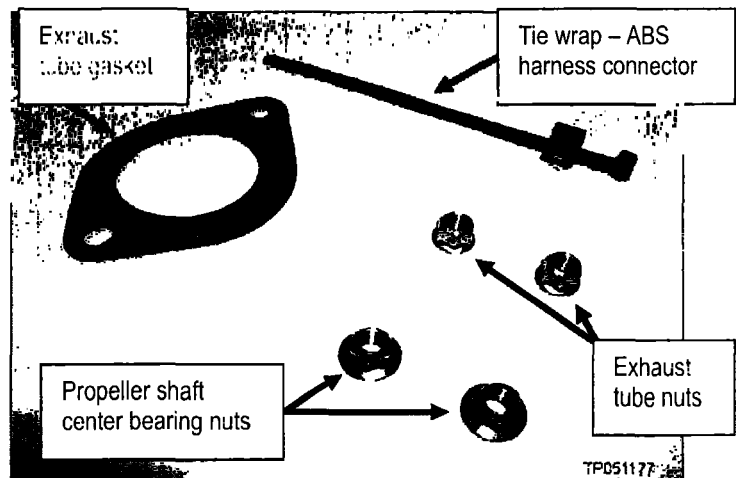
Figure 1c

- Propeller shaft center bearing nuts (see Figure 1c)
- Exhaust tube nuts (see Figure 1c)
- Exhaust tube gasket (see Figure 1c)
- Tie wrap - ABS harness connector (see Figure 1c)

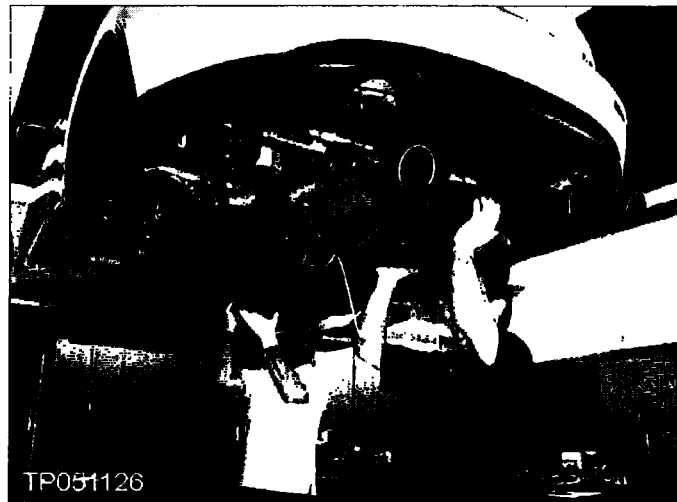
Figure 12

- Carefully remove the exhaust system and place it in a safe location (see Figure 12).

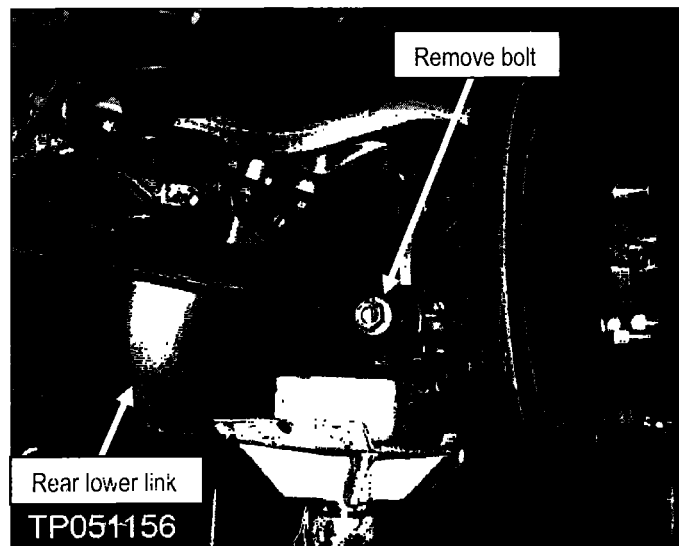
Figure 25

d. Place a support jack under the rear lower link and remove the nut/bolt that holds the link to the knuckle (see Figure 25).

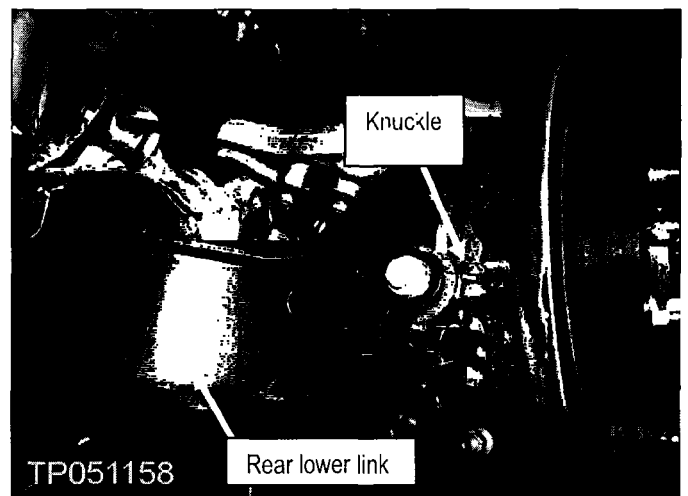
Figure 27

- f. After removing the coil spring, temporarily re-attach the rear lower link to the knuckle (see Figure 27).

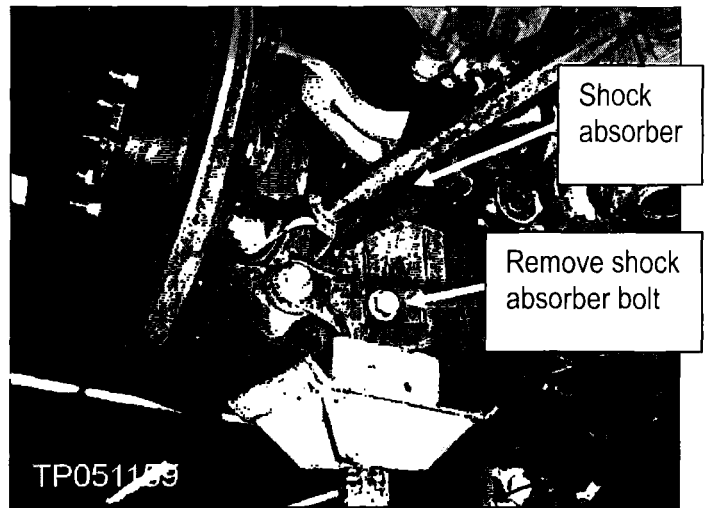
Figure 28

23. Now place a support jack under the front lower link and disconnect the shock absorber from the link (see Figure 28).

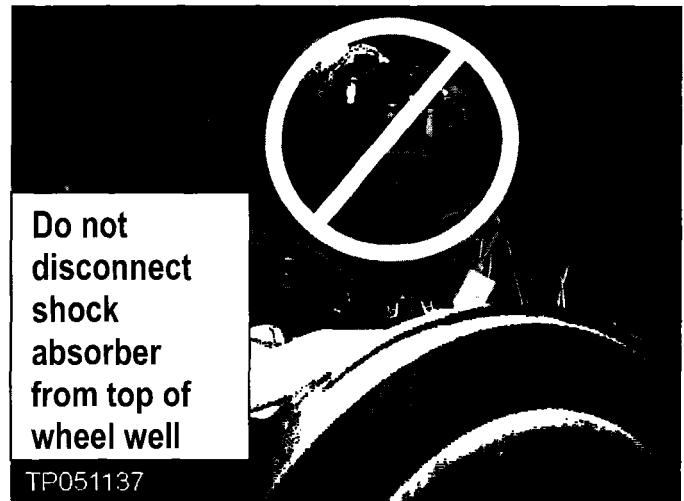
Figure 29

IMPORTANT: DO NOT disconnect the shock absorber from the studs at the top of the wheel well housing (see Figure 29).

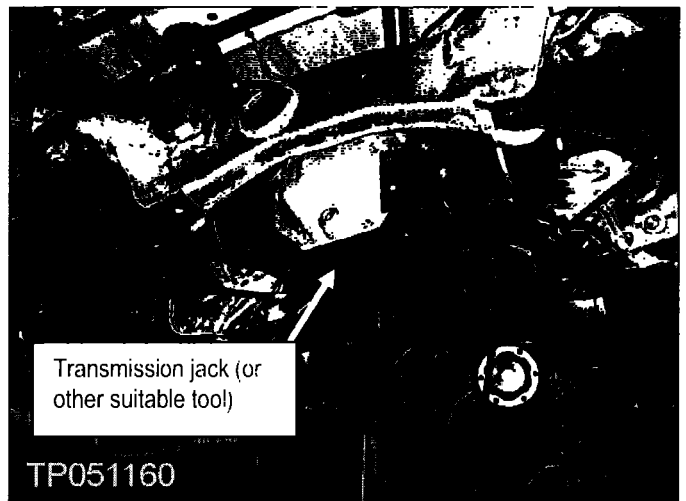
Figure 31

25. Place a transmission jack (or other suitable tool) under the rear differential (see Figure 31).

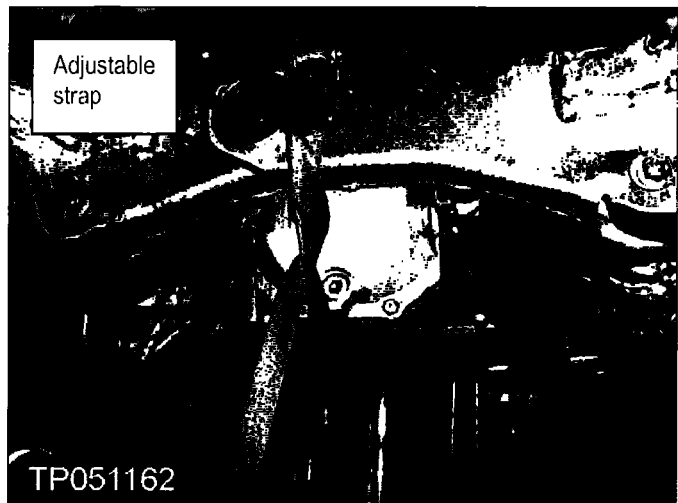
Figure 33

27. Secure the transmission jack to the rear differential with an adjustable strap (or other suitable "tie-down" device). See Figure 33.

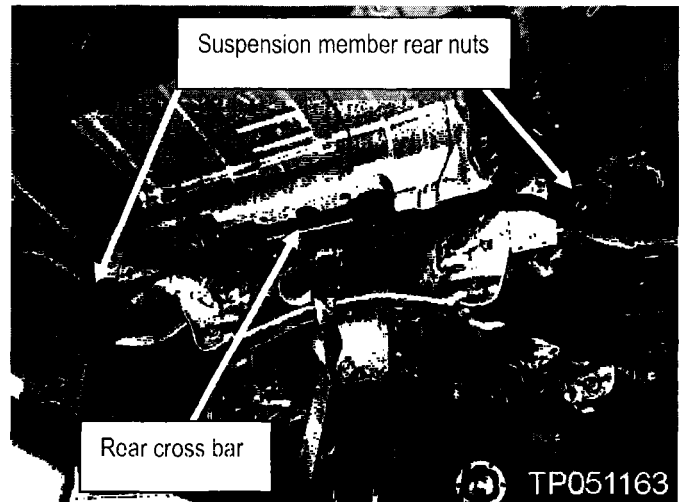
Figure 34

28. Remove the rear cross bar and suspension member rear nuts (see Figure 34).

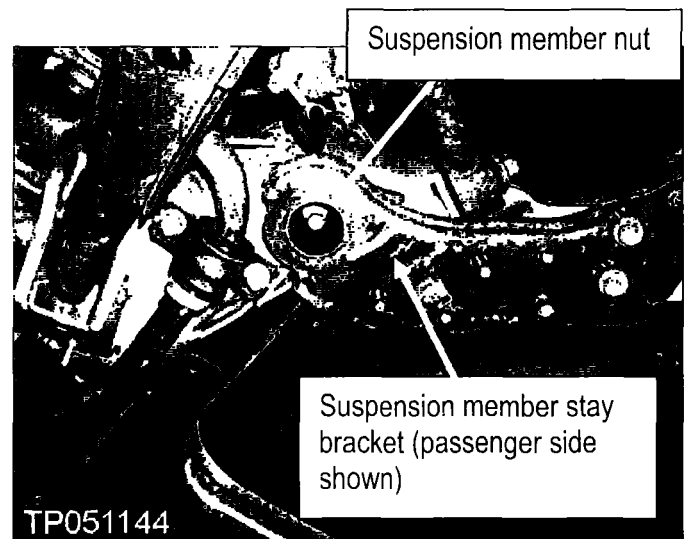
Figure 35

29. Remove the bolts and nuts that hold the suspension member "stay" brackets (see Figure 35). Then remove the stay brackets.

NOTE: The larger nuts hold the suspension member.

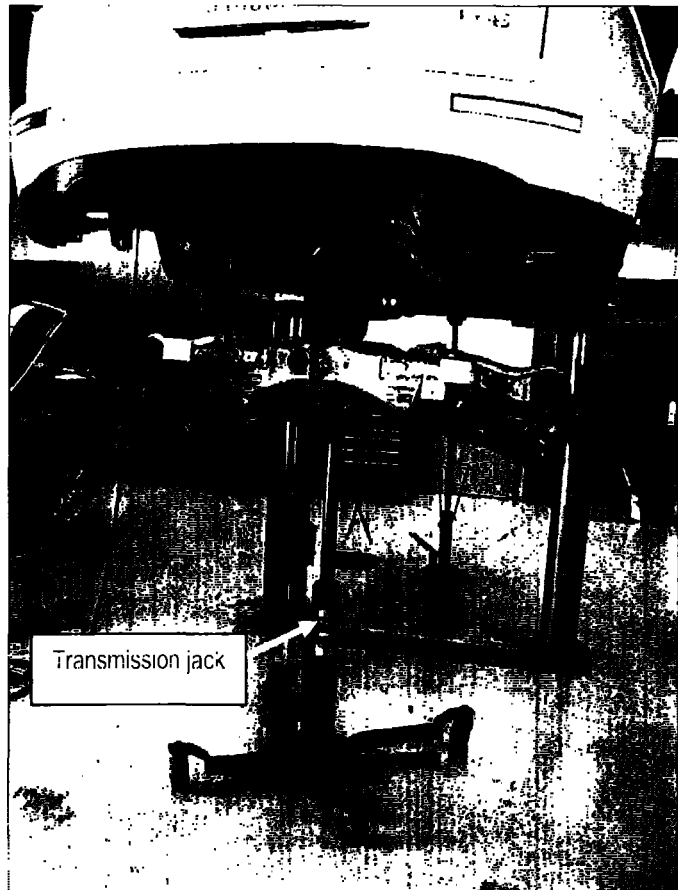
Figure 36

- Carefully lower the suspension member (see Figure 36) and place it in a safe location away from "traffic".

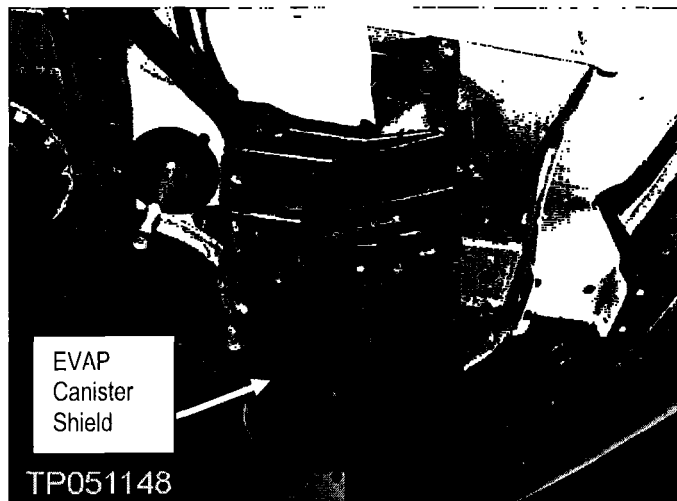
Figure 37

- Remove three nuts and remove the evaporative canister shield (see Figure 37).

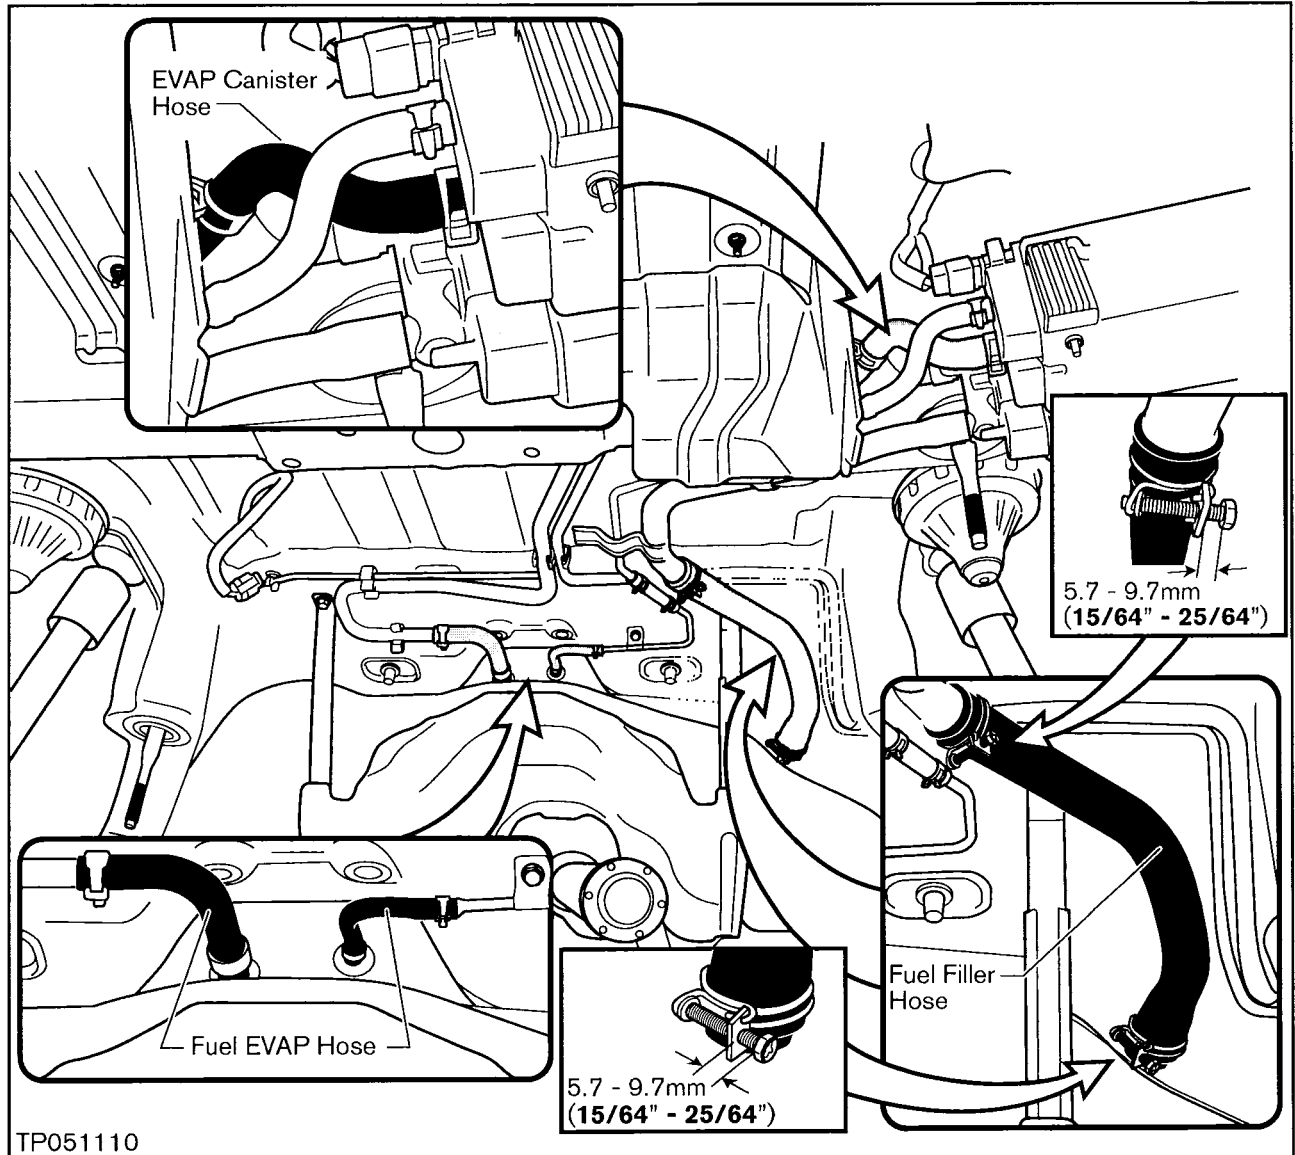
Figure 38

CAUTION: Make sure the fuel tank is less than 1/4 full before you perform this procedure.

1. Remove and replace the four fuel hoses (provided in the kit). See Figure 38.
 - Replace hoses one at a time, making sure they are correctly positioned and secured.
 - Tighten the fuel filler hose clamps so that the distance between the bolt head and metal plate is set to the proper dimension (see Figure 38).

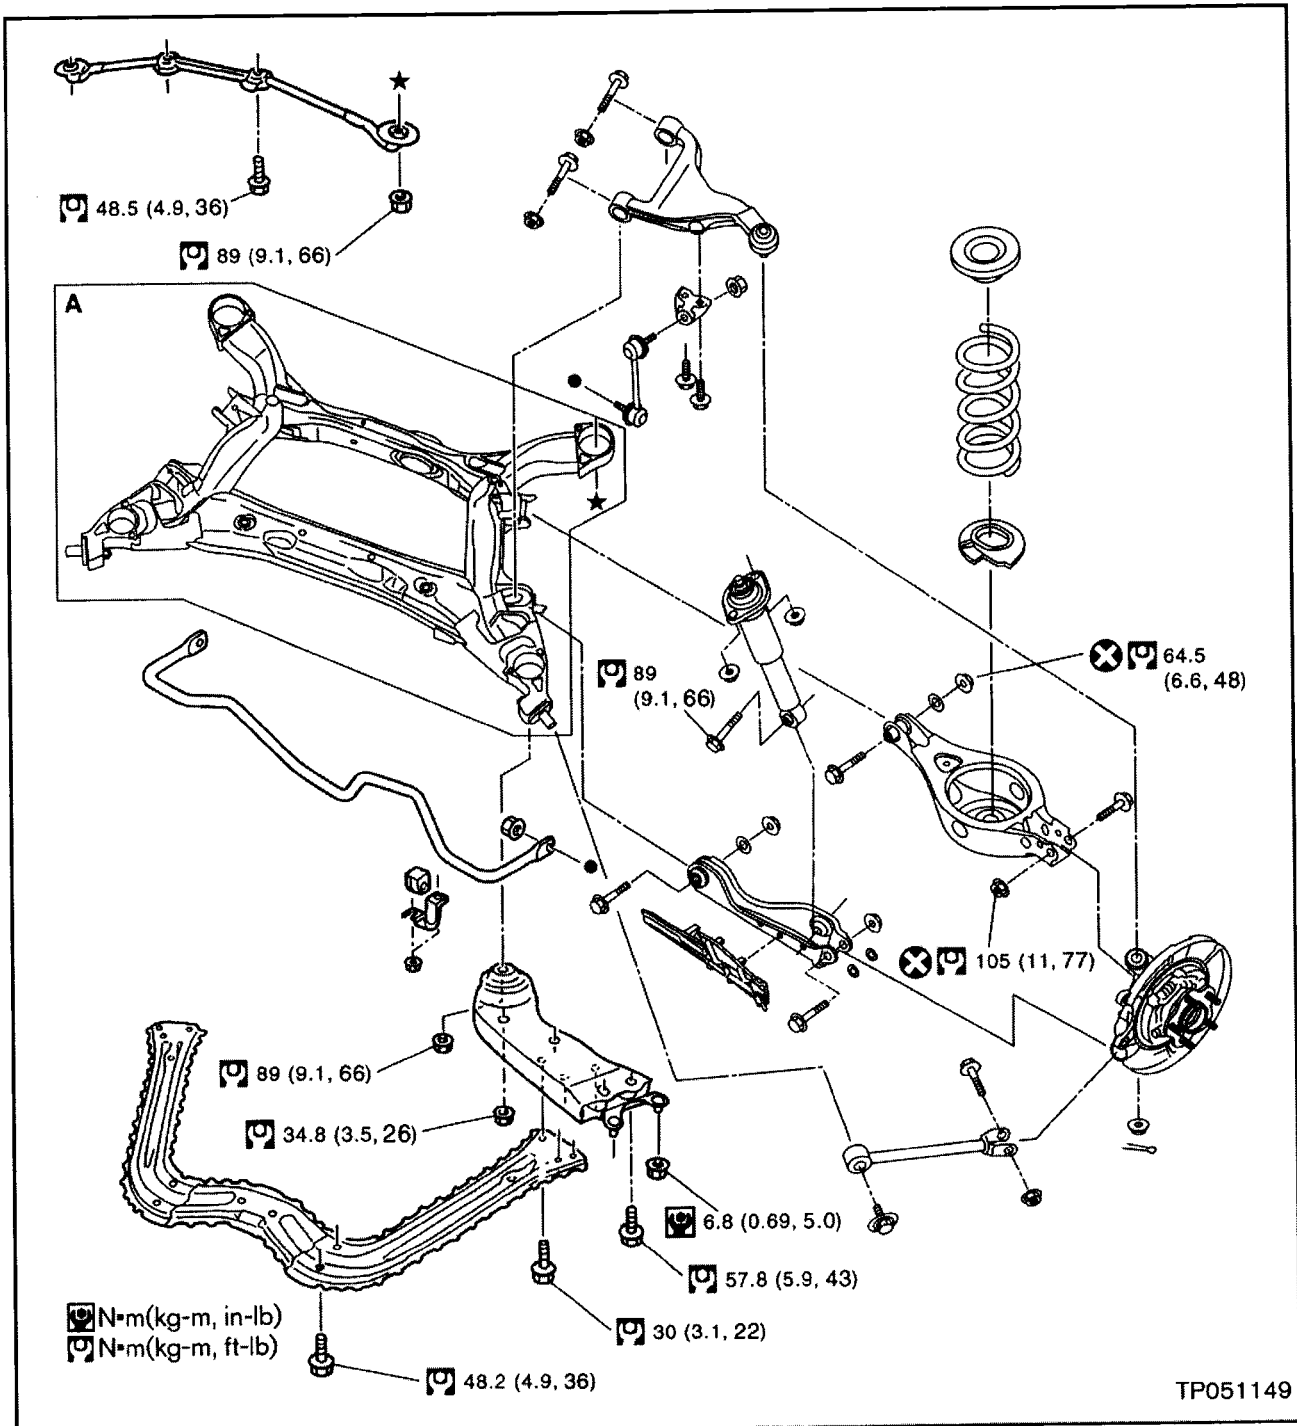
Figure 39

1. Re-install all components in the reverse order of removal, making sure of the following:
 - All suspension fasteners are tightened to the proper torque specification (see Figure 39).
 - All "index" marks are lined up.

- Use new nuts/bolts (provided in the kit) for securing the propeller shaft to the differential pinion flange. Tighten the nuts to: 56.9 Nm (5.8 kg-m, **42 ft-lb**).
 - Use new nuts (see Parts Information) for mounting the propeller shaft center bearing assembly. Tighten these nuts/bolts to: 44 Nm (4.5 kg-m, **70 ft-lb**).
 - Use a new gasket (see Parts Information) between the front and center exhaust tubes. Also, use new nuts (see Parts Information) for securing these tubes together.
2. Re-connect the negative battery cable.
 3. Re-program all radio station pre-sets.
 4. Perform a rear wheel alignment.
