## **WORKHORSE CUSTOM CHASSIS SERVICE BULLETIN**

**BULLETIN NO:** 60601-C

**SUBJECT:** 8.1 L Engine Fuel Rail Damper Retainer Clip

**MODELS:** 2004, 2005 and certain 2006 W20, W22, W24, P32, W52, W18 and FE20 models with 8.1L Gasoline Engine

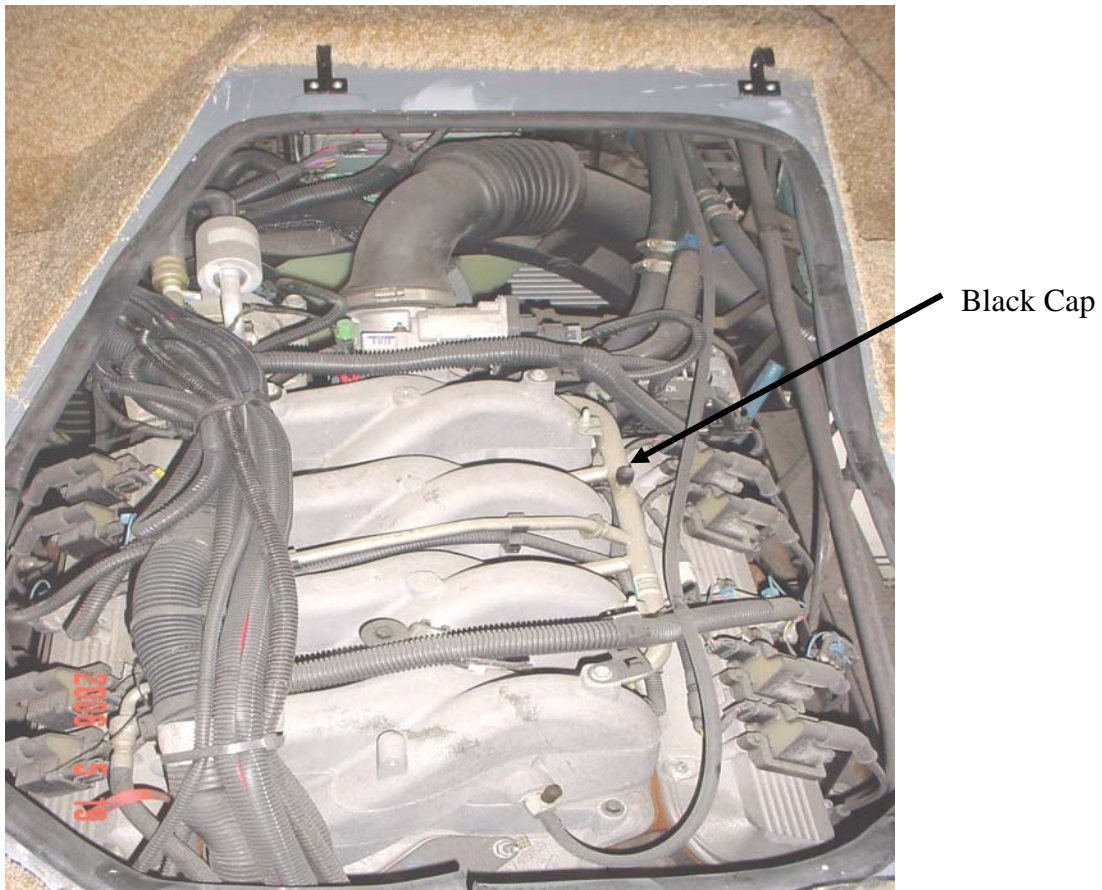
**Photo 1 Black cap on pressure valve on fuel rail on top RH side of Engine**

4. Loosen the fuel filler cap in order to relieve the tank vapor pressure.
5. Relieve any residual fuel pressure through the fuel pressure connection valve shown by photo 1 using a fuel pressure gage, or equivalent, and an approved fuel container. Wrap a shop towel around the fitting while connecting the gage in order to avoid spillage.

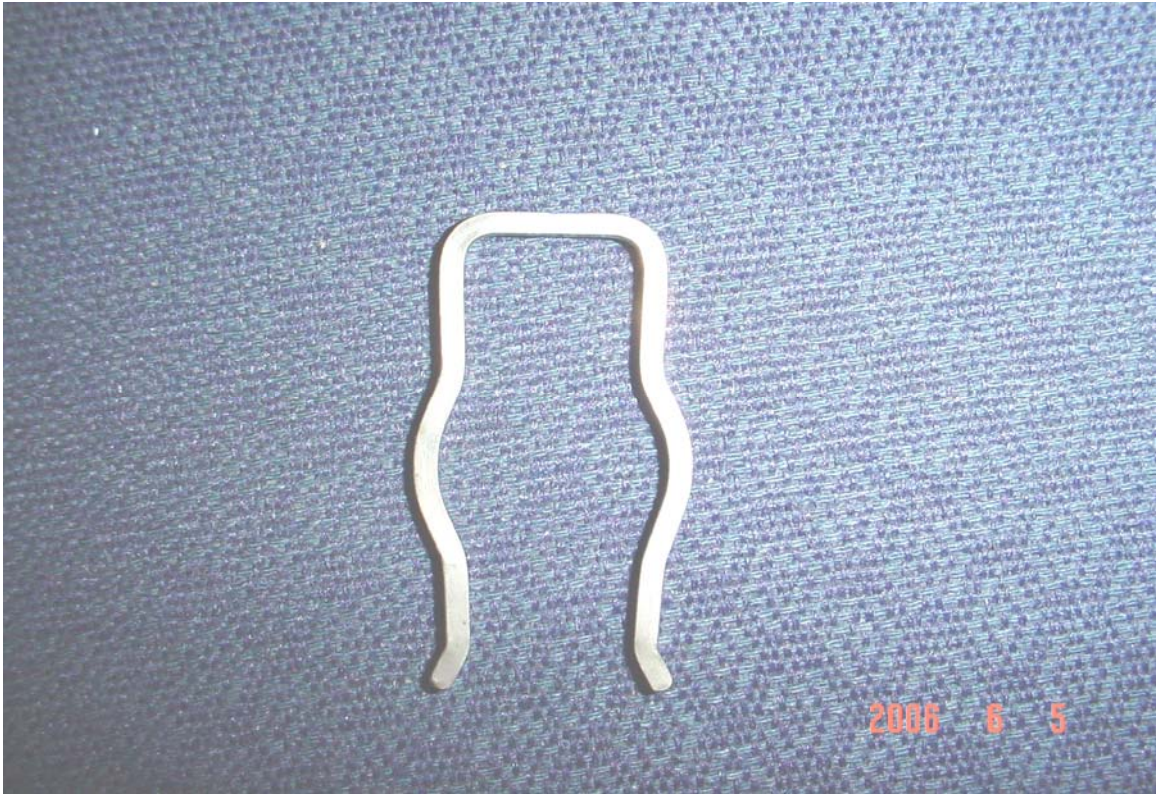
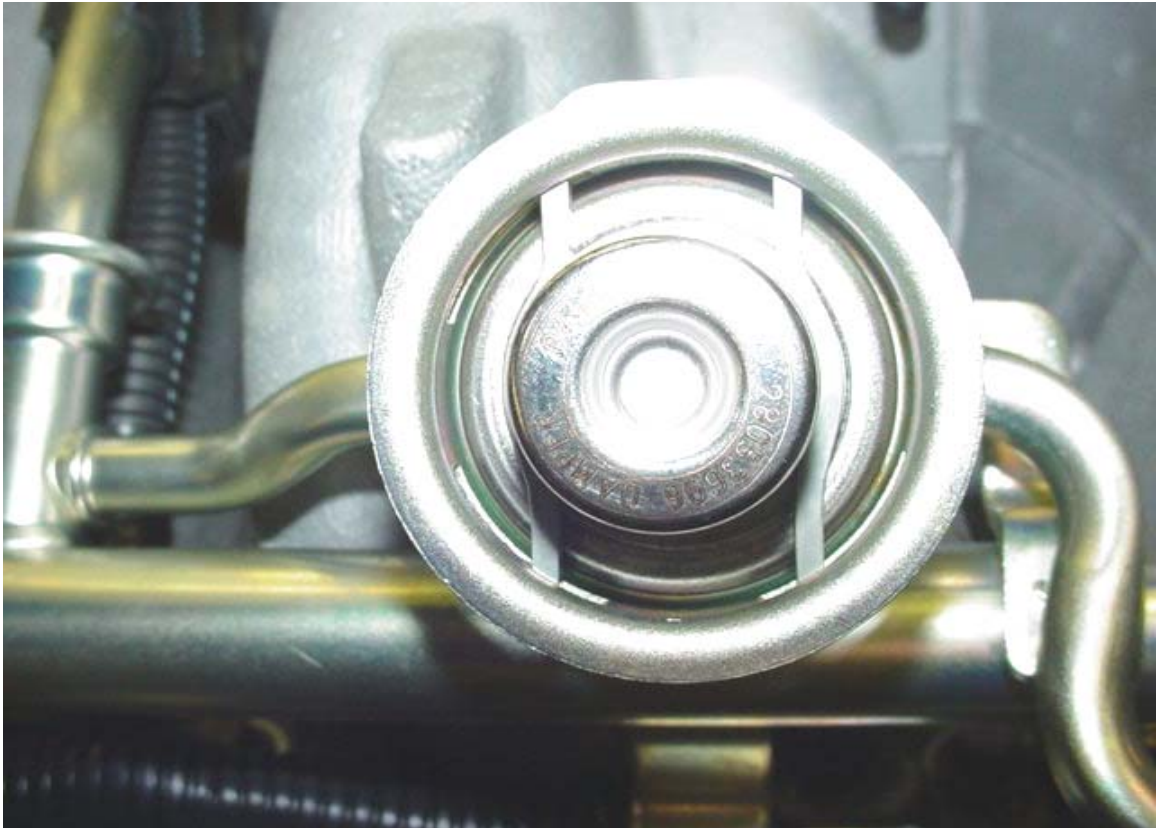
The defect involves an improperly heat treated fuel rail damper retainer clip that may have been installed on the subject engines. An improperly heat treated clip may break, possibly resulting in a gasoline leak at the fuel rail damper. A vehicle fire can result if the leaking fuel is ignited by a spark or flame.

**Photo 2 and 3 retaining clip and damper held by the clip**

6. Push down on the fuel damper while using a flat screw driver to remove the existing clip. (See photos 2 and 3)
7. Do not remove the fuel damper from the fuel rail. If the damper is removed the fuel damper o-ring must be replaced at the technician's/dealer's expense.

8. While holding down the damper, install the new clip in same position as removed clip.
9. Reconnect the negative battery cable.
10. Tighten the fuel filler cap.
