**SAFETY RECALL RVXX0601
SECOND NOTICE SEPT. 2006**

Volvo Trucks North America has decided that a defect which relates to motor vehicle safety exists in certain Volvo VHD, VNL, and VNM model vehicles manufactured with a Volvo D12 Engine from November 2002 through January 2006. These vehicles may be subject to a safety issue in the event that an Exhaust Gas Recirculation ("EGR") Cooler Pipe becomes damaged or loose.

SAFETY DEFECT: The EGR cooler inlet pipes and/or the pipes that connect the EGR valves to the cooler may fail (crack or break).

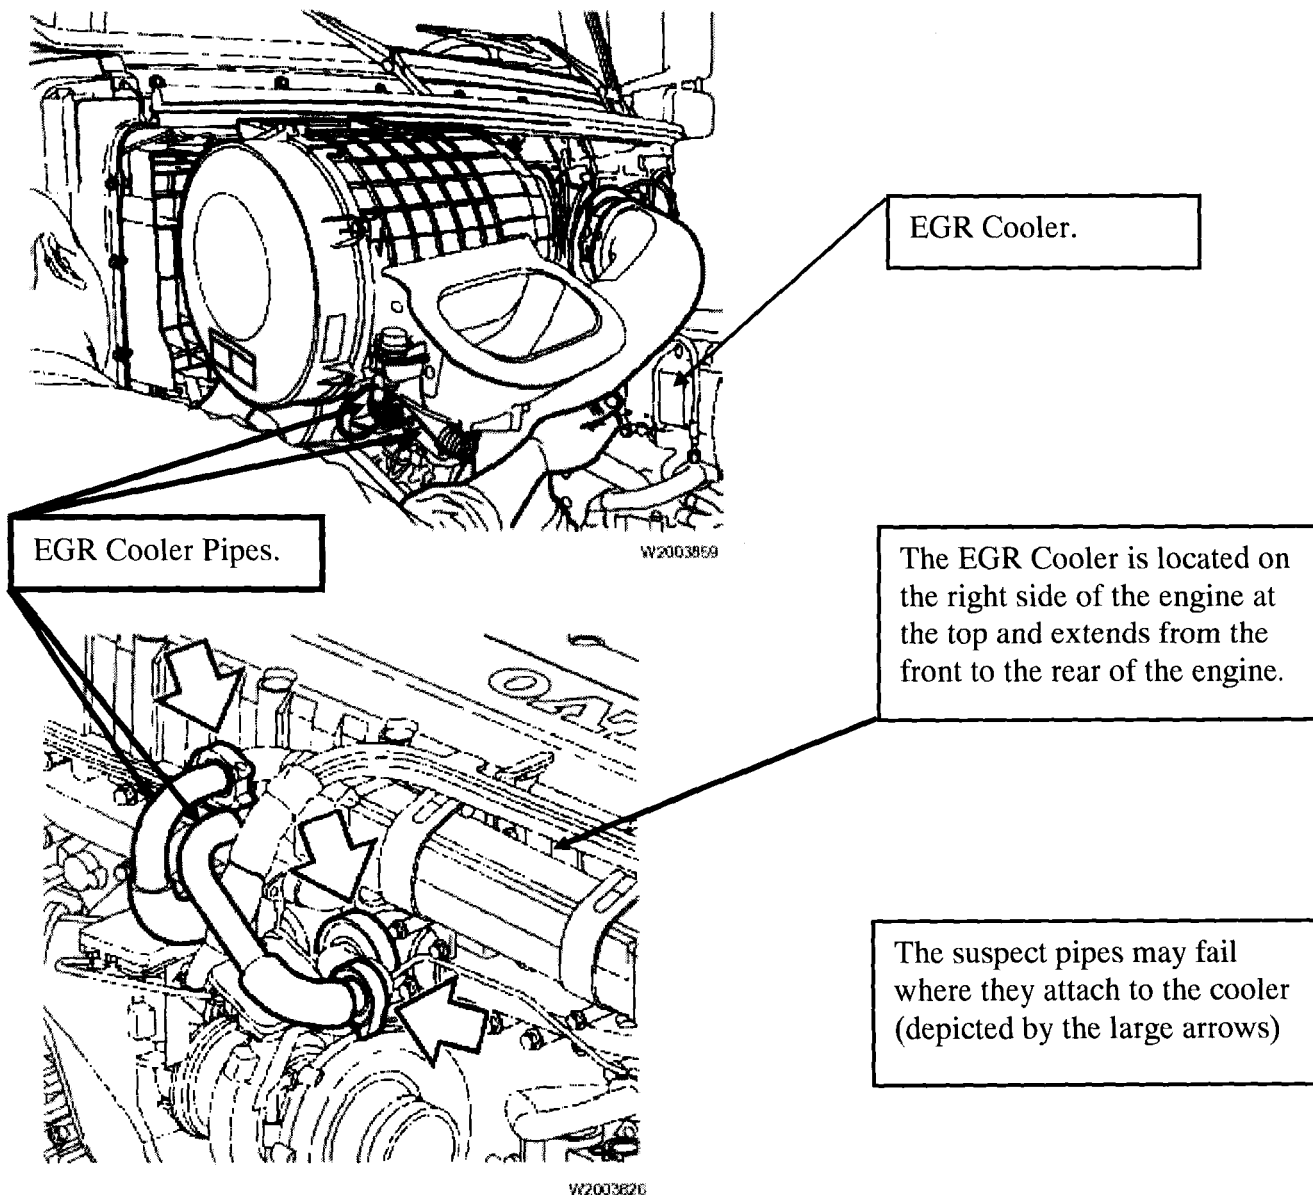
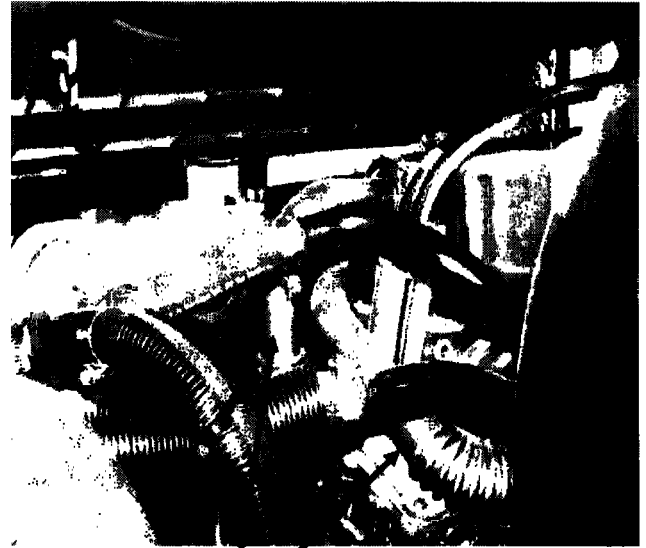
The EGR Cooler Pipes are located under the hood on the upper right side (passenger side) of the engine and can be seen by looking under the air cleaner at the rear of the engine. The following images/pictures show the EGR Cooler pipes and the inspection locations:

Arrows depict EGR Cooler Pipes

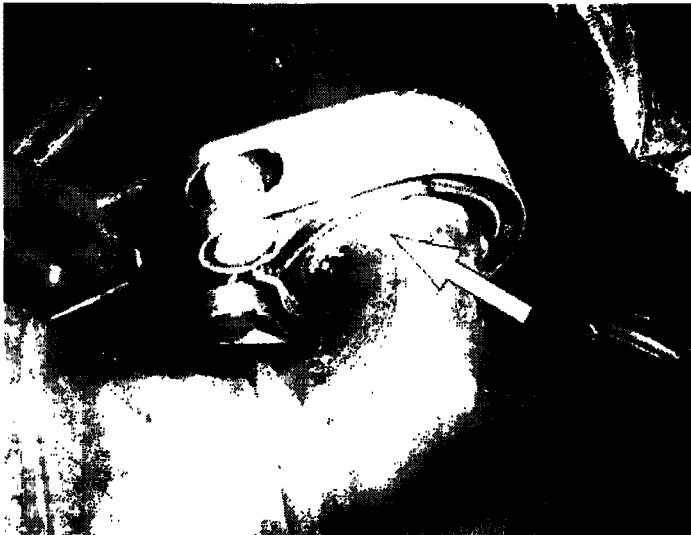
WARNING, EXTREMELY HOT! The EGR System operates at very high temperatures. Unsafe practices such as touching the EGR Cooler pipes before they have cooled can result in serious personal injury.

With the engine OFF **and the pipes cool**, inspect the area around the EGR cooler pipes for signs of cracks or separation of the pipe from the cooler. Sooting could indicate a loose clamp or a crack in an EGR cooler pipe.

If a pipe is cracked or leaking, contact your nearest Volvo Parts and Service Center for repair.

If a **pipe is separated**, **DO NOT OPERATE THE VEHICLE!** Contact the Volvo Action Service Support Center at 1-877-800-4945 for further instructions.
