Re: Draft Documents for Recall of:  
KTM 950 Adventure; 950 Adventure S; 950 Supermoto; 950 Superenduro; 2004,  
2005, and 2006 model year.

**PART 573 Defect and Noncompliance Report**

- » KTM North America has determined that a defect which relates to motor vehicle safety exists in all 2004, 2005 and 2006 950 Adventure, 950 Adventure S, 950 Supermoto and 950 Super Enduro models. To ensure the highest level of performance, reliability and customer satisfaction, it is necessary to update the rear brake system to the most current specifications. Please read this entire bulletin before taking any action as each model year requires individual kits!

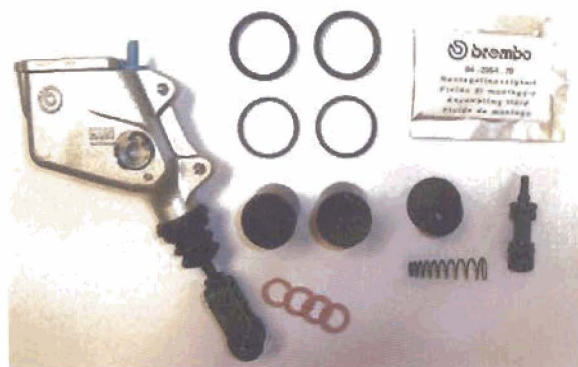
| RETROFIT – U1<br>Brake kit U1 (600 13 100 000) | |
|---|---|
| Cu-seal ring 4x | 42013226000 |
| Brake fluid DOT 5 1 liter | 00062030000 |

- » Please note that each model year requires different parts and repair procedures!! The model year of the motorcycle can be found in KTM Dealer.Net or by checking the 10<sup>th</sup> digit of the motorcycles VIN Number. Example VBKVA44056MXXXXXX is a 2006 model.
- » Factory Direct Modification - Retrofit U1 (600.13,100.000) is required for all 2004 models listed below. 50 minutes repair time. **Parts should only be ordered under the KIT PART NUMBERS at the top of the chart**

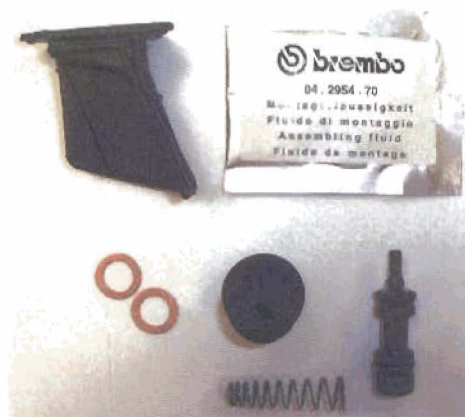
» **Factory Direct Modification - Retrofit U2 (600.13.100.100)** is required for all 2005 models listed below. 45 minutes repair time. **Parts should only be ordered under the KIT PART NUMBERS at the top of the chart.**

| RETROFIT – U2<br>Brake kit U2 (600 13 100 100) | |
|---|---|
| Repair kit piston | 60013061000 |
| Cu- seal ring 2x | 42013226000 |
| New Membrane | 60113065000 |

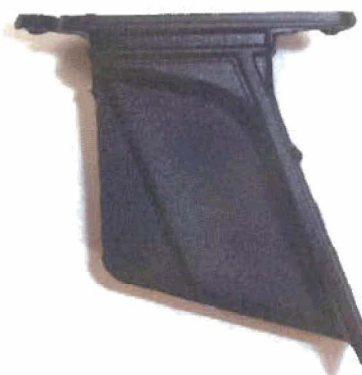
» **factory Direct Modification - Retrofit U3** is required for all 2006 models listed below. Please see chart for required parts and part numbers. 25 minutes repair time. **Parts should only be ordered under the KIT PART NUMBERS at the top of the chart.**

| RETROFIT – U3<br>Brake kit U3 (600 13 100 200) | |
| Brake fluid DOT 5.1 1/4l | 00062030000 |
| New Membrane | 60113065000 |

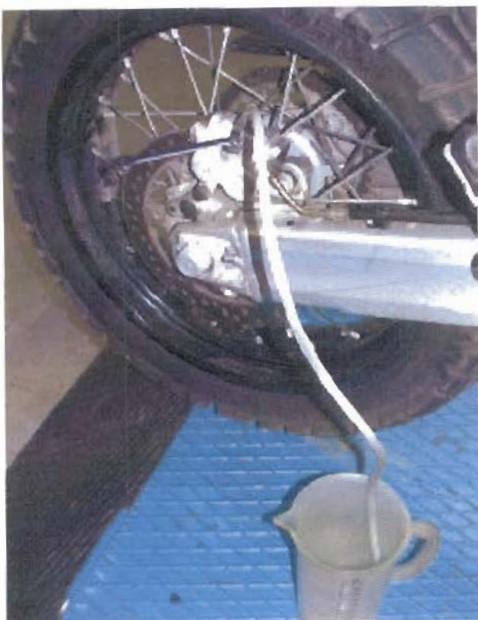
Picture 1

### Drain the rear brake fluid:

» Repair instructions for **U1 Retrofit**, for complete repair instructions please refer to the 950 / 990 Repair manual on CD # 3.206.035

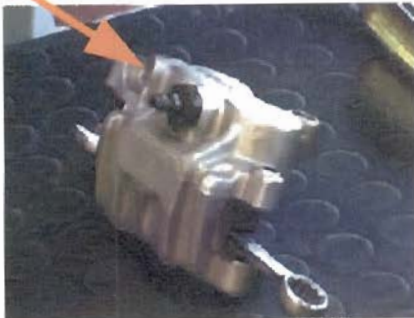
Picture 2

3. Use a spacer in place of the brake pads and blow compressed air into the brake line bore to push the pistons out. (picture 2)
4. Remove the caliper pistons, the scraper rings and the seal rings. Be careful not to cause any damage to the brake cylinder surface

» **Replacing the brake pistons in the rear brake caliper:**

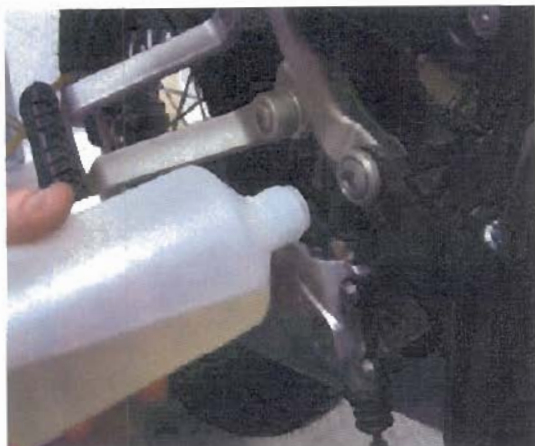
**Picture 3****» Fill and bleed the rear brake system:**

1. Fill the fluid in the master cylinder to the top. (picture 3)
2. Pump the brake pedal several times
3. Apply pressure to the brake and open the bleed screw
4. Close the bleed screw and slowly release the rear brake pedal
5. Repeat this procedure several times
6. Press the brake pedal down and secure it in this position
7. Open the bleed screw
8. Press the brake caliper against the brake disc so that the pistons are pushed back into the brake caliper. (picture 4)
9. Press the brake pedal fully down and close the bleed screw
10. Repeat this procedure several times until firm brake pressure is noticed
11. On the last repetition close the bleed screw without pressing down on the rear brake pedal

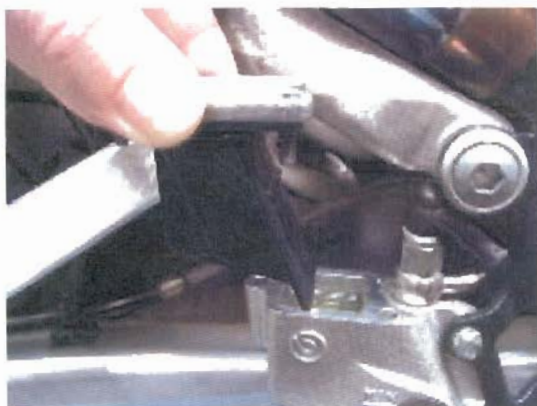
**Picture 5**

- » The reservoir must be filled at least 3mm over the full line so that the brake fluid overflows when the cap with the new membrane is mounted (picture 5) NOTE: Cover all painted parts to protect them from spilled brake fluid

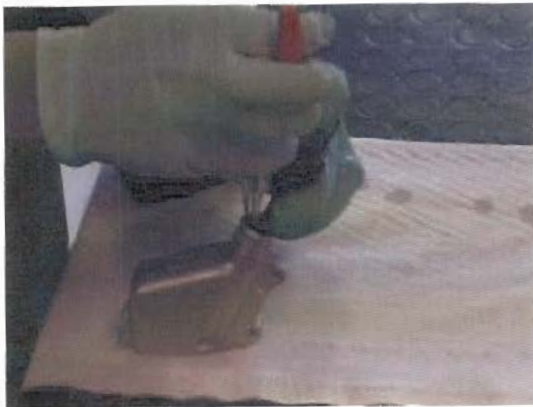
Picture 6

### » Replacing the master cylinder piston kit:

3. Lubricate and carefully install the new piston kit (600.13.061.000) into the master cylinder and secure it with the cir – clip.
4. Push the rubber cover back into position
5. Secure the master cylinder to the motorcycles frame using Loctite 243 on the 2 fasteners
6. Mount the brake line using new copper washers and connect the brake light switch to the master cylinder
7. Connect the master cylinder with the brake pedal
8. Replace the reservoir diaphragm with the new membrane (601.13.065.000)

1. Drain the rear brake fluid as described in **Retrofit U1** above
2. Remove the rear master cylinder from the motorcycle along with the rear brake light switch and the brake line from the master cylinder to the rear caliper. Remove the connection to the rear brake pedal.

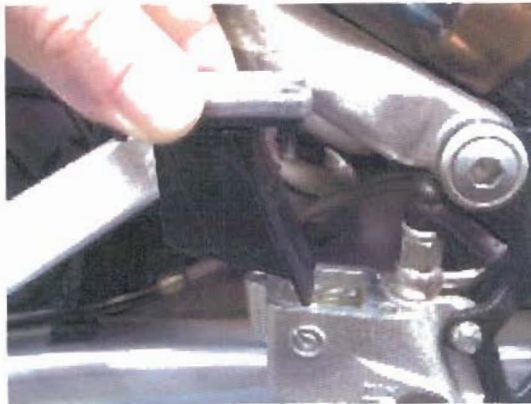
1. Replace the reservoir diaphragm in the master cylinder with the new membrane (601.13.065.000)
2. Fill and bleed the rear brake system as described in **Retrofit U1** and flush through at least 3 complete reservoirs of brake fluid DOT 5.1

- » **Confirm the rear brake pressure point:** Pump the rear brake pedal several times until the brake pads rest against the rear brake disc. Confirm solid brake pressure and carry out a test ride of the motorcycle.
- » **NOTE:** Normal wearing parts associated with the rear brake system of this motorcycle will not be covered under KTM Warranty. I.e. brake pads, brake rotor(s) and etc...
