NOTICE OF SAFETY RECALL

Re: Voluntary Recall of Hitching Post Pro, Expressway and Trailblazer Hitch-Style Bicycle Racks

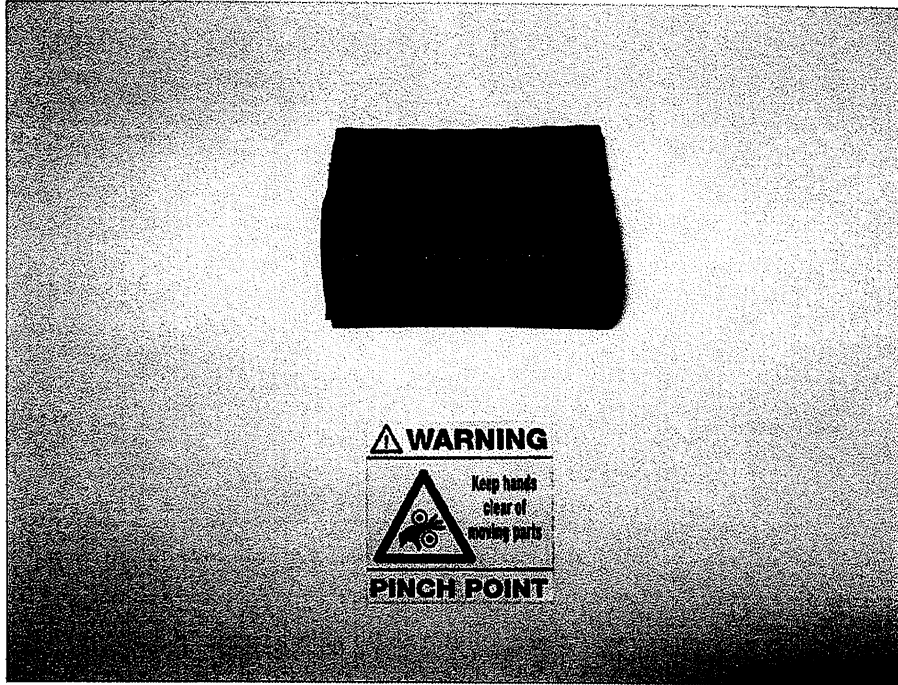
PARTS INCLUDED
PIÈCES INCLUSES
PIEZAS INCLUIDAS

part pièce parte	description description descripción	part number numéro de pièce numero de parte	qty. qte cant.
A	bumper / pare-choc / amortiguador	753-3859	1
B	warning label / étiquette d'avertissement / etiqueta de advertencia	515-5213	1

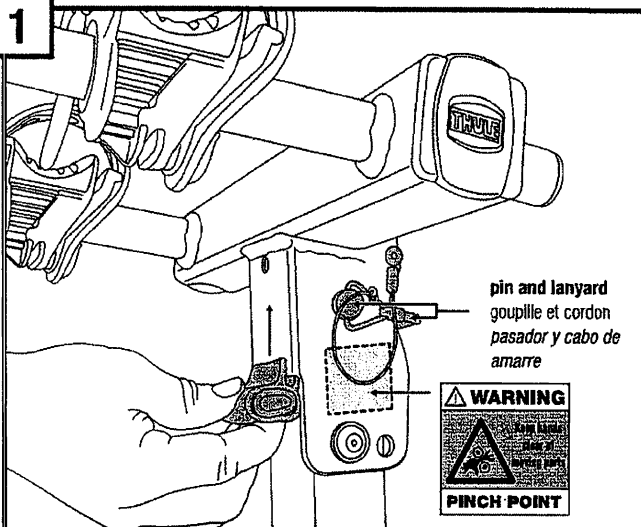
WARNING: Ensure pin and lanyard are secured before installing bumper and warning label.

- **With carrier in secured upright position, press bumper onto bracket location as illustrated.**

- **Install warning label in location as illustrated.**

TIP: Moisten edge of bracket to ease installation of bumper.
CONSEIL: Mouillez le bord du support pour faciliter l'installation du pare-choc.
CONSEJO: Humedezca el borde de la ménsula para facilitar la colocación del amortiguador.

We have recently determined that a pinch point exists between the bike arm bracket and the upright assembly of the hitch-style bicycle rack. When moving the bike arm bracket to its down position, the pinch point has the potential to cause severe injury.

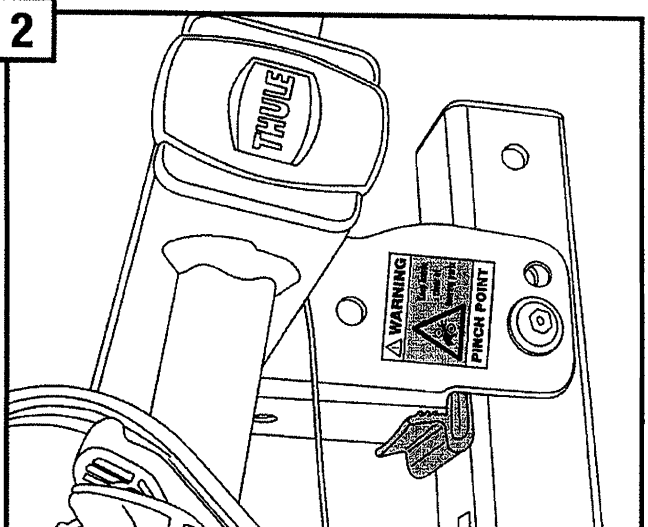
- **Remove pin and lanyard, lower upper bike arm assembly and ensure proper function of bumper as illustrated.**
