**Re: Defect Information Report (FL-498), NHTSA 07V-250, Supplemental No.: 1**

Subject: RECALL 07V-250 – Fuel Fill Installation

# Repair Procedure

SUBJECT: FUEL FILL INSTALLATION

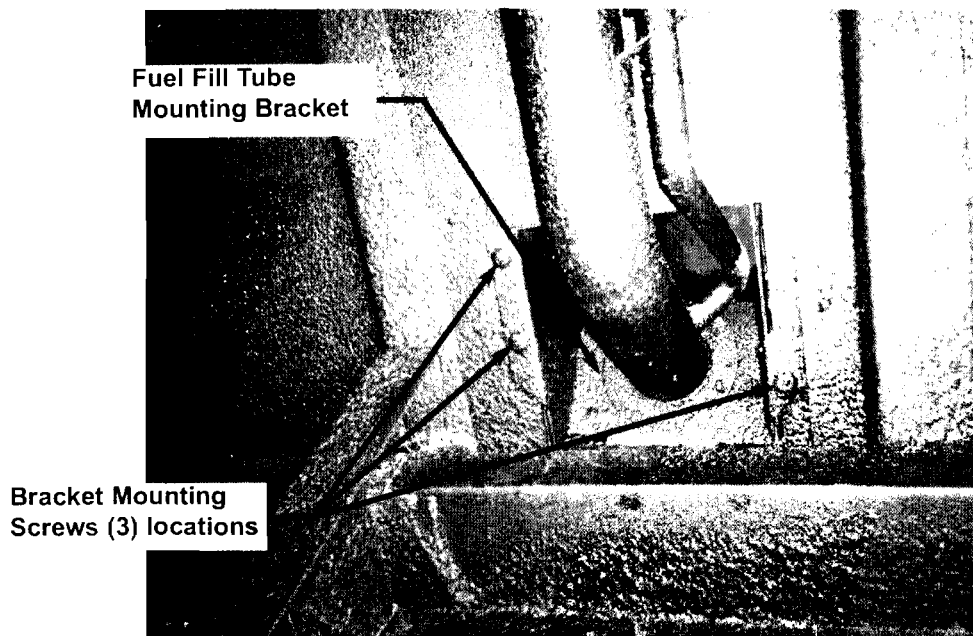
Figure 1

- 1) Park vehicle.
- 2) Secure wheels with wheel chocks.
- 3) From under vehicle, locate the Fuel Fill Tube Mounting Bracket. **Figure 1**

- 4) Proper mounting of this bracket would involve: (See **Figure 1** for proper placement.)
  - a. Tighten Mounting screws completely down to floor.
  - b. Install a minimum of three (3) Screws, part #TBB 69003123.
  - c. Place Bracket squarely in opening.
