August 22, 2007

**SUBJECT: DEMONSTRATION / DELIVERY HOLD:** Safety Recall 07S56:  
Certain 2008 Explorer, Mountaineer, and Sport Trac Vehicles Equipped With 6R  
Transmission – Oil Cooler Line Attachment Bolt Torque

Certain 2008 Explorer, Mountaineer, and Sport Trac Vehicles Equipped With 6R Transmission  
Oil Cooler Line Attachment Bolt Torque

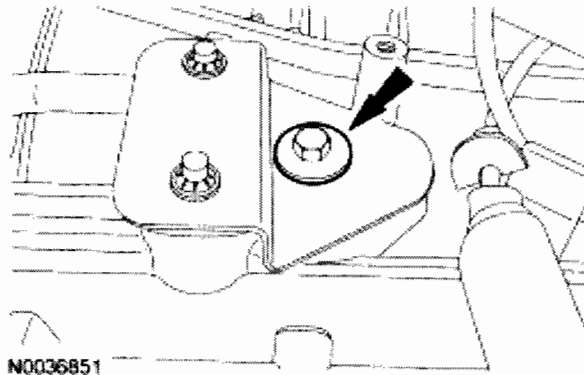
1. Lift vehicle and locate the transmission fluid cooler line attachment bolt on the left side of the transmission. (See illustration below.)

2. Tighten Transmission Fluid Cooler Line Attachment bolt to 25 Nm (18 lb-ft).
