**NHTSA CONSUMER ADVISORY: Secure Floor Mats in 2007/2008 Lexus ES 350, Camry, Other Toyotas. Advisory Also Extended to Other Vehicles.**

***Toyota to Conduct Floor Mat Recall***

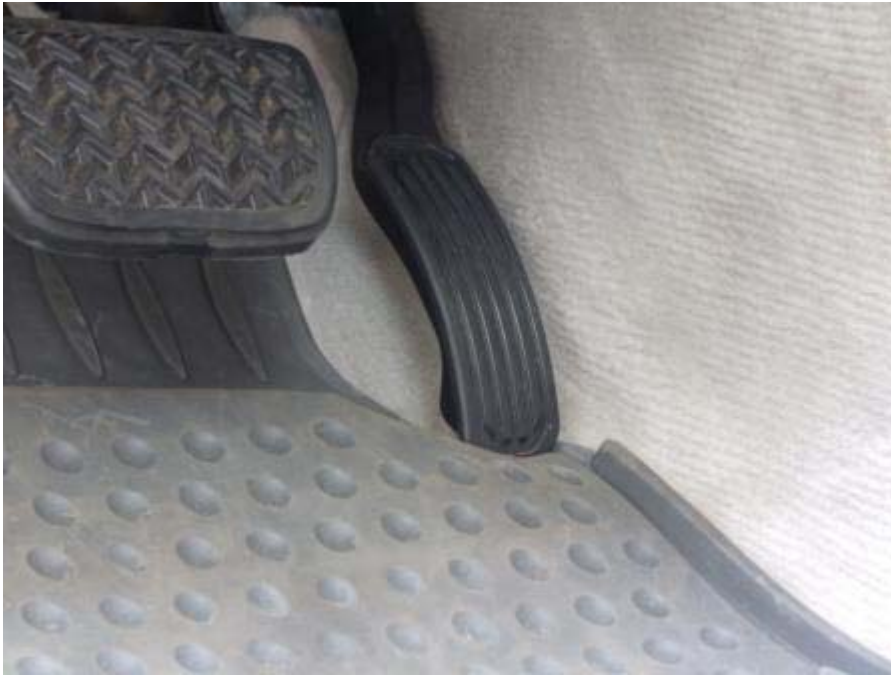
NHTSA and Toyota noted that, if unsecured, the mats being recalled can slip forward and trap the accelerator pedal, causing the vehicle to accelerate uncontrollably.

***Example of an unsecured driver-side floor mat trapping the accelerator pedal in a 2007 Lexus ES350***

While the recall is underway, drivers of these Toyota vehicles are strongly urged to make sure the driver-side floor mat is properly secured to the retention hooks on the floorboard. Also, never overlay two mats on top of each other because the retention hooks cannot secure the top-most mat which can then slip and trap the accelerator pedal.

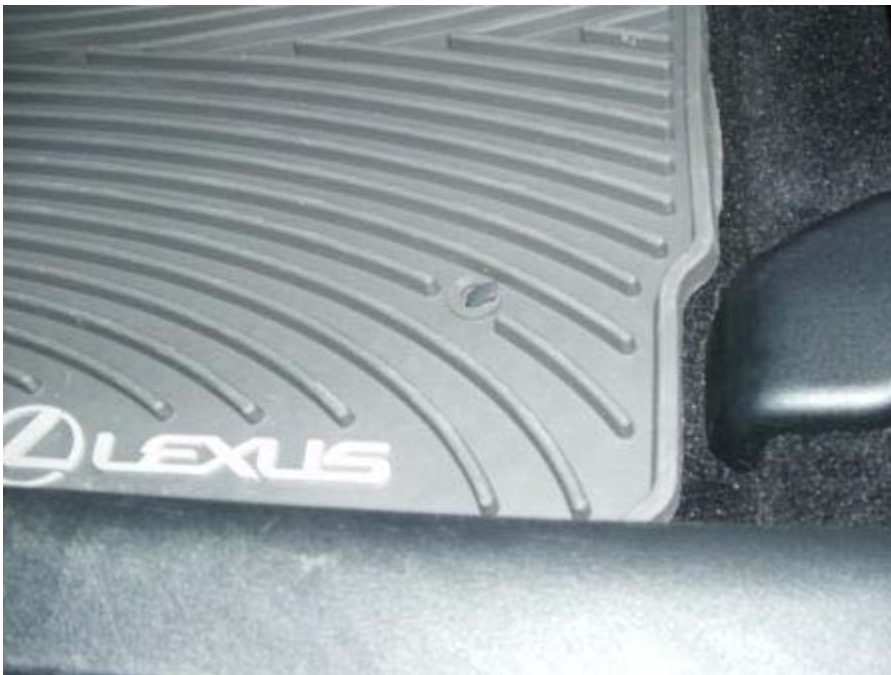
***Always make sure your driver-side floor mat is properly secured by the tabs. Never overlay two mats on top of each other because the top-most mat can not be secured properly by the retention hooks.***
