## Harsco Track Technologies

### SERVICE BULLETIN

**DATE:** 2-2007 **BULLETIN NO:** 02-036A

**TITLE:** 200457 STEERING STOP GROUP

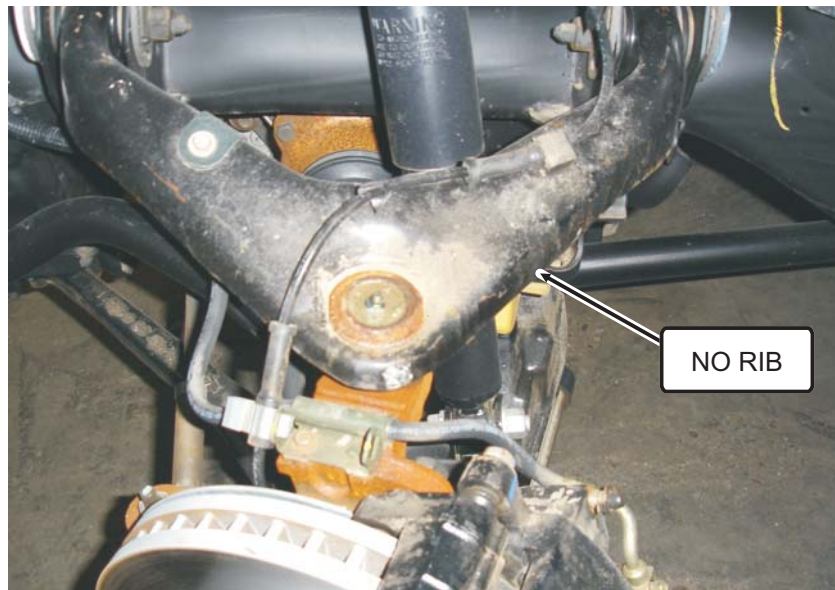
FIGURE 2  
UPPER CONTROL ARM WITHOUT RIB

1. Determine if a control arm guard plate is or is not needed.
  - a. If the control arm on the vehicle does not have a rib, as shown in Figure 2, a guard plate is needed. Go to 3.1 Installing Control Arm Guard Plate.
  - b. If the control arm on the vehicle has a rib, as shown in Figure 3, a guard plate is not required. Go to 4.0 Anti-Lock Brake Sensor Wire Relocation.
