R07LW

# Emergency Exits

**MODELS AFFECTED:** Certain A3FE & A3RE units manufactured from January 14, 2005 through March 13, 2007.

# RECALL

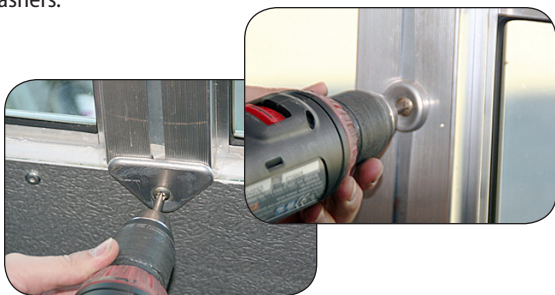
**4** From inside bus, remove 6 window retaining screws and washers.

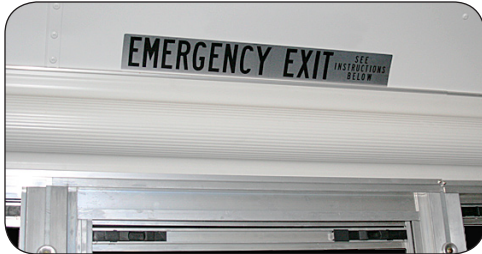
- 18.1 Apply decal #1495399 (**EMERGENCY EXIT-SEE INSTRUCTION BELOW**) directly above window on headlining panel. **Do NOT** apply to wire molding.

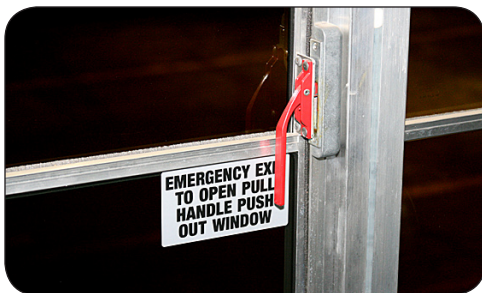
- 18.2 Apply decal #0812222 (**EMERGENCY EXIT TO OPEN PULL HANDLE PUSHOUT WINDOW**) to glass. Locate decal on lower sash glass 6 inches from latch handle.

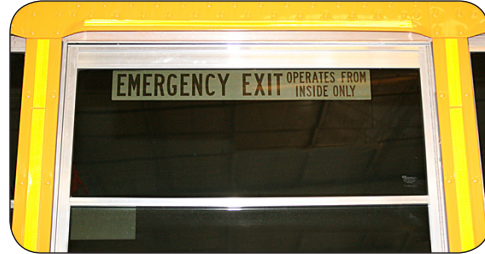
- 18.3 Apply decal #1495530 (**EMERGENCY EXIT-OPERATES FROM INSIDE ONLY**) at top and centered on upper sash glass. Decal to be read from outside bus.
