## Re: Defect Information Report – Supplemental Report No. 5 07V-343, FL-509, ZF 8018 Steering Gear Spacer, Phase 3

**December 2008  
FL509 -- Phase 3  
NHTSA #07V-343  
TC #07-252**

**Recall Notification  
Subject: ZF Lenksysteme 8018 Steering Gears**

**Models Affected: Specific Freightliner Custom Chassis VCL, XB, and XC motorhome chassis manufactured between June 13, 2002, and June 13, 2007, with certain independent front suspension assemblies with ZF Lenksysteme 8018 steering gears.**

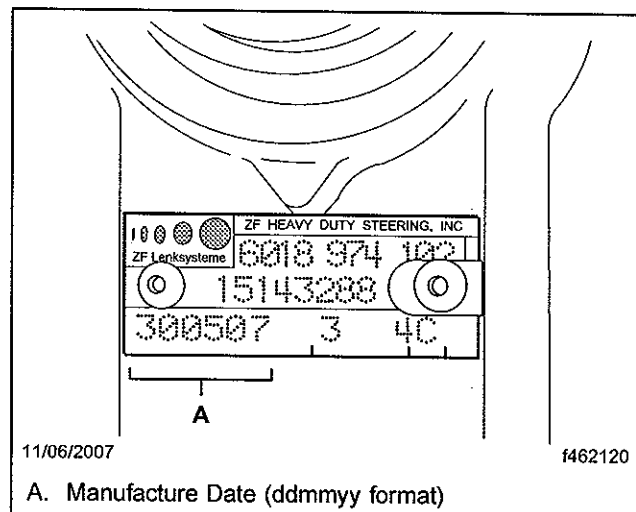
Fig. 1, Data Plate Identification

2. Shut down the engine, set the parking brake, and chock the tires.
3. Check the date code on the data plate of the steering gear. See **Fig. 1**.
  - 3.1 If the date code is 250407 or more, nothing further needs to be done. Go to Step 4.

- 3.2 If the date code is less than 250407:  
If the vehicle is in FL509A, go to "Steering Gear Replacement."  
If the vehicle is in FL509B or FL509C, go to "Mileage Inspection."

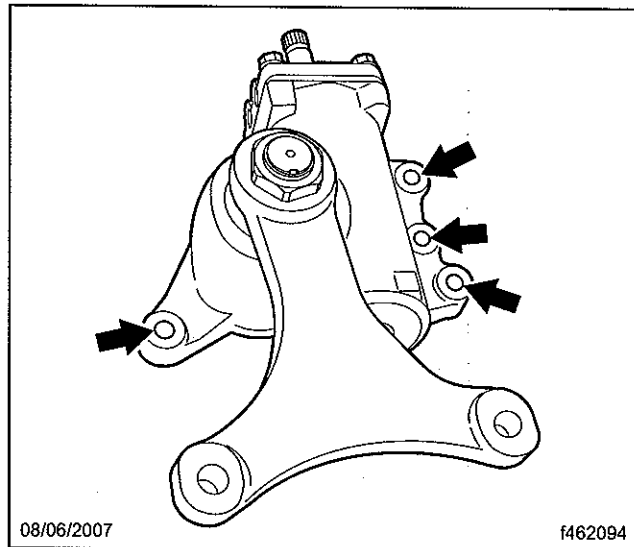
Fig. 2, Steering Gear Mounting Bolts

5. Remove the steering gear.
    - 5.1 Using a 1-3/16 impact socket, loosen the four mounting bolts. See **Fig. 2**.
- IMPORTANT: Use two assistants while performing the following procedures.
- 5.2 Remove three nuts, leaving the centermost assembled in order to prevent the steering gear from falling.
  - 5.3 Position 1 x 4 boards (as needed) across the lower control arms, and use a transmission jack to support and receive the gear when it's disconnected. Remove the last nut, lower the gear, and remove to one side.

6. Install the new steering gear.  
**IMPORTANT:** Use two assistants while performing the following procedure.
    - 6.1 Position the new steering gear and pitman arm below its assembled position.

- 6.2 Using a transmission jack, lift the gear into place, piloting on the mounting bolts, then quickly thread at least one nut into place to prevent the gear from falling.

- 6.3 Install all remaining nuts, then tighten all four nuts 378 to 462 lbf-ft (18 to 22 N·m).
    - 6.4 Connect the pressure and return hoses to the steering gear.
