## **Re: Defect Information Report – Supplemental Report No. 4 07V-343, FL-509, ZF 8018 Steering Gear Spacer, Phase 2**

## **Subject: ZF Lenksysteme 8018 Steering Gears**

**Models Affected: Specific Freightliner Custom Chassis VCL, XB, and XC motorhome chassis manufactured between June 13, 2002, and June 13, 2007, with certain independent front suspension assemblies with ZF Lenksysteme 8018 steering gears.**

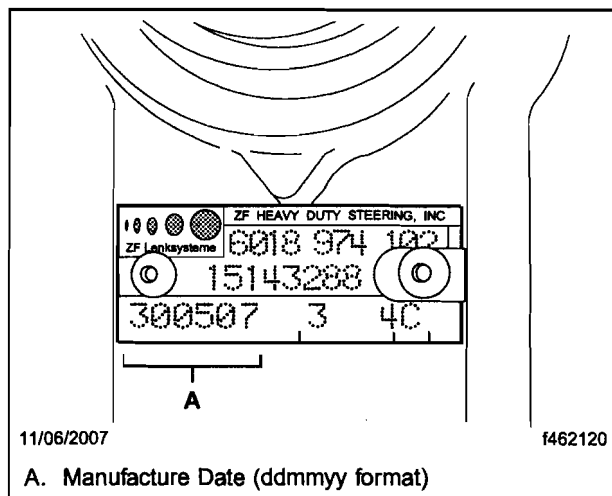
Fig. 1, Data Plate Identification

1. Check the base label (Form WAR259) for a completion sticker for FL509 (Form WAR260) indicating this work has been done. The base label is usually located on the front wall under the dash in motor homes. If a sticker for FL509 is present, nothing further needs to be done. If a sticker is not present, go to the next step.
2. Shut down the engine, set the parking brake, and chock the tires.
3. Check the date code on the data plate of the steering gear. See Fig. 1.
  - 3.1 If the date code is 250407 or more, nothing further needs to be done. Go to Step 4.
  - 3.2 If the date code is less than 250407:  
If the vehicle is in FL509A, go to "Steering Gear Replacement."  
If the vehicle is in FL509B or FL509C, go to "Mileage Inspection."

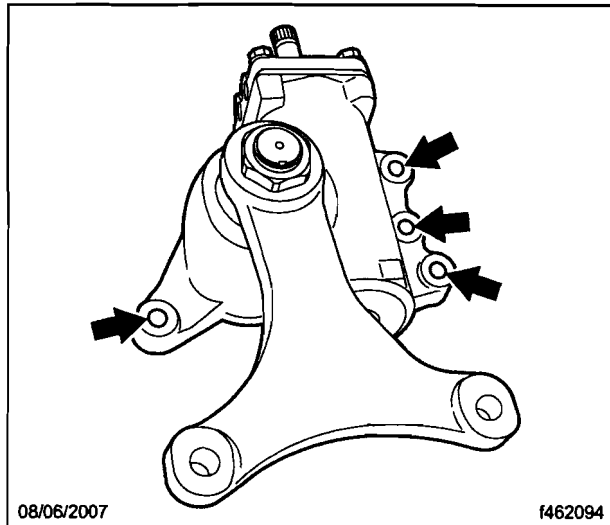
**Fig. 2, Steering Gear Mounting Bolts**

5. Remove the steering gear.
  - 5.1 Using a 1-3/16 impact socket, loosen the four mounting bolts. See **Fig. 2**.  
**IMPORTANT:** Use two assistants while performing the following procedures.
  - 5.2 Remove three nuts, leaving the centermost assembled in order to prevent the steering gear from falling.
  - 5.3 Position 1 x 4 boards (as needed) across the lower control arms, and use a transmission jack to support and receive the gear when it's disconnected. Remove the last nut, lower the gear, and remove to one side.

- 6.3 Install all remaining nuts, then tighten all four nuts 378 to 462 lbf-ft (18 to 22 N·m).
    - 6.4 Connect the pressure and return hoses to the steering gear.
