Tiffin Motorhomes is sending you this letter advising you of a problem with the front TV. It is not secured sufficiently and could fall out when the motorhome is moving. Please follow the work instructions enclosed to make this repair. We are sending you screws "Next Day Air" UPS to use. We are allowing **a half hour** for this job. Do not allow this motorhome to be driven by potential customers until this repair has been made. Please fill out the form attached and send in with warranty claim to be paid. This repair must be made as soon as possible as it has the potential to be very dangerous. **Absolutely under no circumstances are you to allow a customer possession of the motorhome until the repair has been made.**

## **ALLEGRO T.V. PROBLEM**

# Allegro Front TV Service Installation

WI-000138

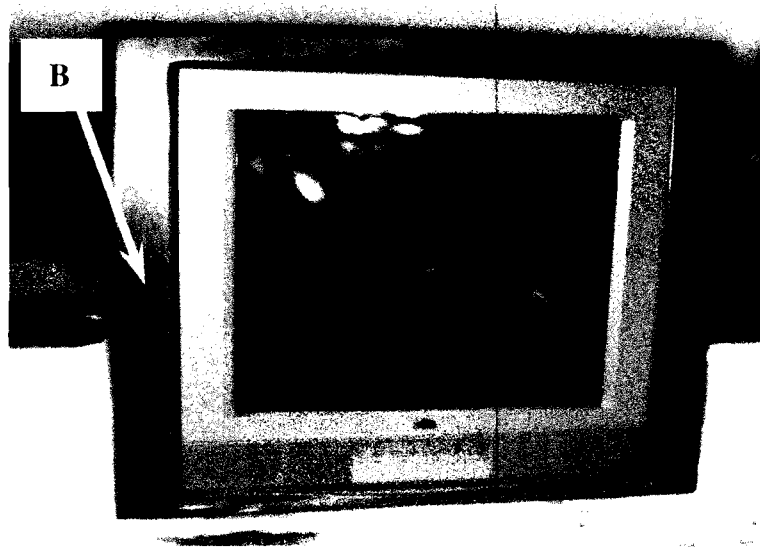
2. Remove the TV Ring "B".

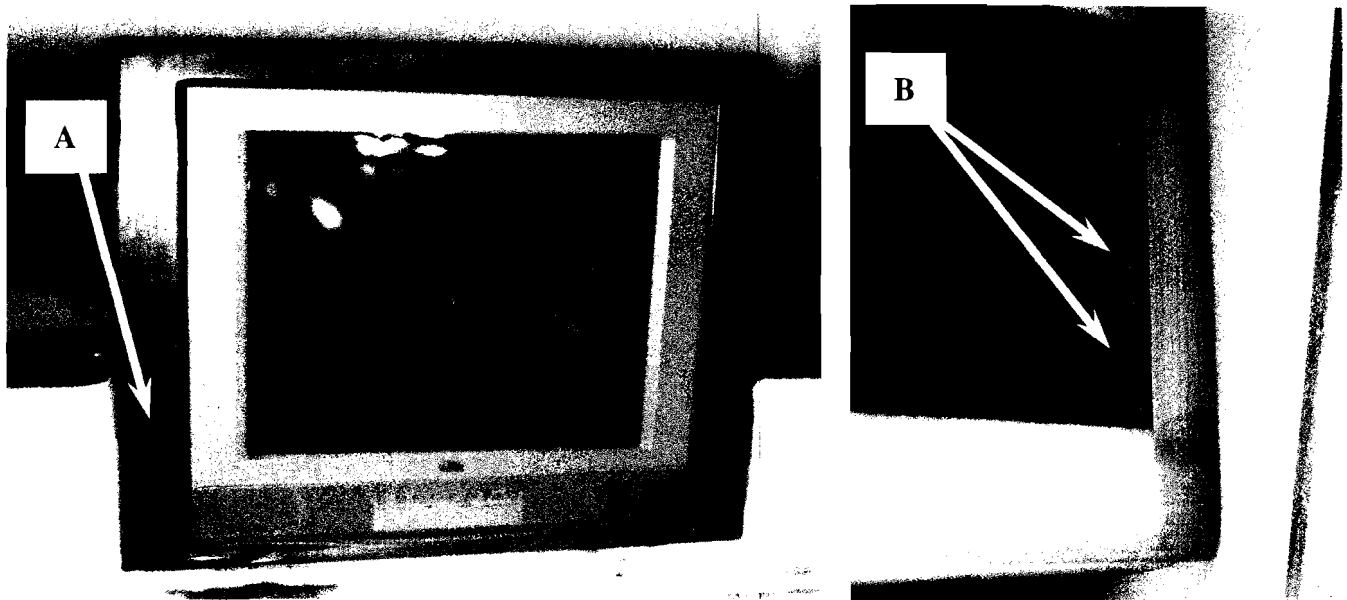
4. Put the TV Ring "A" back in place and Drive the Screws "B" back Down on the Cabinets on Each Side of the TV Compartment.
