# Recall Bulletin 70702

**RECALL  
BULLETIN:  
70702**

Jamboree,  
Jamboree  
Sport, Tioga,  
Tioga Ranger,  
with serial  
numbers listed  
in this Bulletin

**SUBJECT:**  
Class C Steel  
Spare Wheel  
and Tire  
Replacement

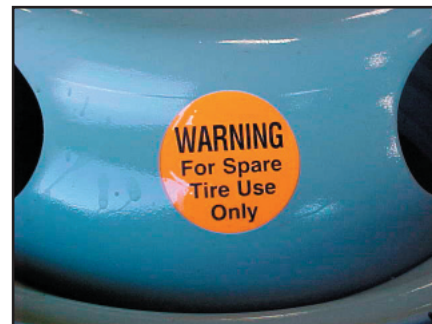
- Spare Wheels with 8 hand holes are not affected by this Recall.
- Ford wheels are not affected by this Recall.
- Spare wheels with tires that have a Warning label attached, as shown in the photograph to the right are not affected by this Recall. The Warning label indicates the spare wheel has already been replaced. New replacement spare wheels will have the Warning label attached.

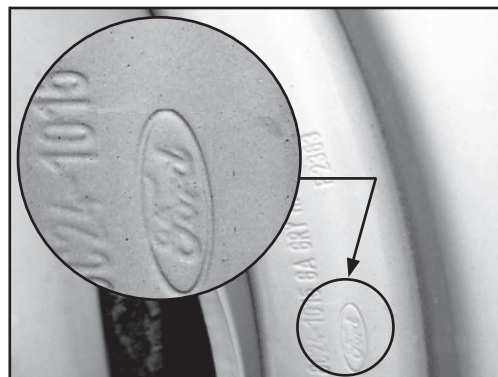
**Figure 1**

1. Locate and examine the spare wheel with tire.
  - (A) If the spare wheel has 8 hand holds, no further action is necessary.
  - (B) If the spare wheel has 4 hand holds, proceed to Step 2.
2. Look for the “FORD” logo stamped into the valve-stem side of the spare wheel, approximately 180° from the valve stem. (See Figure 1.)

*Ford wheels are not affected by this Recall.*

- If the “FORD” logo is found on the spare wheel, contact Fleetwood Dealer Technical Support for authorization to inspect the additional wheels, as it is possible that the spare may have been previously mounted on an axle during a previous repair.
- If the “FORD” logo is not present on the valve-stem side of the wheel, check the opposite side for a stamping. Wheels marked either “CHINA” or “VENEZUELA” must be replaced with a new wheel and tire, part #535995 (includes wheel with mounted tire). See Figures 2 and 3.

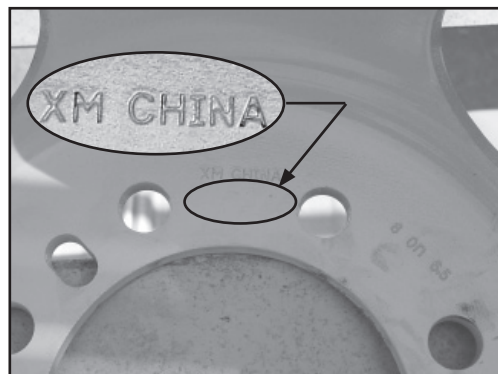
**Figure 2**

*Wheels marked “CHINA” must be replaced according to this Recall.*

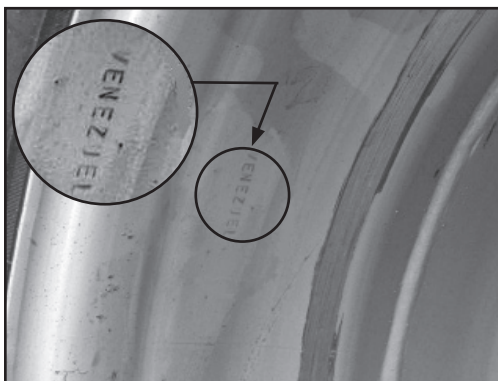
**Figure 3**

*Wheels marked “VENEZUELA” must be replaced according to this Recall.*
