Problem statement...

On certain Starcraft 2007 11RT, 13RT and 14RT frames there is the potential for a coupler/A-frame problem. The best way to identify these units is to measure the width of the top of the coupler (width is 3") and to determine if there is a notch in the side of the tongue. Please refer to the attached pictures.

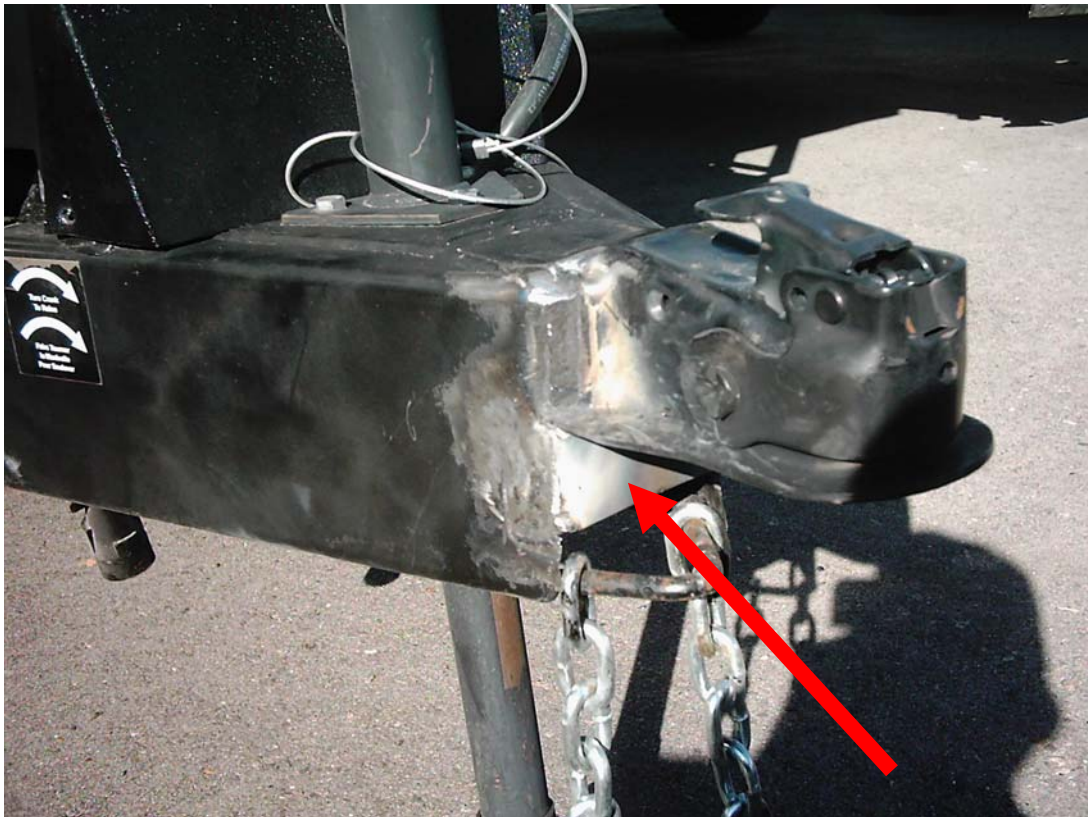
The repair will require the addition of a steel bracket to help reinforce the coupler/A-frame interface.
