**Noncompliance Recall: RDX Certification Label**

**BACKGROUND**

On some early-production 2008 RDXs, the certification label on the driver’s doorjamb does not contain the required tire and rim size information. This would cause the vehicle to be noncompliant with 49 CFR Part 567, “Certification.”

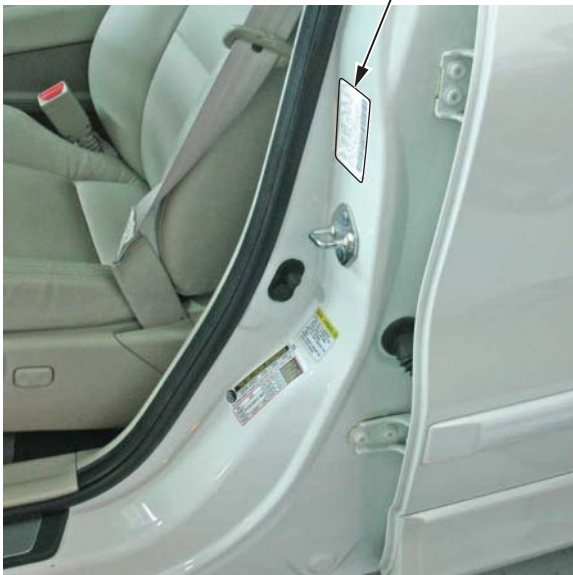
**CERTIFICATION LABEL**

In addition to these verification items, check the certification label on the driver’s doorjamb:

- If the tire and rim size information is on the label, the label is correct, and no further action is needed.
- If the tire and rim size information is not on the label, the label is incorrect and must be replaced.

Remove the certification label from the driver’s doorjamb, and apply a new, VIN-specific label.

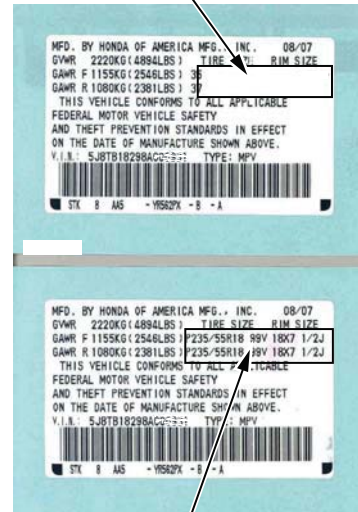
**TIRE/RIM INFORMATION IS MISSING**  
The label must be replaced.

**TIRE/RIM INFORMATION IS LISTED**  
The label is OK.

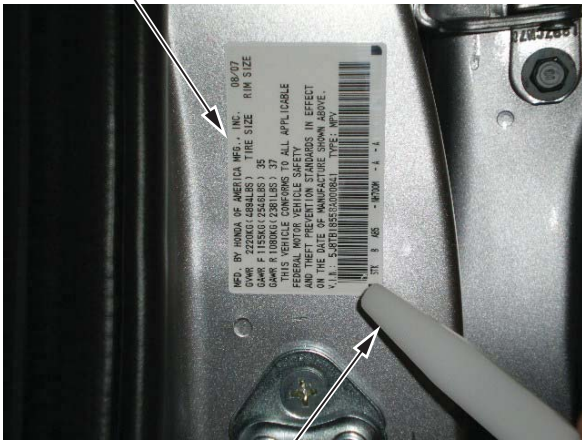
### CERTIFICATION LABEL

1. Make sure the VIN on the new certification label matches the VIN on the vehicle. Look at the VIN plate on the top of the dashboard or the label in the driver's doorjamb.
2. Using a trim tool (KTC Handy Remover, T/N AP 201-N [or equivalent]), begin at a corner of the label, and peel the label off the doorjamb. As much as possible, try to remove the label together with its clear laminate. The label will come off in several pieces. Be sure to remove the entire label.

The label may come off in pieces.

NOTE: If the label won't come off with just the trim tool, use a heat gun. When using a heat gun, be careful not to overheat the paint.

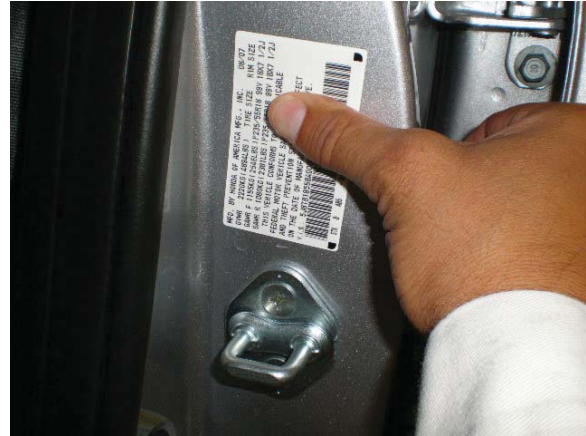
3. Remove the label residue and adhesive with 3M adhesive remover on a clean shop towel. Allow the area to dry.  
NOTE: Do not allow the adhesive remover to contact any of the other labels on the doorjamb.
4. Attach the new label to the doorjamb in the same location and direction as the removed label.

Make sure there are no wrinkles in the new label.

- To avoid tearing the label, do not reposition it once you've begun to apply it.
- Apply the label slowly, from one end to the other.
- To avoid wrinkles in the label, press it down firmly once it's applied.
