Winnebago Industries, Inc. has started a recall campaign.

SUBJECT: Campaign #107 – Itasca Suncruiser® and Itasca Ellipse® Reflectors

INSTRUCTIONS TO PERFORM CAMPAIGN 107

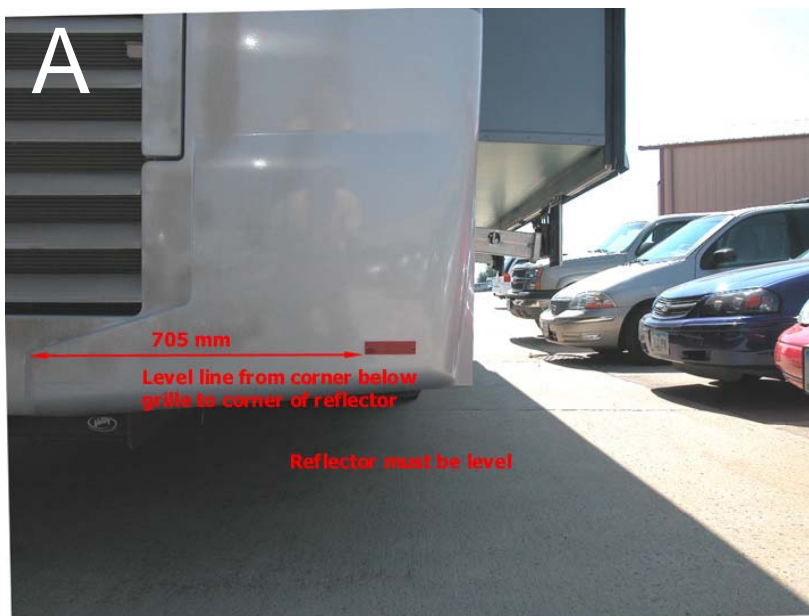
1. Remove the self-adhesive backing strip on the back side of the reflector and position 705 mm out from the angled inner-most corner below the rear grille. Reflector must be level. See Photo A.
2. Using a screw gun with a #2 Phillips tip, insert the black screw into the reflector hole and install screw until almost seated. Finish installing screw by hand with a Phillips screwdriver to ensure that overtightening does not occur. Install second black screw into opposite side of reflector.

2006, 2007, and 2008 Itasca Ellipse

NOTE: These models require the use of all four included reflectors.
