# COACHMEN RV GROUP

RE: Safety Recall 07V-539

The following is a service bulletin for incorrectly plugged leads in the slideout ignition over ride amp connector on 2008 model year Freelanders 3130, Maverick 313, and Freedom Express 31 Class C Mini Motorhomes.

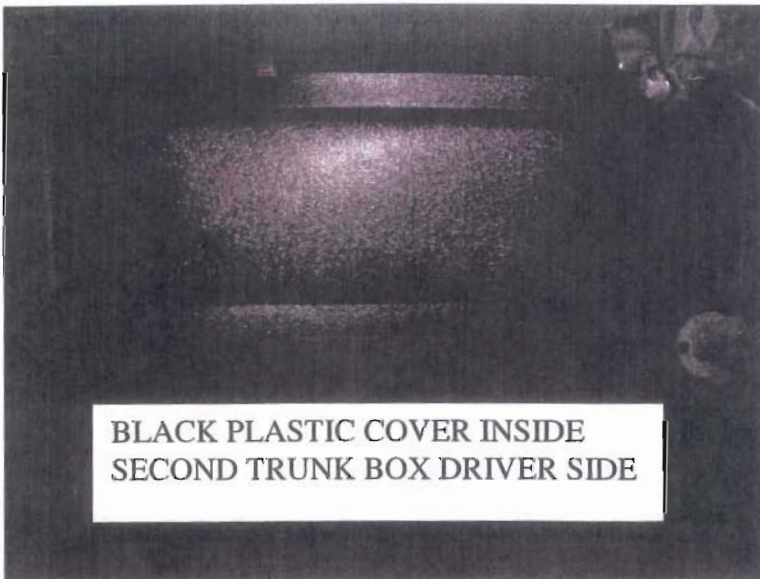
The electrical amp connector is located on the driver side, inside of the second trunk box behind a black plastic cover attached with 4-6 screws.

BLACK PLASTIC COVER INSIDE  
SECOND TRUNK BOX DRIVER SIDE

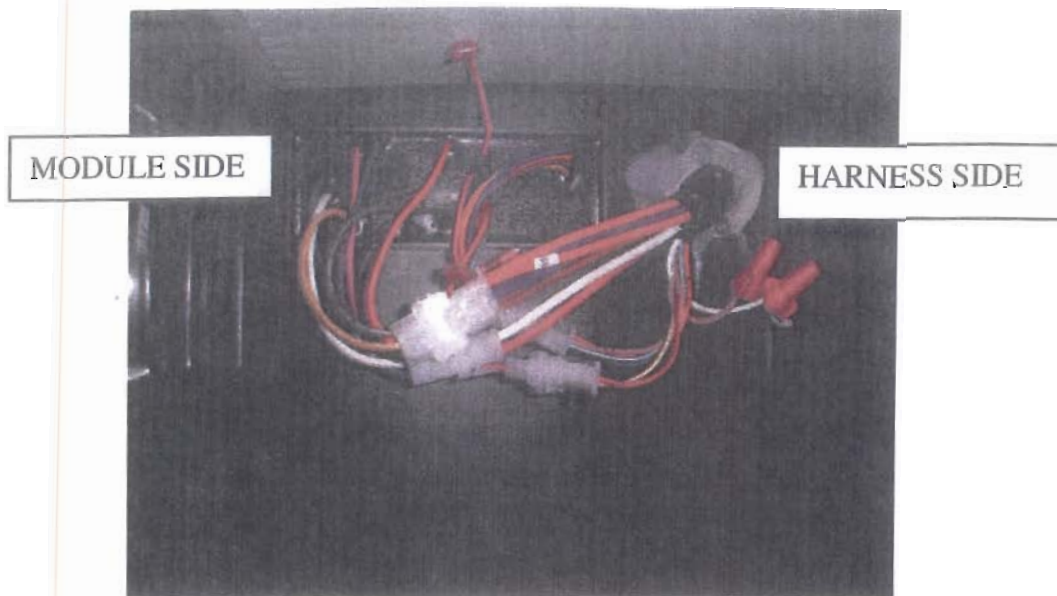
1. Remove black plastic cover from inside of second trunk box, driver side.
2. Look for a 3 cavity plastic amp connector.

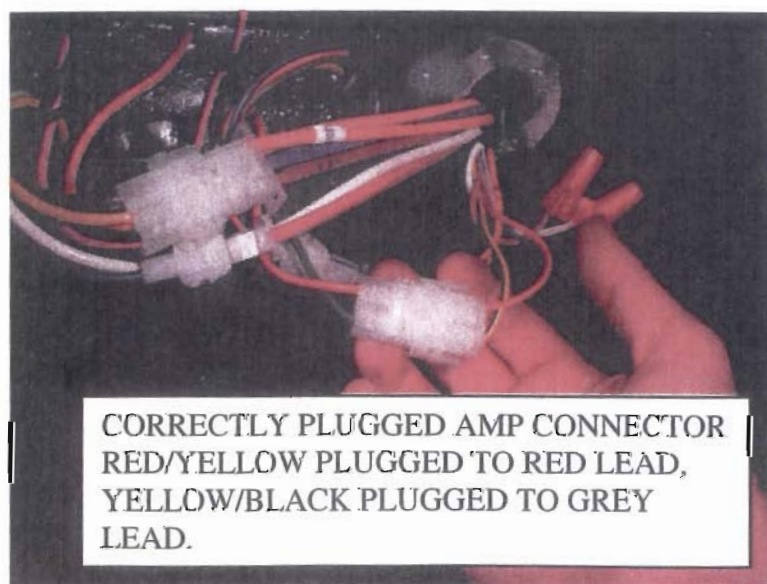
- A. If wired correctly, you will have a red/yellow lead coming from the harness plugging into a red lead from the module and a yellow/black lead from the harness plugging into a grey lead from the module. If unit is plugged correctly, no repair is required. Replace plastic cover.

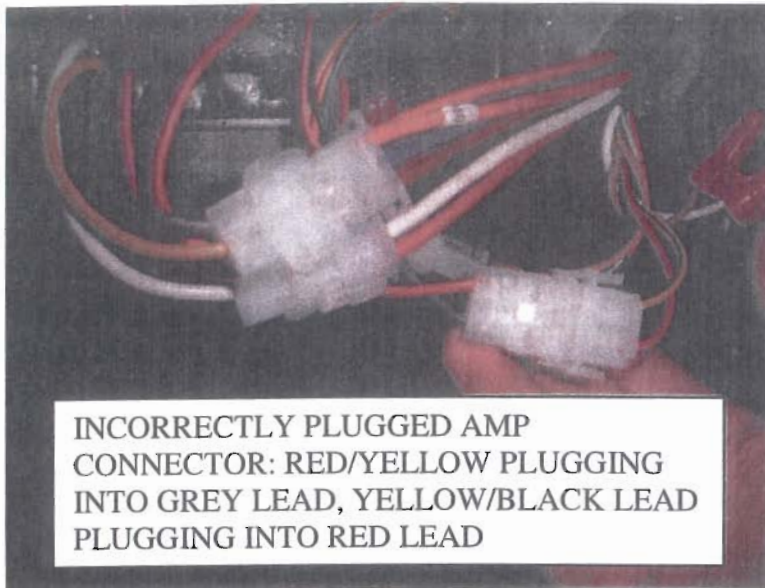
- B. If wired incorrectly, you will have yellow/black lead from the harness plugging into a red lead from the module and a red/yellow lead from the harness plugging into a grey lead from the module.
