Federal Recall Information

TRW TAS-85 Steering Gear

Service Procedure TAS-134

TAS85 Series Steering Gear Replacement

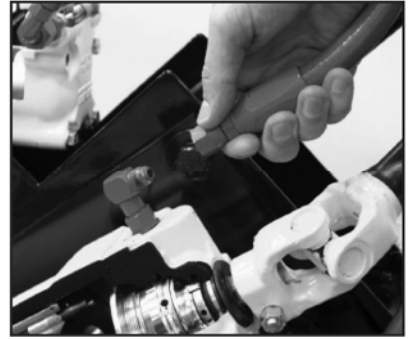
Figure 1

5. Place a drip pan under the steering gear to catch the oil.
6. Remove both the pressure and return lines (Figure 1) from the steering gear and allow the oil to drain into the empty container.

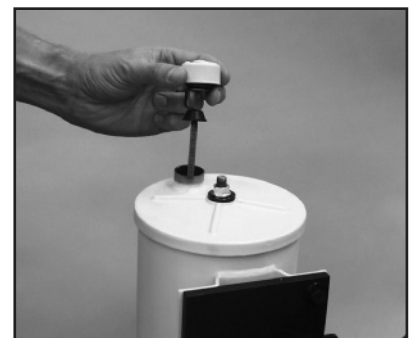
Figure 3

1. Fill reservoir with approved replacement fluid and reinstall the filler cap (Figure 3).
2. Start engine for 10 seconds, stop, and check reservoir fluid level and top off if necessary. You may need to repeat this procedure 3 or 4 times.

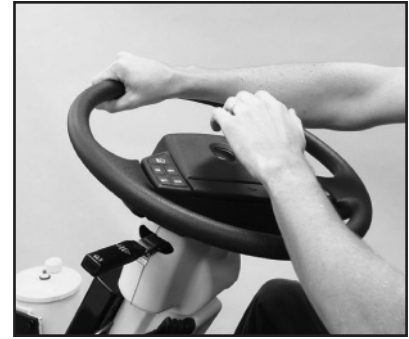
Figure 4

3. Upon completion of filling the reservoir, start the engine and let it idle. At engine idle, steer full right and full left (Figure 4) once and return to straight ahead. Stop engine and check power steering reservoir level and top off if required.

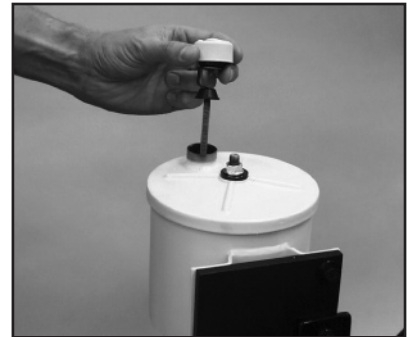
1. Fill the reservoir.
2. Start the engine, let it run for 10 seconds - without steering, then shut it off.
3. Check the reservoir, and refill if the fluid level has dropped.
Figure 7
4. Repeat this process at least three times, checking and refilling the reservoir each time if necessary.
