**Safety Defect and Noncompliance Report Guide for Vehicles**  
**PART 573 Defect and Noncompliance Responsibility and Reports** <sup>(1)</sup>

**08V-014**  
**(11 pages)**

**Glaval Bus, A Division Of Forest River, Inc.**

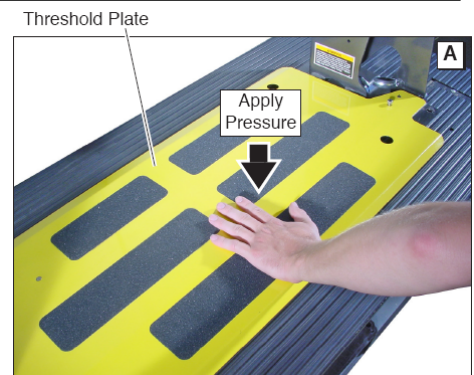
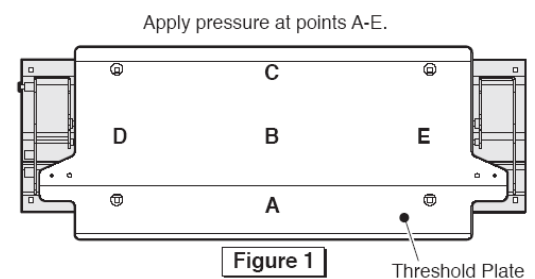
1. Turn Lift Power switch ON. Deploy the lift platform fully to the ground.
2. Remove the threshold plate. Loosen and remove two Allen head shoulder bolts securing the plate (see Photos B and C) Keep bolts. Slide the plate outward and lift to remove it (four keeper standoffs engage key-hole slots). See Photos E, F and G.
3. An adhesive-backed plastic tag is supplied (contained within the recall letter from Braun) to serve as an alarm activation shim (minimal thickness required to activate the highly sensitive alarm strip switches).

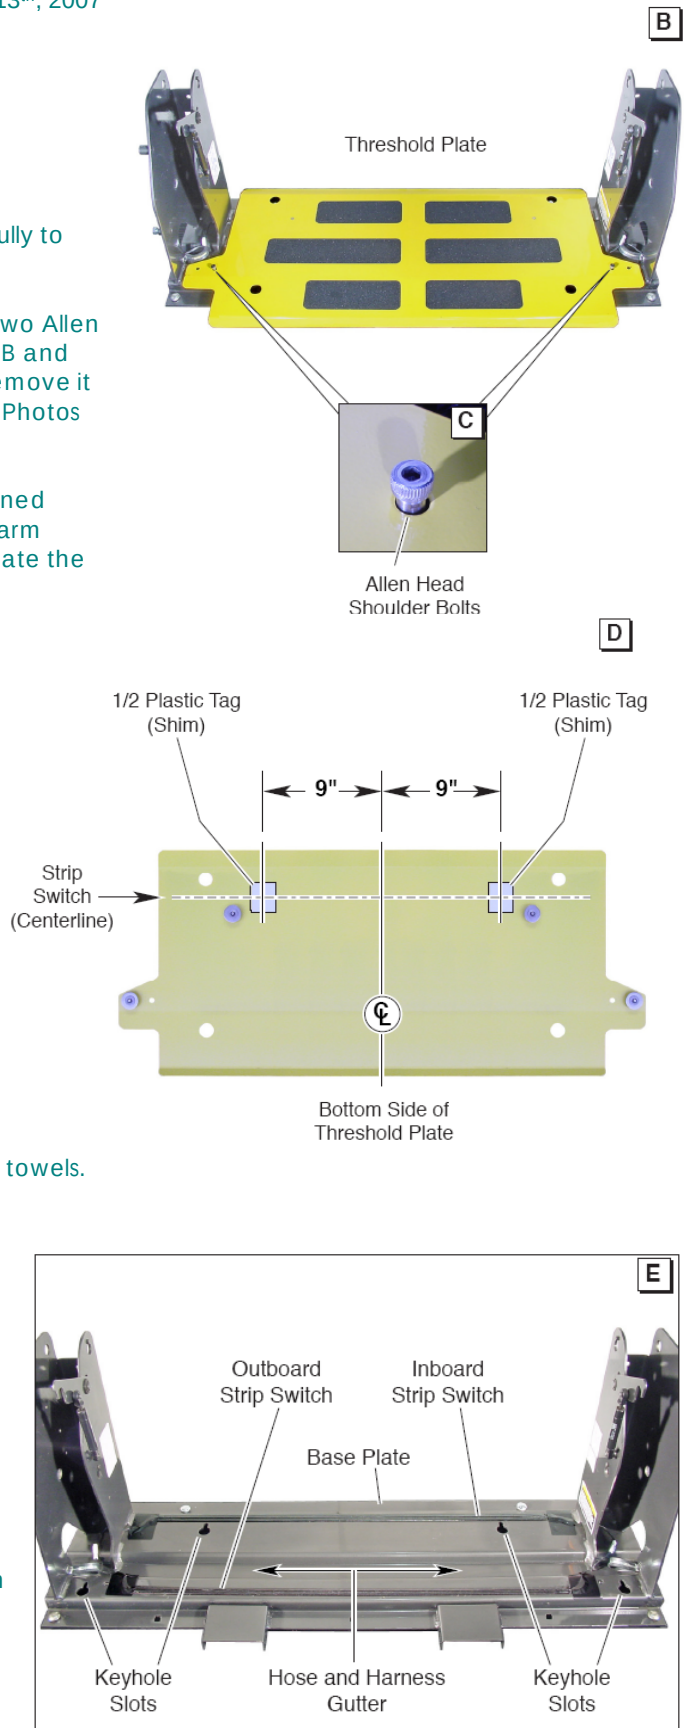
When repositioning the threshold plate – **note the following:**

**ENSURE** all hoses and wiring harnesses routed through the base plate gutter are positioned fully in the gutter and not located anywhere they could potentially interfere with activation of the tape switches. See Photo E.
