**Re: Defect Information Report – Supplemental Report No. 2
08V-029, FL-521, Air Disk Brake Mounting Bolts**

Subject: Air Disk Brake Caliper Bolts

Models Affected: Specific Freightliner Argosy, Business Class M2, Cascadia, Century Class S/T, and Columbia vehicles and Freightliner Custom Chassis XC-R motor home chassis manufactured between January 1, 2007, and November 19, 2007, with air disk brakes.

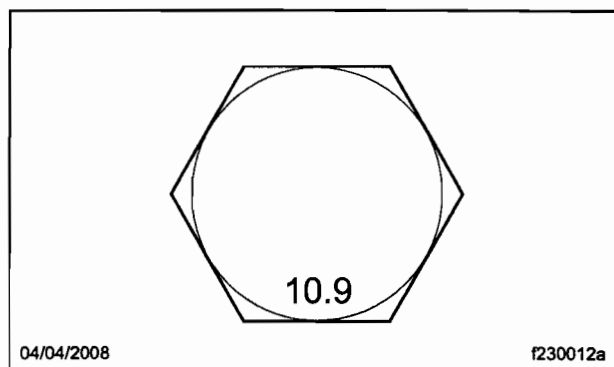
Fig. 1, Bolt Strength Identification

2. On each caliper on the front axle (FL521A and FL521B), inspect each anchor plate bolt to ensure it has "10.9" stamped on the bolt head. Inspect all front axle calipers. See Fig. 1.
3. On FCCC motor home chassis (FL521A), if all bolts ARE marked "10.9," clean a spot on the base label, write the recall number, FL521, on a blank red completion sticker, and attach it to the base label. If any bolt on the front axle is NOT marked "10.9," replace all bolts on that caliper. Go to "Caliper Anchor Plate Bolt Replacement – Front Axle."

If any bolt on the front axle is NOT marked "10.9," replace all bolts on that caliper. Go to "Caliper Anchor Plate Bolt Replacement – Front Axle."

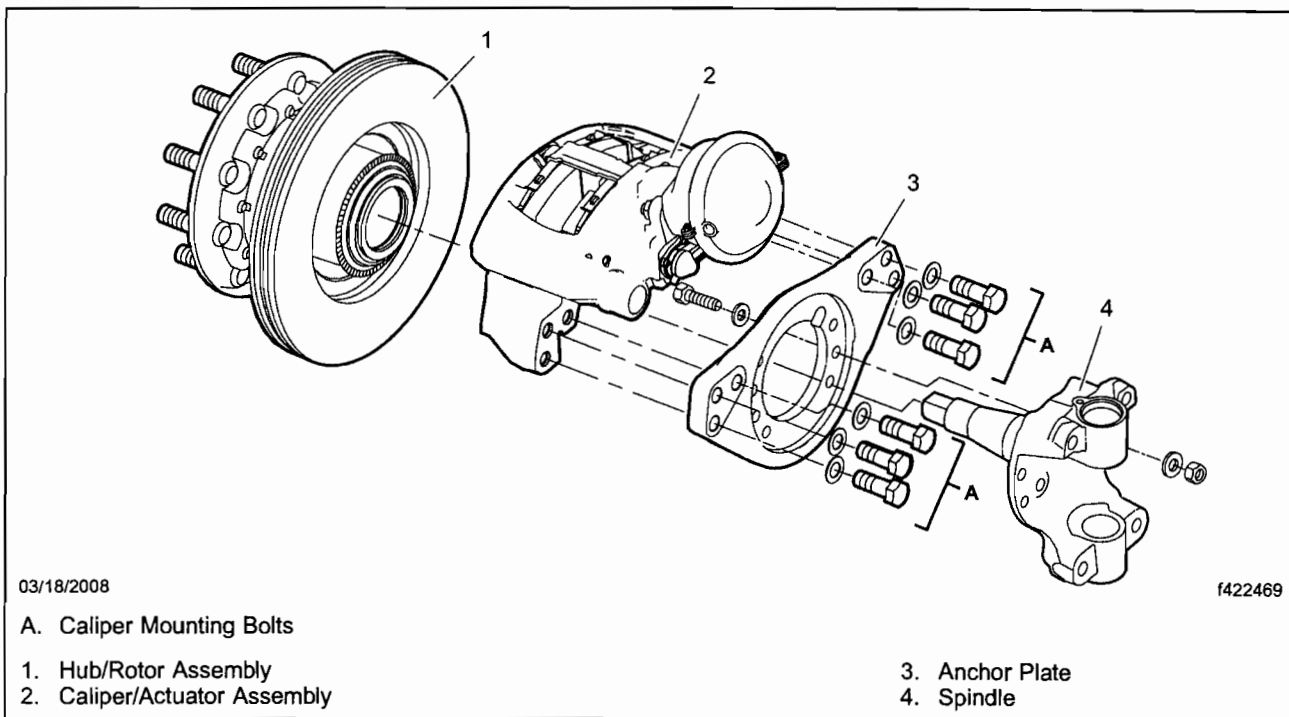
Fig. 2, Steer Axle Components

2. Raise the front of the vehicle and turn the wheels all the way one direction. Lower the vehicle.
3. Remove one caliper mounting bolt (leaving the others in place) and discard it. See Fig. 2, Ref. A.

4. Using compressed air, blow any Loctite® residue from the bolt hole.

5. Hand-start the new bolt, then turn it in and out with an impact wrench, if available, to clean out the threads. Do not over tighten. Remove the bolt, blow out the hole, then, blow any residue off the bolt.
6. Apply Loctite to the bolt threads, then install the bolt through the caliper mounting bracket. Tighten the bolt 355 to 375 lbf-ft (480 to 510 N·m).
7. Repeat the previous steps for each of the three bolts on the accessible side of the caliper.
8. Go to the other side of the vehicle and repeat the steps for the accessible bolts on that side.
9. Raise the front of the vehicle and turn the wheels all the way in the opposite direction. Lower the vehicle.
10. Repeat the previous steps for the remaining bolts on both sides of the vehicle.
11. Clean a spot on the base completion label. Attach a completion sticker for FL521 to the base label.
12. Remove the tire chocks.
