## Defect Information Report

08V-285  
(5 Pages)

**1. Gore Trailer Mfg**

The vehicles covered by this report are recreation vehicles that were equipped with certain models of refrigerators manufactured by Dometic, LLC between June 2003 and September 2006. The vehicle models in question are as follows: Camper Package and Pamilco Package.

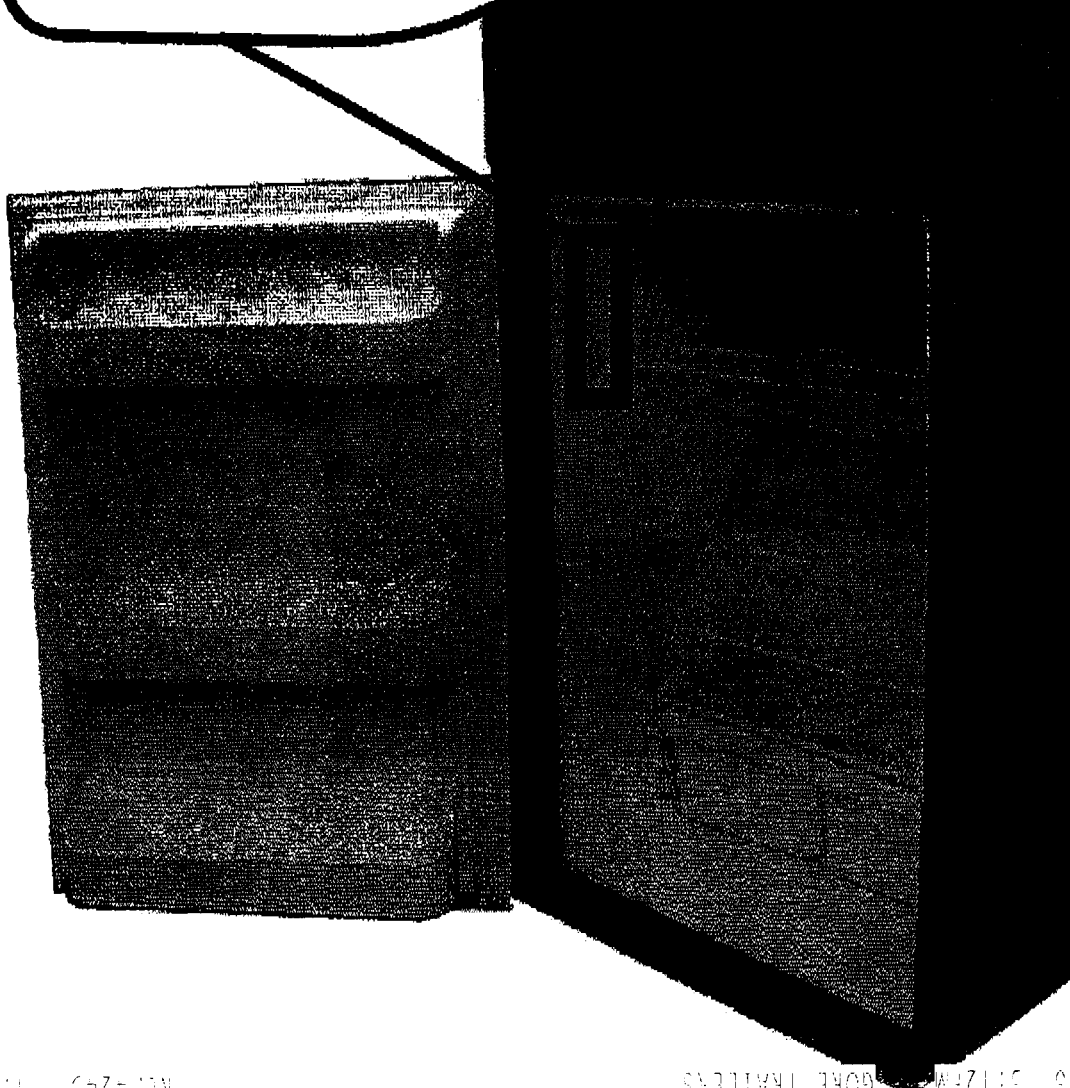
## **Where to find the serial and model numbers on your Dometic refrigerator**

The serial and model numbers are both located on a sticker inside the fridge door. It could be on either side of the interior.

Remember, the model number starts with RM or NDR, and the serial number is 8 digits long.

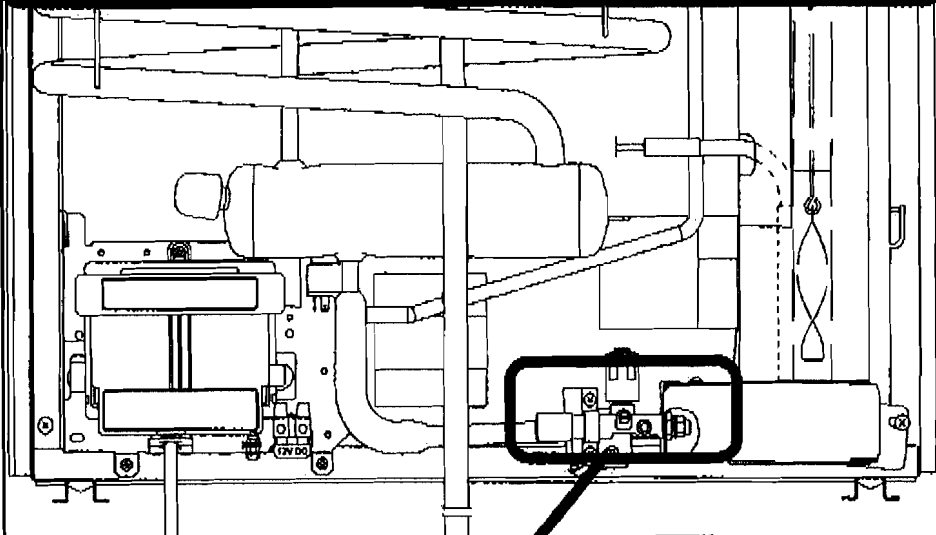
## HOW TO TURN OFF GAS SUPPLY

The manual gas valve is located at the back of your refrigerator near the floor as seen in the diagram to the left. Access the back of your refrigerator by removing the vent on the side of your coach.
