**573.6 Defect Information Report**

MY 2008 Victory Vision motorcycles.

# TECHNICAL SERVICE BULLETIN

**SUBJECT:** Loose Circuit Breaker Terminal Nuts and ECM Reprogramming

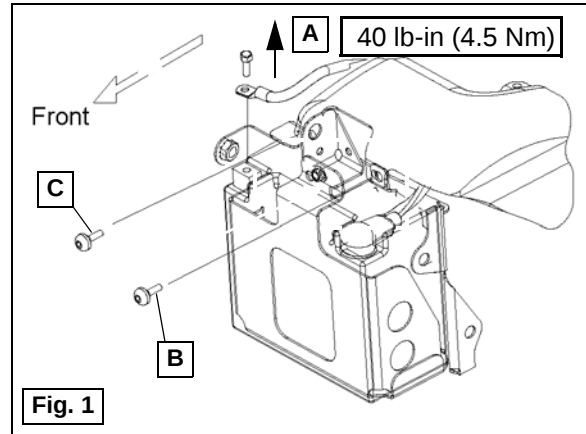
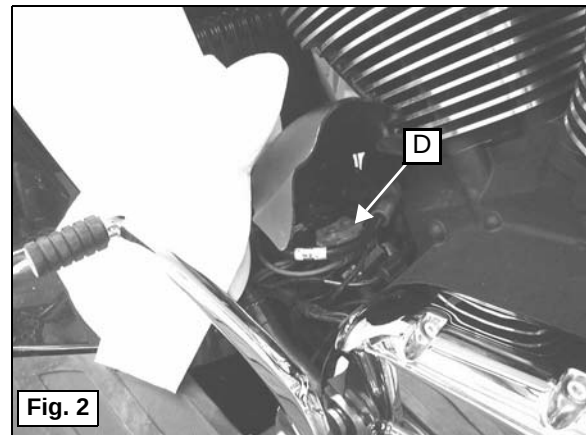
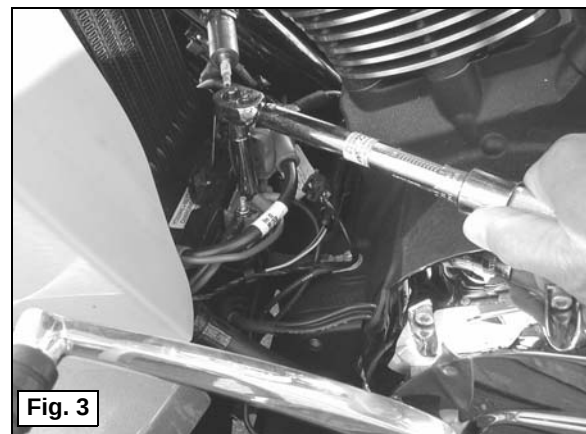
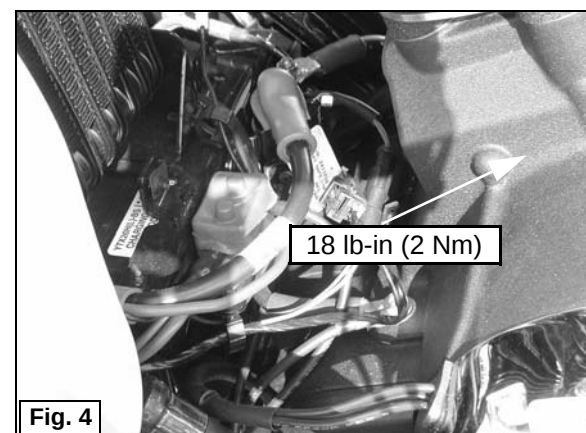
## Circuit Breaker Terminal Nut Torque

1. Remove battery negative (-) cable (A). (Fig. 1)
2. Remove screw (B) from electrical cover (4mm internal hex). (Fig. 1)
3. Loosen screw (C).
4. Place a protective cloth between cover and lower leg fairing. Prop cover for access to circuit breaker (D). (Fig. 2)
5. Lift protective cover off circuit breaker.
6. Using a thin wall 3/8 inch deep socket, torque *BOTH* nuts to 25 lb-in (2.8 Nm). (Fig. 3)
7. Re-install protective cover securely over circuit breaker, pushing it firmly onto the studs. (Fig. 4)
8. Set electrical cover back in place and remove protective cloth.
9. Install screw. Torque both screws to x.x Nm (xx lb-in).
10. Install battery negative cable. Torque terminal bolt to 4.5 Nm (40 lb-in).
11. Perform reflash procedure following basic procedure outlined on page 5, and instructions within Digital Wrench.

Overview: Tighten *both* circuit breaker terminal nuts to specified torque on all affected vehicles. Use a thin wall socket to ensure full engagement with the nut. Keep the socket at a 90 degree angle to the terminal stud when torquing the nuts.
