**Date:** April 28, 2009 – (GGP claiming info revision - supercedes bulletin dated 4/20)

**Subject:** NHTSA Recall #08V-522 Scarabeo 500 Fuel pump hose & clamps

**Service Communication:** 2009-005 USA

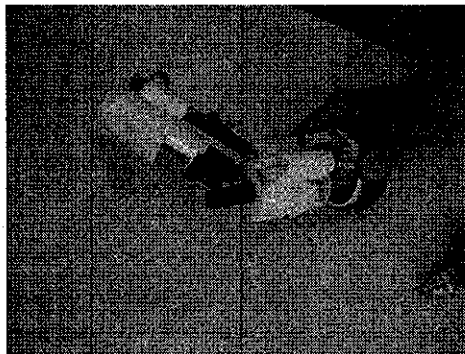
**Press new hose on to filter side**
