CUSTOMER LETTER

RE: IMPORTANT SAFETY RECALL INFORMATION REGARDING YOUR APRILIA RSV 1000 AND TUONO 1000 MOTORCYCLES

REPAIR PROCEDURE

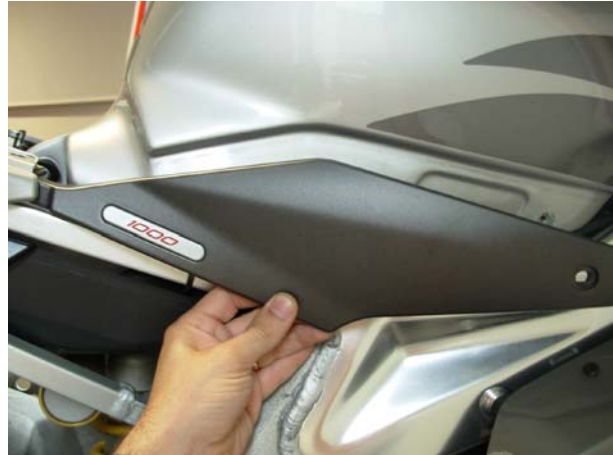
- Completely drain fuel tank.
- Remove the seat
 - Remove the right and left side body panels

CAUTION
FUEL VAPOURS ARE FLAMMABLE AND HARMFUL IF INHALED. CARRY OUT THIS OPERATION IN A SUITABLE ENVIRONMENT AND USING SUITABLE PROTECTIONS

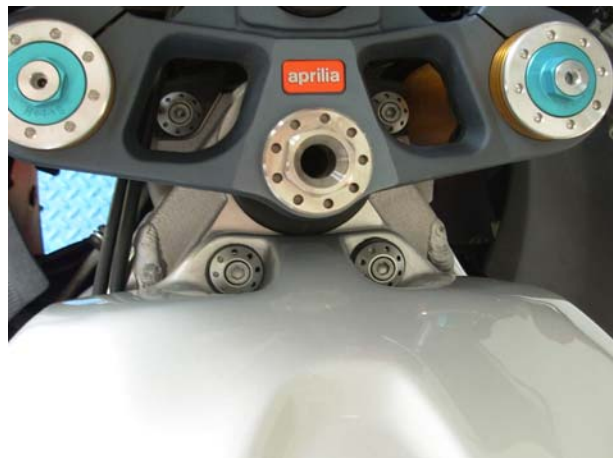
- Remove the two front screws from tank

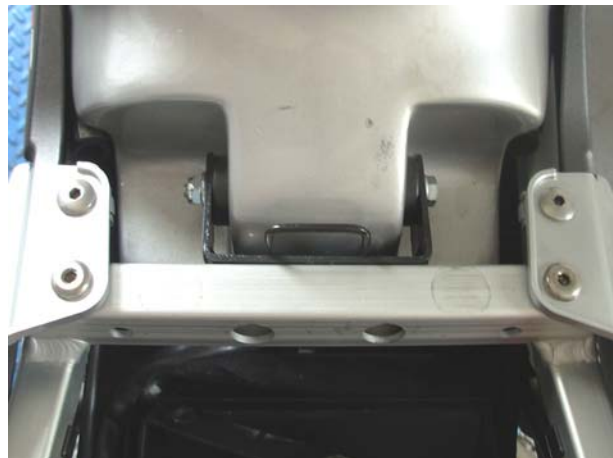
- Remove through bolt at rear of tank

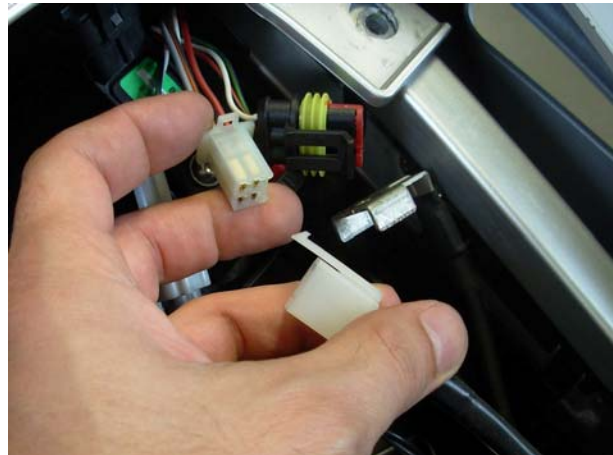
- Disconnect the fuel pump connector.
- Lift the fuel tank and tilt it to the left, paying attention not to force the fuel lines and supporting the tank

CAUTION
PAY ATTENTION NOT TO DAMAGE AND/OR
SCRATCH THE TANK PAINT

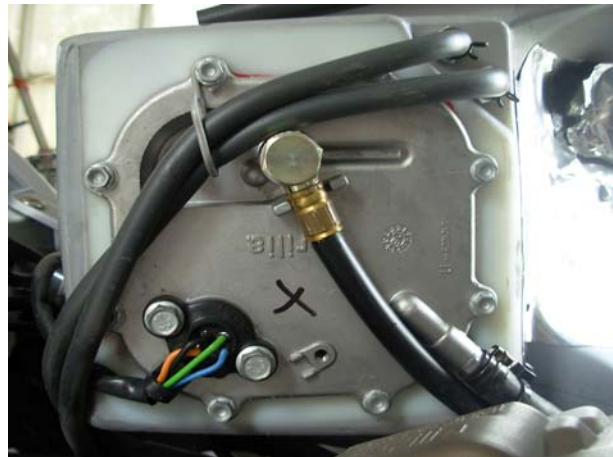
- Remove the 8 retaining screws from fuel pump flange

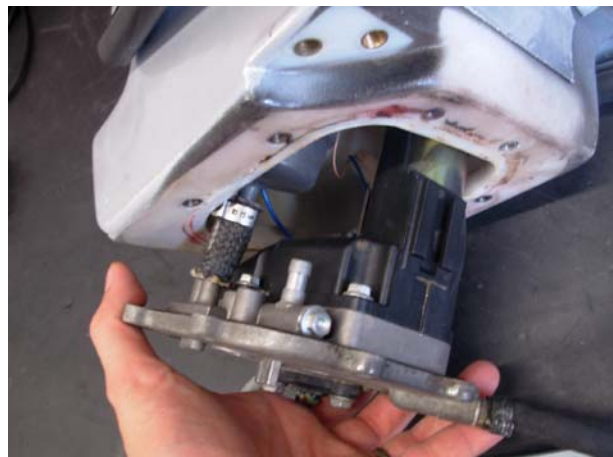
- Slide out the complete pump assembly from tank.

CAUTION
AFTER REMOVING THE PUMP ASSEMBLY,
THE TANK HAS NO RETAINER. PAY
ATTENTION NOT TO DROP IT.

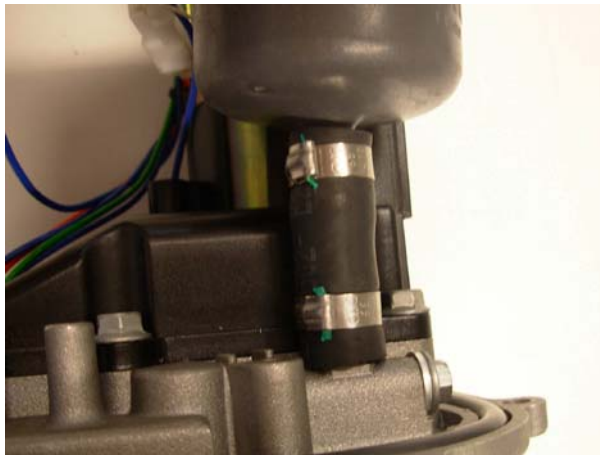
- Leaving the pump connected to fuel lines, release the two click clamps fastening the fuel hose between the mounting flange and the fuel filter. Discard old hose.

CAUTION
THE CLICK CLAMPS YOU REMOVED CAN NOT BE REUSED AND SHALL BE RENEWED WITH THE NEW ONES SUPPLIED WITH THE KIT.

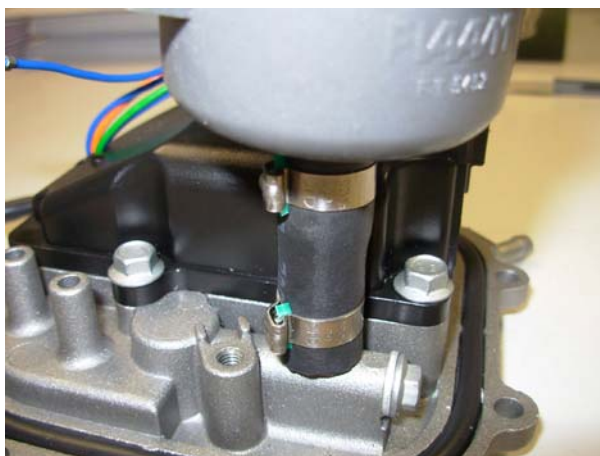
- Install the new fuel line AP8144476 with two new click clamps 890435.
- Refit the pump to tank, tighten screws finger tight and then tighten them in a cross pattern

TIGHTENING TORQUE 6 Nm

- Reassemble vehicle parts following the removal procedure in the reverse order
