# Service Bulletin

## SAFETY RECALL

### 2007-2008 VTX1300C/R/S/T Fuel Valve Diaphragm Replacement

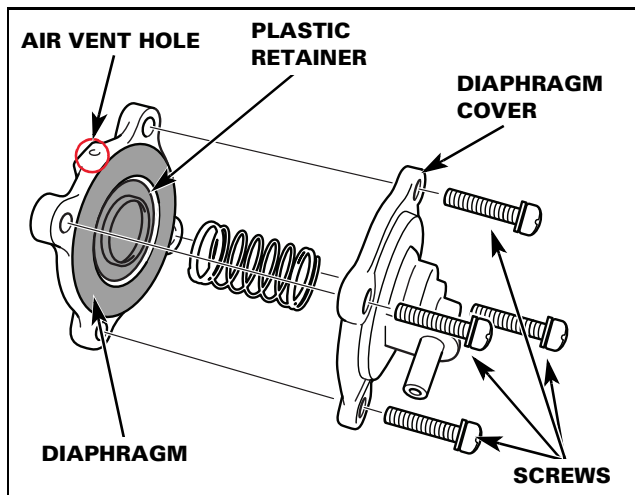
4. Replace the diaphragm, spring, cover, and screws with new parts included in the kit. Install the new diaphragm with the plastic retainer facing the diaphragm cover.

**NOTE:** Make sure the air vent hole is facing downward towards the ground.
