Safety Recall: Windshield Wiper Motor Does Not Work

(Supersedes 08-043, dated June 17, 2008, to update the information marked by the black bars)

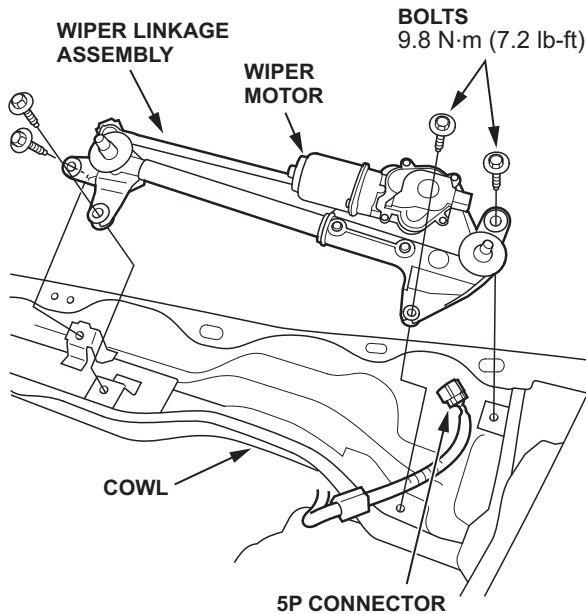
5. Disconnect the wiper motor 5P connector, and detach the wire harness from the wiper linkage.

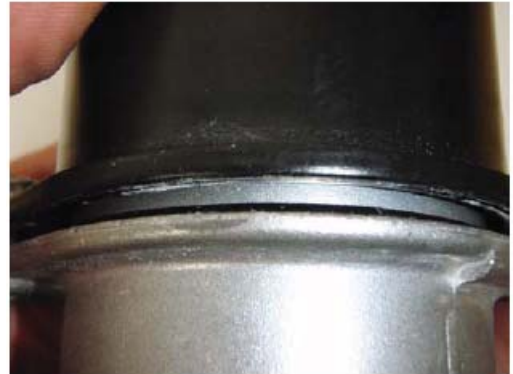
INSIDE OF CASE IS CLEAN
(Install *cover kit* only. Do not install *motor kit*.)

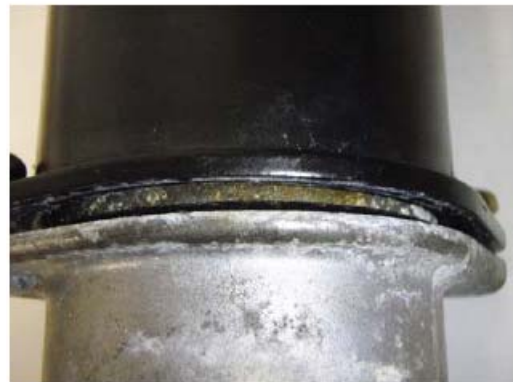
INSIDE OF CASE IS CORRODED
(Install *motor kit* only. Do not install *cover kit*.)

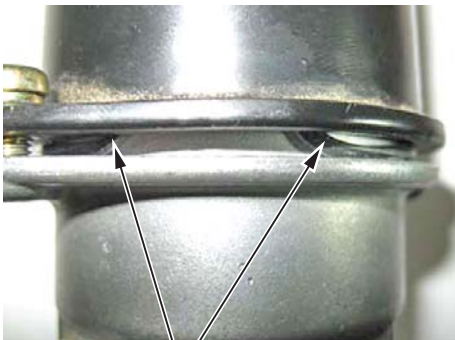
NO GOOD
O-ring is pinched and/or rolled.

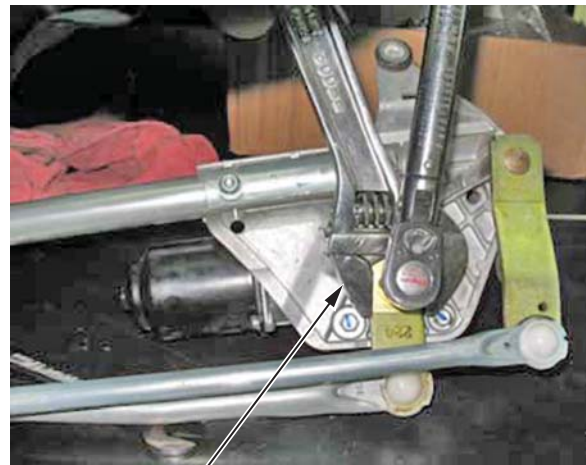
18. Move the linkage until you can fit an adjustable wrench on the wiper arm link, then hold the link with the adjustable wrench while torquing the center nut to **31 N·m (23 lb-ft)**.

Hold the link while you tighten the nut.
31 N·m (23 lb-ft)
