SI B33 02 08
Rear Axle

Recall Campaign 08V-170: Replace Rear Stabilizer Bar

X5 (E70)

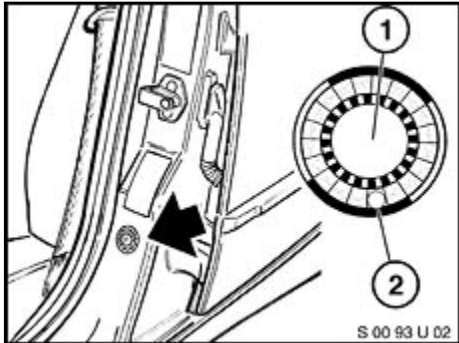
LABEL INSTRUCTIONS

This Recall Campaign has been assigned code number **520**. After the vehicle has been checked and/or corrected, obtain a label (SD 92-335) and:

- A. Emboss your BMW center warranty number in the middle of the label (1);
- B. Punch out code number **520** (2), printed on the label; and
- C. Affix the label to the **B** pillar as shown.

If the vehicle already has a label from a previous Service Action/Recall Campaign, affix the new label next to the old one. Do not affix one label on top of another one because a number from an underlying label could appear in the punched-out hole of the new label.
