ITB08-034a

VOLUNTARY RECALL CAMPAIGN 2004 – 2006 INFINITI QX56 AIR CONDITIONER CONDENSER FAN

NHTSA #: 08V-284

APPLIED VEHICLES: 2004 – 2006 QX56 (JA60)

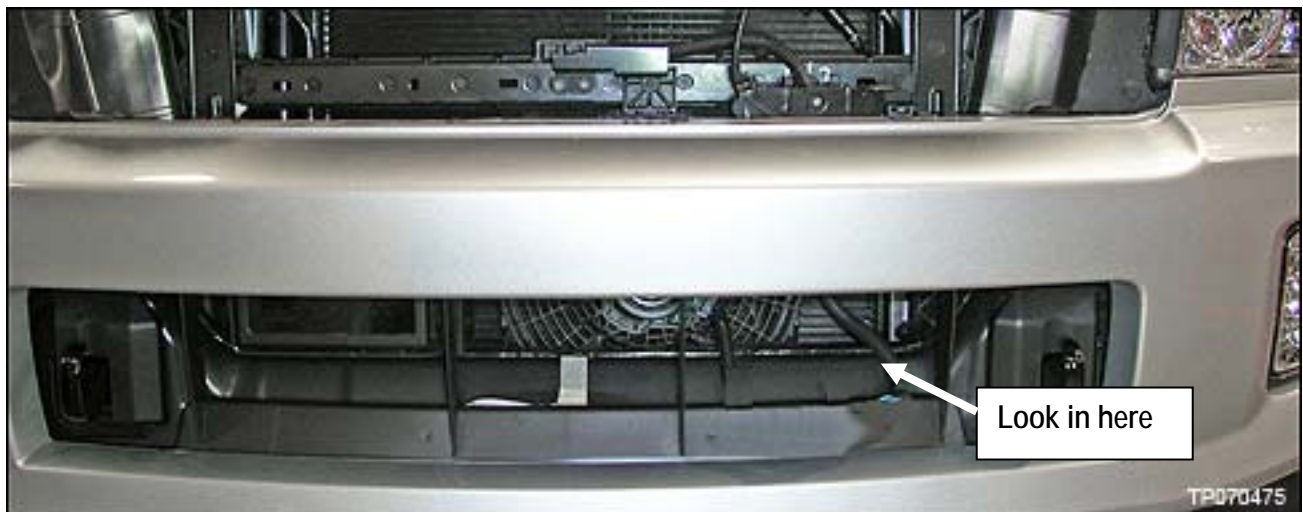
Figure A-1

1. Look in the lower area of the front fascia.

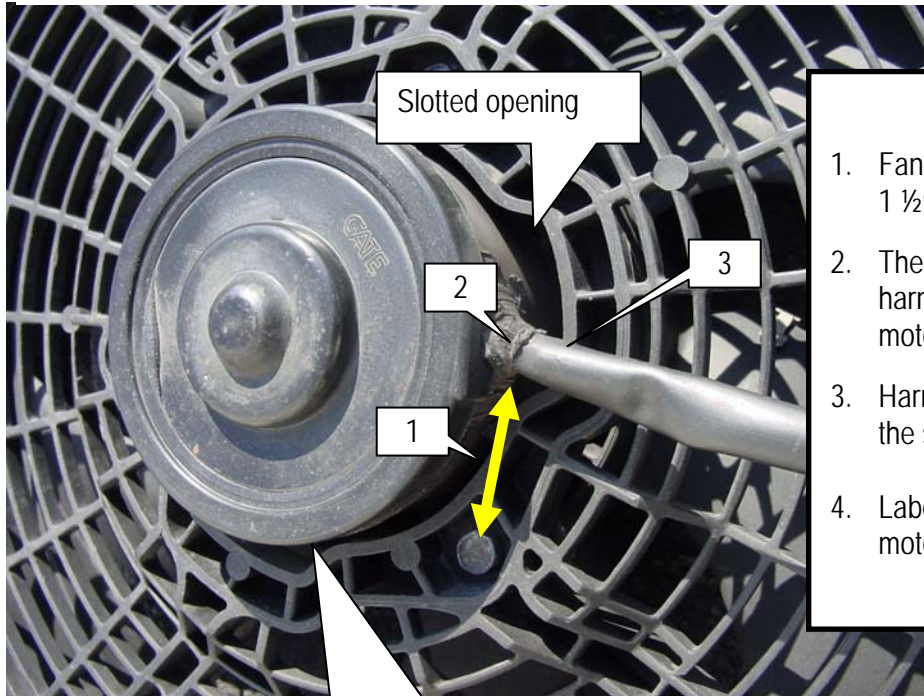
Figure A-3

Type 1 Fan - 90 watt motor

No action required

1. Fan motor harness position is 1 ½" from mounting bolt.
2. There are no exposed wires. Plastic harness cover goes right up to the motor.
3. Harness goes across the lower part of the slotted opening.
4. Label on the lower side of the fan motor has the word "GATE".

4: Label has the word "GATE"

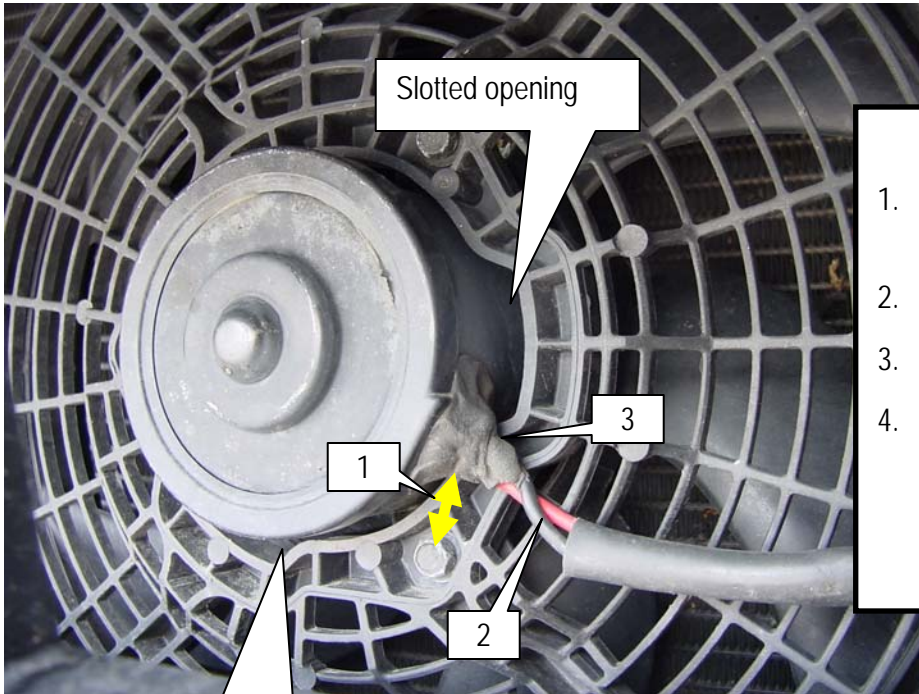
Figure A-4

Type 2 Fan - 90 watt motor
Go to Procedure B - Cooling Fan Motor Inspection

- Identification:**
1. Fan motor harness position is ½ inch from mounting bolt.
 2. Red and Black wires are exposed.
 3. Wire harness is below slotted opening.
 4. Label on the lower side of the fan motor does not have the word "GATE".

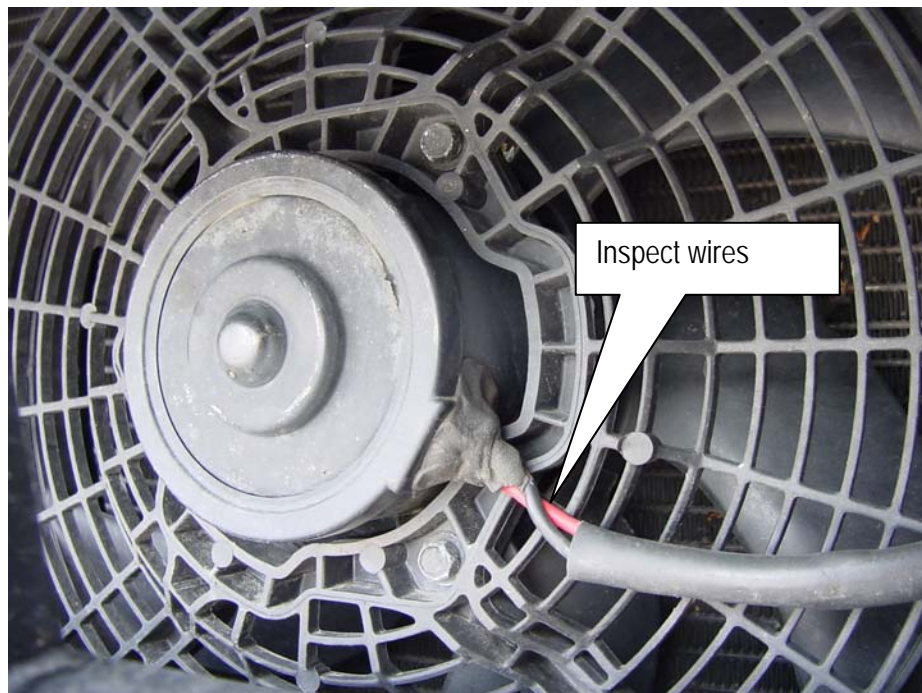
Figure B-1

1. Inspect the wires near the condenser fan motor:

- Make sure there is no damage to the wire insulation and the wires are in good condition.
- **If the wires are damaged** (cracked or missing insulation), STOP; no more testing is needed. Go to Procedure C on page 17 and replace the condenser fan assembly.

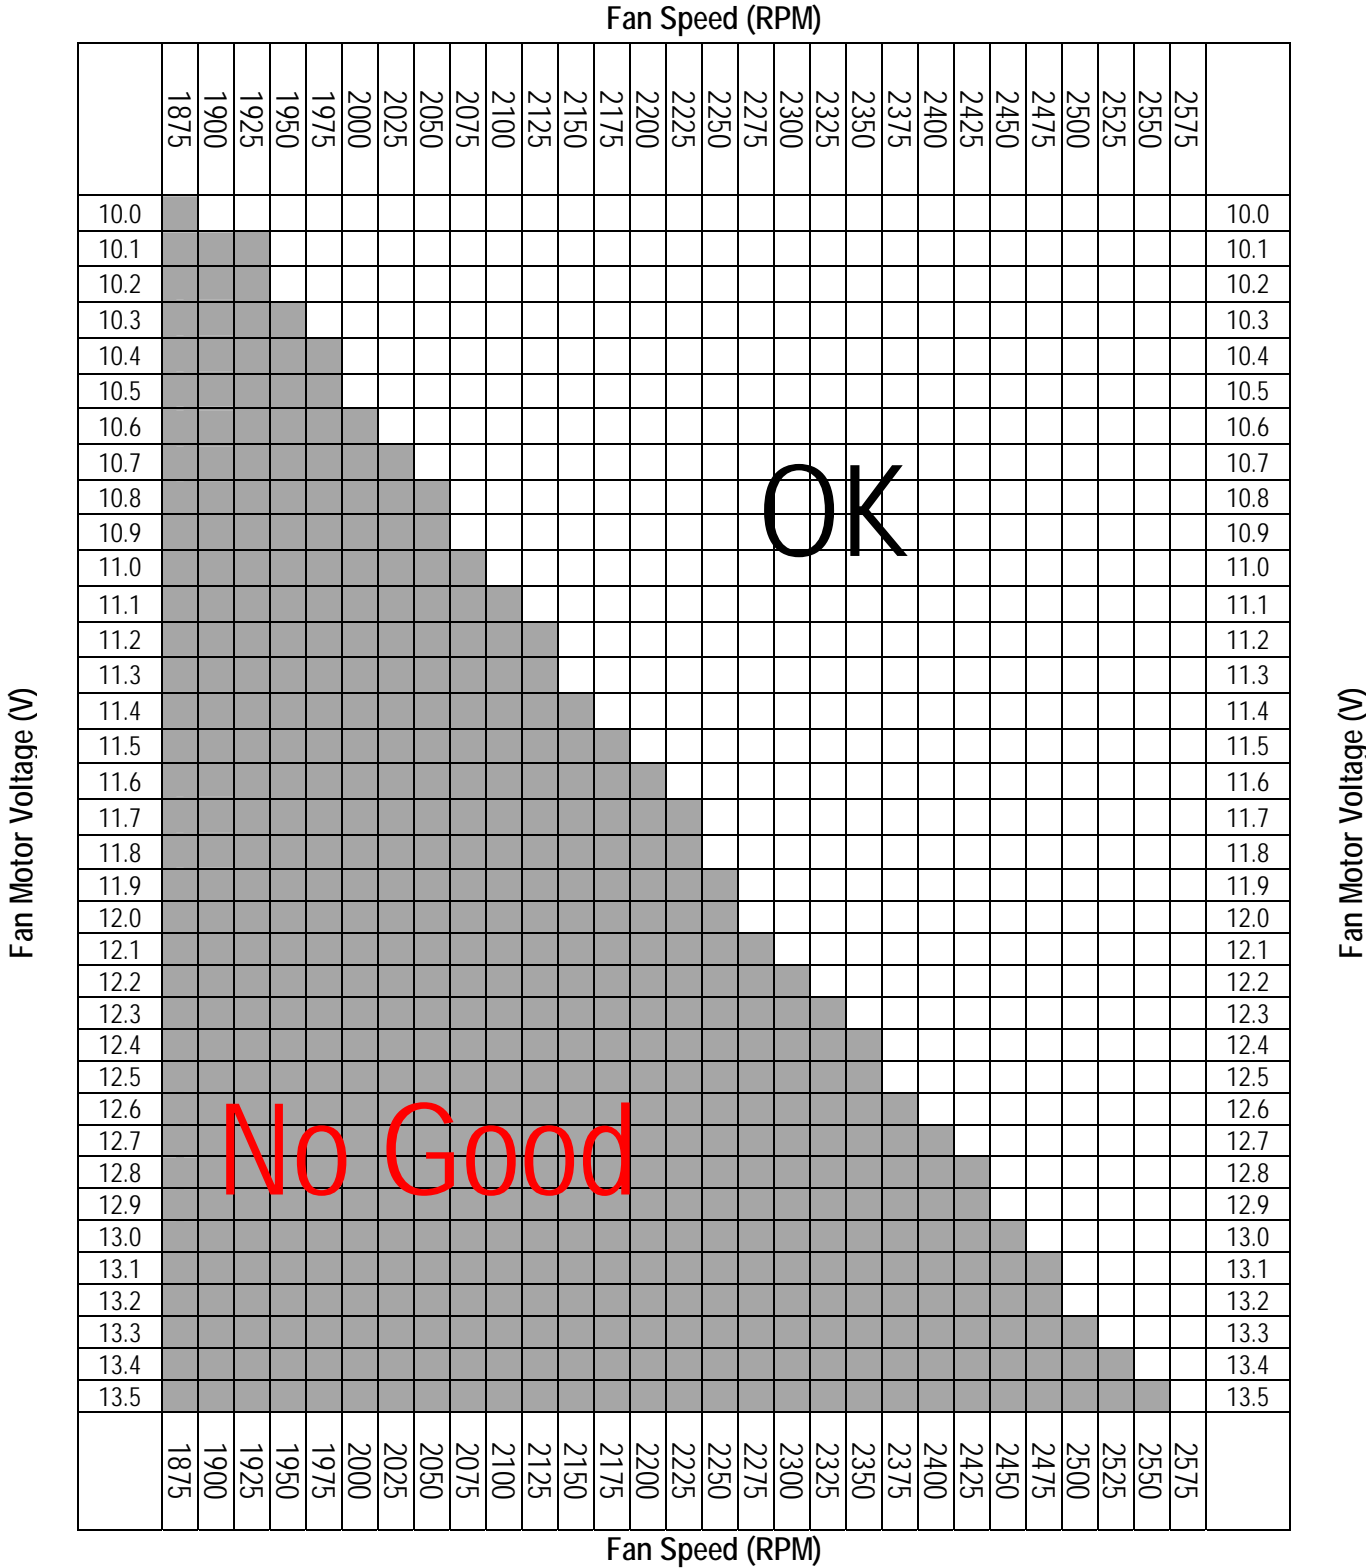
13. Use the chart below to determine if the fan motor is OK or No Good.

- Find the intersecting point of your RPM and Voltage readings that you wrote down in step 10.

NOTE: If voltage reading is less than 10.0 V, charge the vehicle battery and retest. Do not perform fan motor test with a charger attached to the vehicle battery.

15. Determine your next steps as follows:

If the fan motor is OK:

- a. **Remove** the Condenser Fan Assembly – Procedure C steps 1 through 15.
- b. Install the Condenser Fan Motor Protective Coverings – Procedure D.
- c. Reinstall the Condenser Fan Assembly – Procedure C steps 16 through 31.
- d. Confirm Condenser Fan Motor operation – Procedure F.

If the fan motor is No Good:

- a. **Replace** the Condenser Fan Assembly – Procedure C.
- b. Install the Max Fuse – Procedure E.
- c. Confirm Condenser Fan operation – Procedure F.

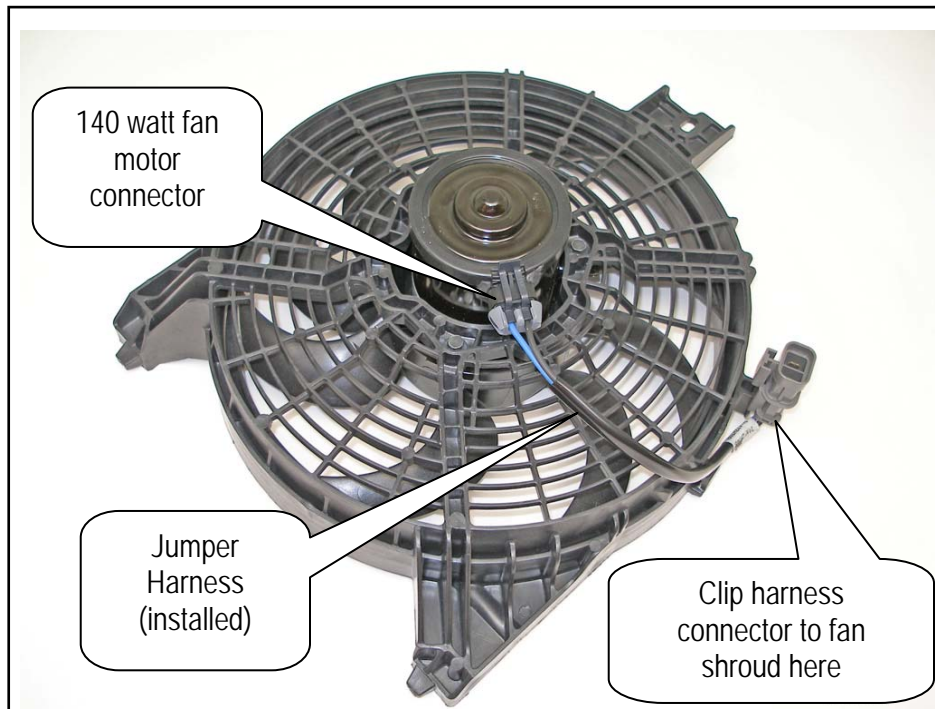
Figure C-11

Jumper harness installation on NEW 140 watt fan assembly

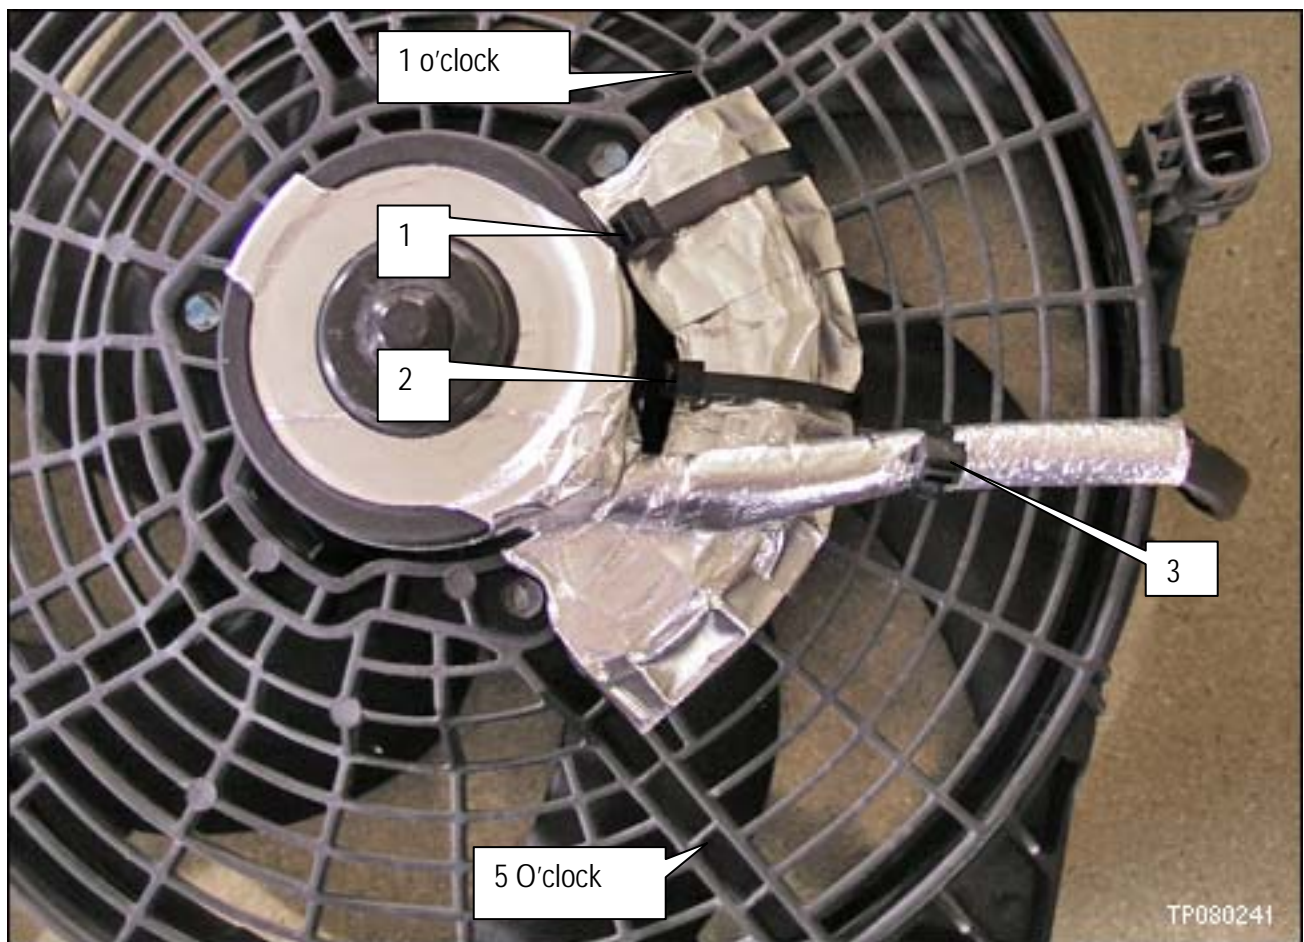
Figure D-17

14. Attach 3 tie-wraps as shown in Figure D-17.

- Use 7½ inch (19.5 cm) tie-wraps from the protector kit.
- Use the large 1 o'clock and 5 o'clock ribs for reference.
- **Pay close attention to the tie wrap locations.** Count the slots in the fan shroud to confirm correct tie-wrap locations.
