ITB08-034c

VOLUNTARY RECALL CAMPAIGN 2004 – 2006 INFINITI QX56 AIR CONDITIONER CONDENSER FAN

CAMPAIGN ID #: PB080 – for Applied Vehicles built before March 17, 2005
PB076 – for Applied Vehicles built on or after March 17, 2005

APPLIED VEHICLES: 2004 – 2006 QX56 (JA60)

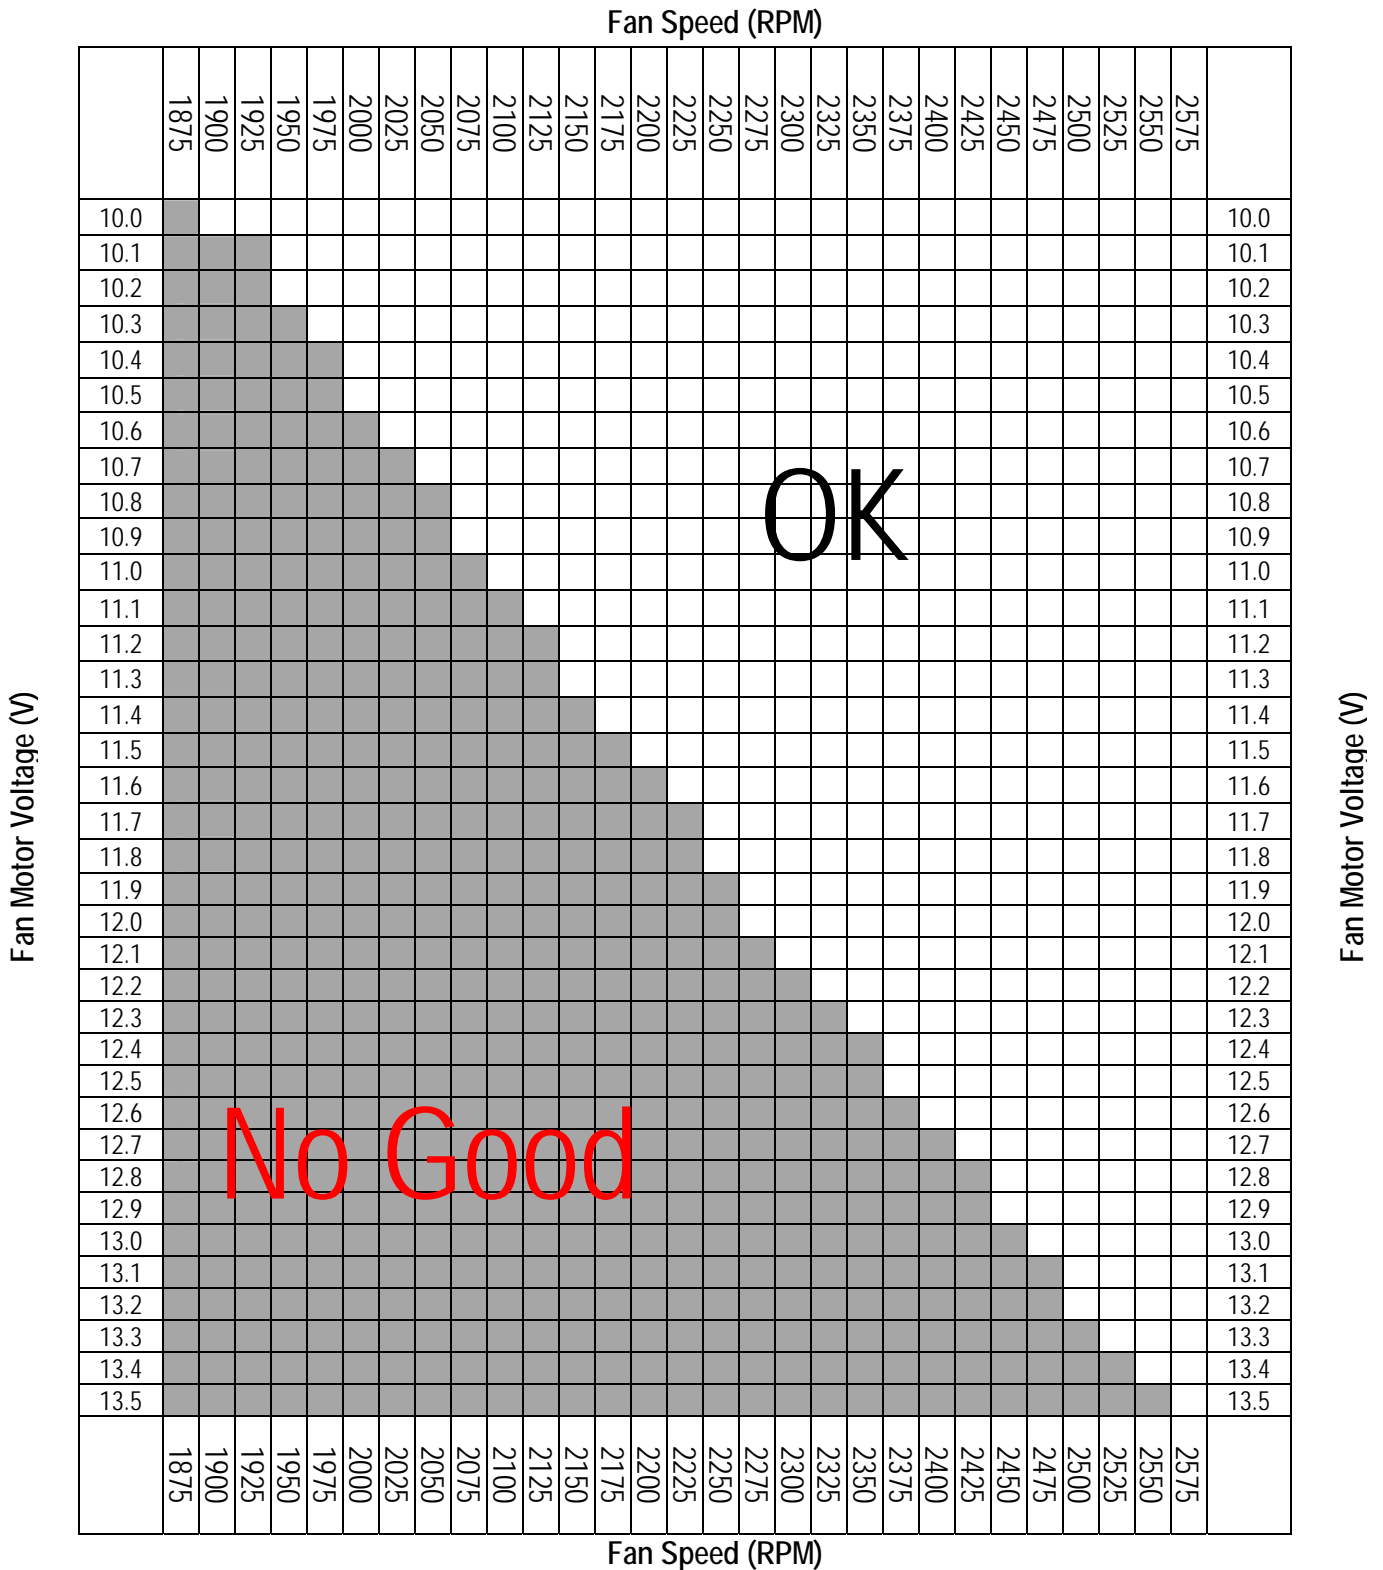
13. Use the chart below to determine if the fan motor is OK or No Good.

- Find the intersecting point of your RPM and Voltage readings that you wrote down in step 10.

NOTE: If voltage reading is less than 10.0 V, charge the vehicle battery and retest.
Do not perform fan motor test with a charger attached to the vehicle battery.

15. Determine your next steps as follows:

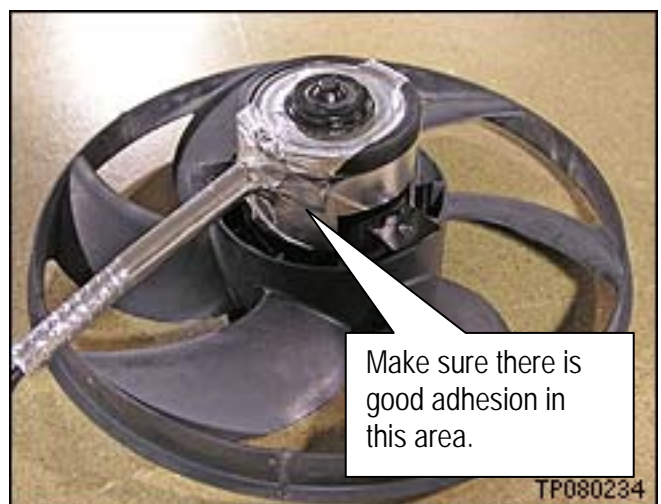
Figure D-11

9. Press and smooth all parts of protector 3. Make sure it is completely stuck to the fan motor.
 - Pay special attention to the area shown in Figure D-11. Make sure there is good adhesion in this area.

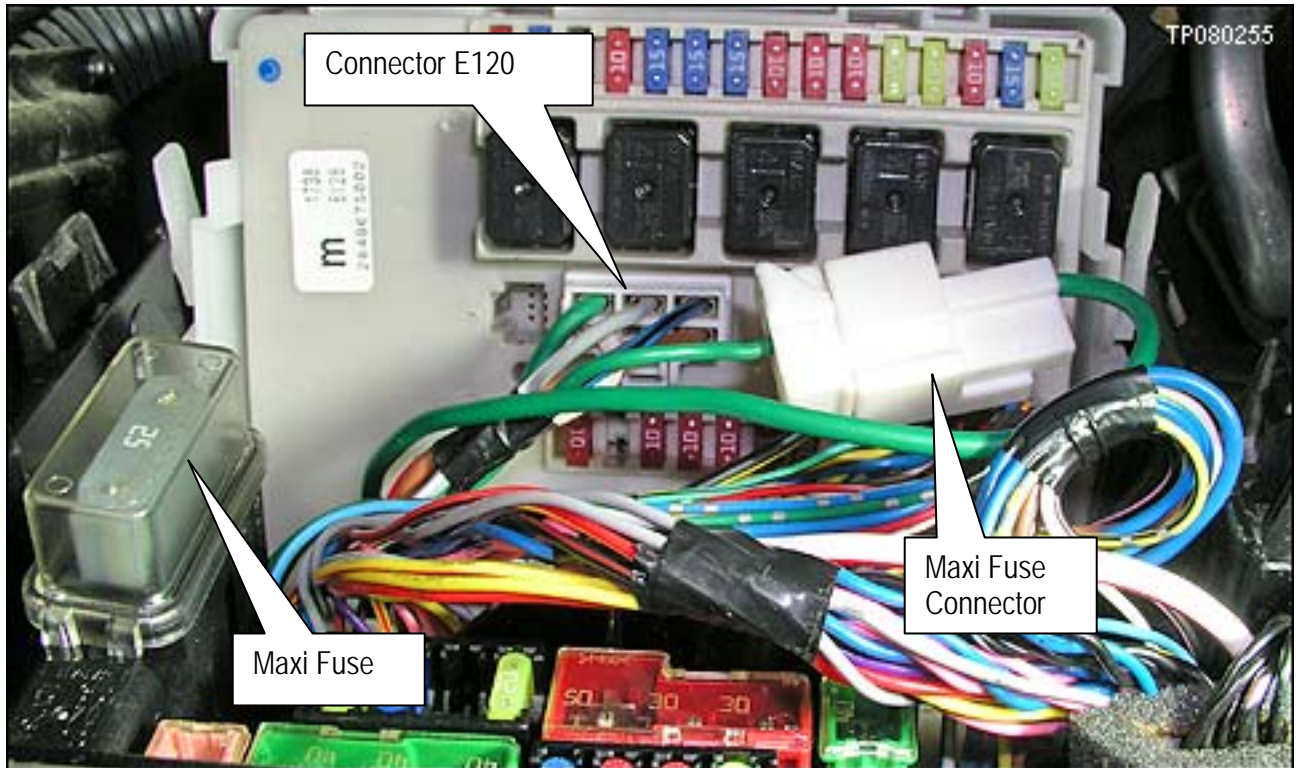
Figure E-6

7. Reconnect connector E120.
8. Connect the Maxi Fuse connector.
9. Position the Maxi Fuse, wires, and connector into the IPDM E/R box as shown in Figure E-6.
