# RECALL CAMPAIGN BULLETIN

NTB08-068a

## VOLUNTARY RECALL CAMPAIGN 2004 - 2006 NISSAN TITAN AND ARMADA AIR CONDITIONER CONDENSER FAN

**NHTSA #:** 08V-284

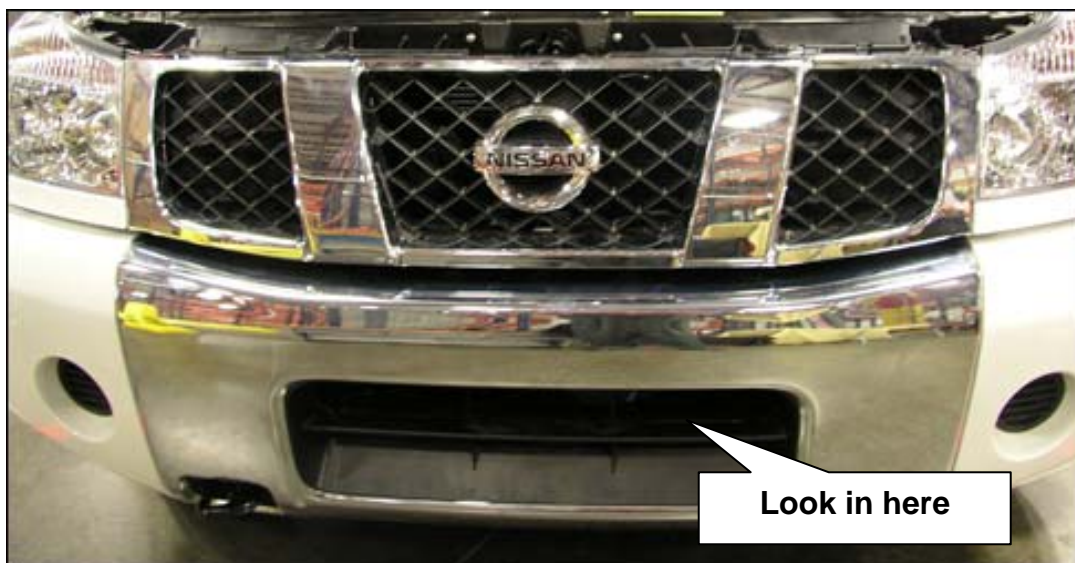
Figure A-1

1. Look in the lower bumper area and locate the condenser fan motor.

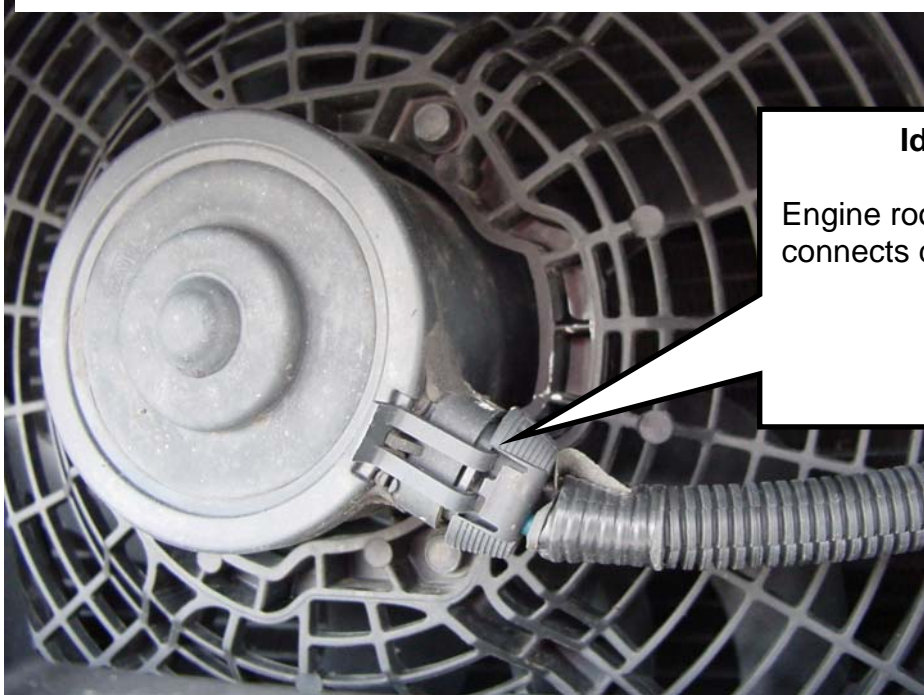
Figure A-2

**Type 3 Fan - 140 watt motor**

**Identification**  
Engine room harness  
connects directly to fan motor.

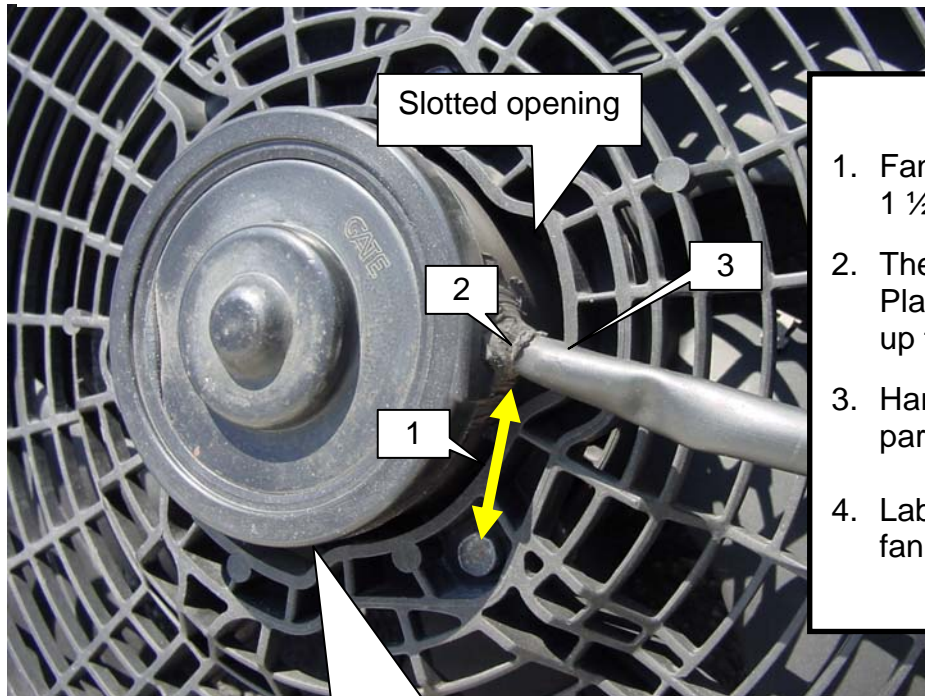
Figure A-3

## Type 1 Fan - 90 watt motor

1. Fan motor harness position is 1 ½" from mounting bolt.
2. There are no exposed wires. Plastic harness cover goes right up to the motor.
3. Harness goes across the lower part of the slotted opening.
4. Label on the lower side of the fan motor has the word "GATE".

4: Label has the word "GATE"

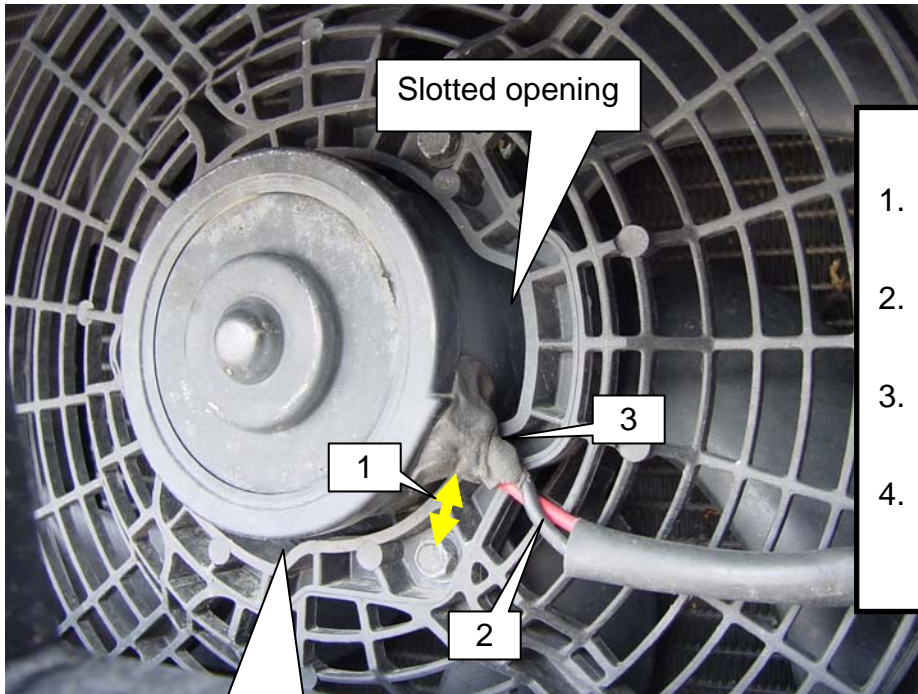
Figure A-4

## Type 2 Fan - 90 watt motor

- Identification:**
1. Fan motor harness position is 1/2" from mounting bolt.
  2. Red and Black wires are exposed.
  3. Wire harness is below slotted opening.
  4. Label on the lower side of the fan motor does not have the word "GATE".

4: Label does not have the word "GATE"

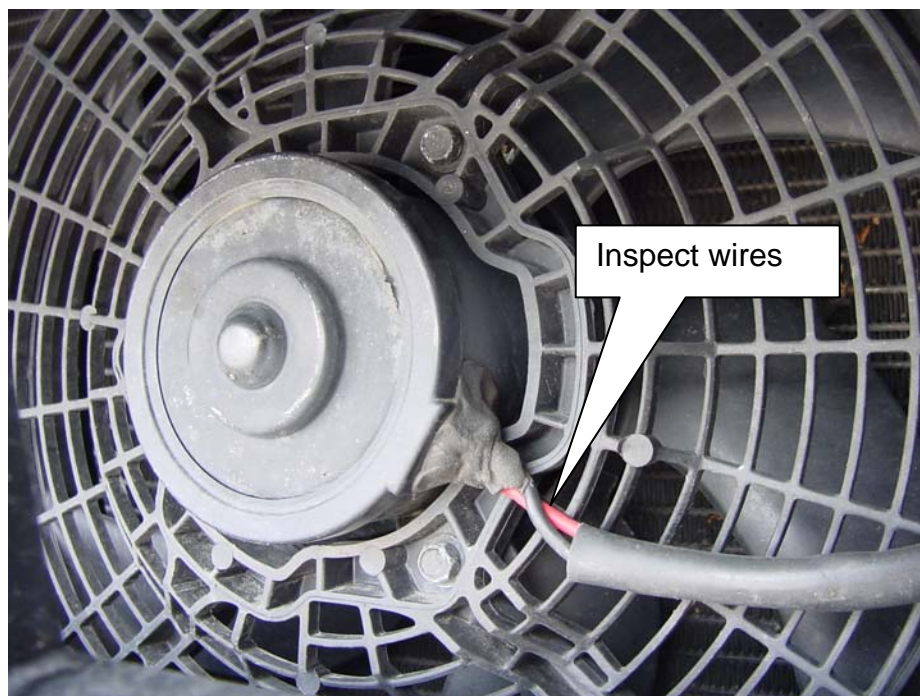
Figure B-1

### 1. Inspect the wires near the condenser fan motor:

- Make sure there is no damage to the wire insulation and the wires are in good condition.
- **If the wires are damaged** (cracked or missing insulation), STOP; no more testing is needed. Go to Procedure C on page 17 and replace the condenser fan assembly.

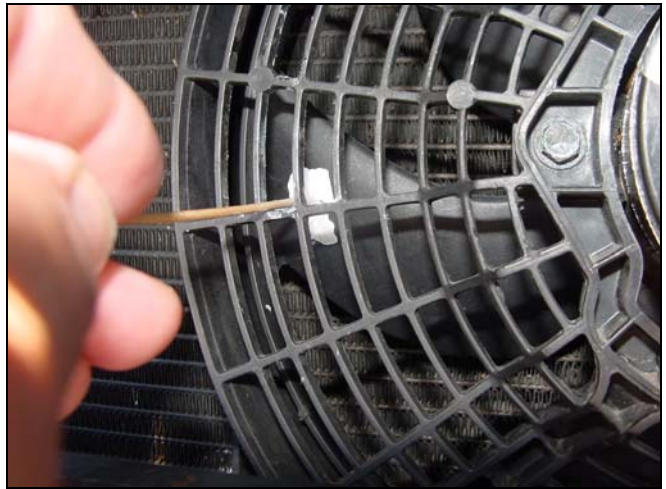
Figure B-2

4. Paint a “dime sized” area on the outer portion of one fan blade.

- Make sure the painted area is completely filled in (no unpainted spots or thin paint in the dime sized area).
- Allow the paint to dry—about 5 minutes.

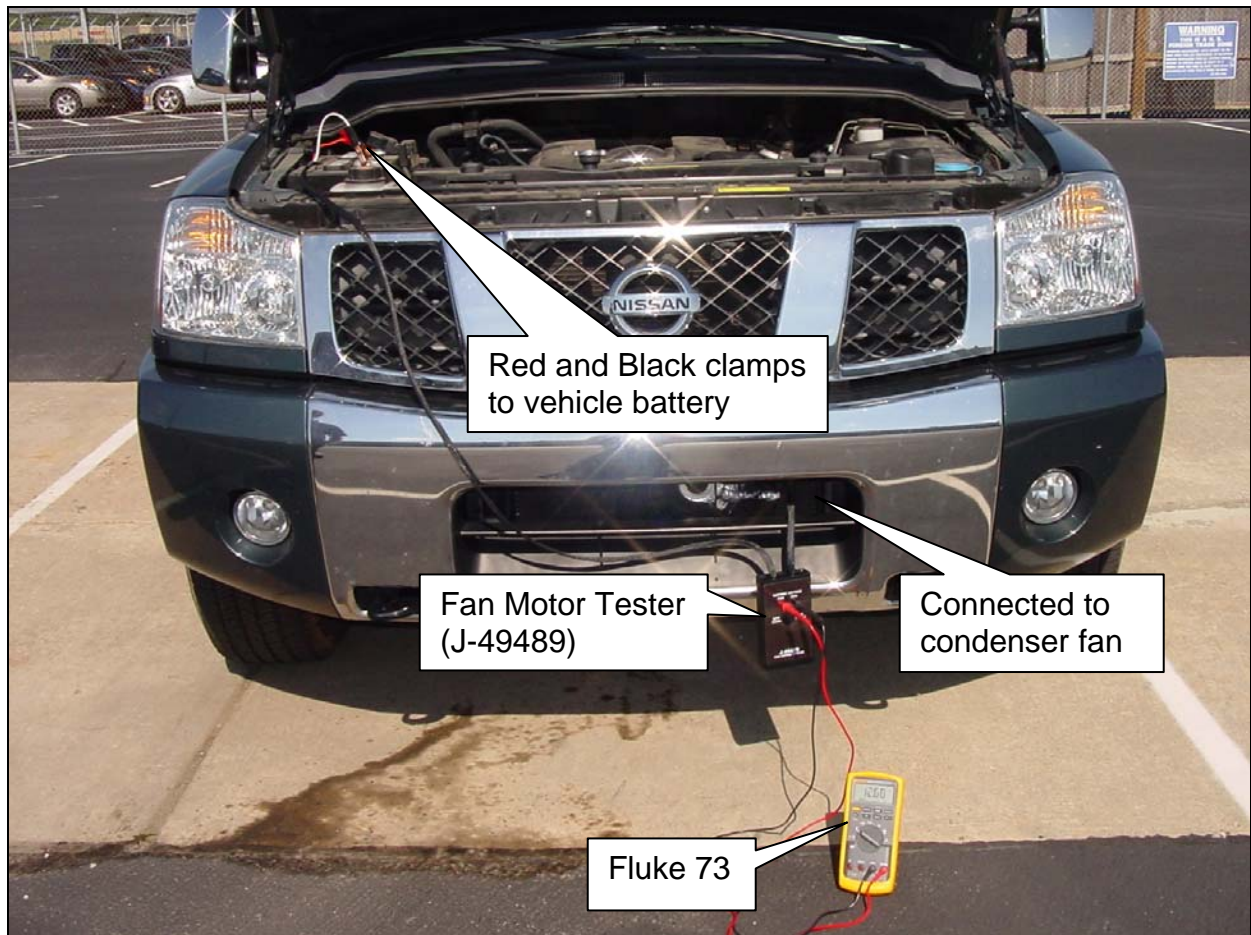
Figure B-4

6. Connect the Fan Motor Tester and the Fluke 73 Digital Multimeter (using the fluke meter test leads) as follows (see Figure B-4):
- Connect Fan Motor Tester harness connector to the condenser fan.
  - Connect Fan Motor Tester to the vehicle battery; Red clamp to + (positive) / Black clamp to – (negative).
  - Connect the Fluke 73 digital multimeter to the MOTOR VOLTAGE test ports on the Fan Motor Tester; V+ red probe to POS / COM black probe to NEG.

**NOTE:** When connected as above with the Fan Motor Tester switched OFF, the LED on the switch will illuminate green; this indicates the tester has battery power.

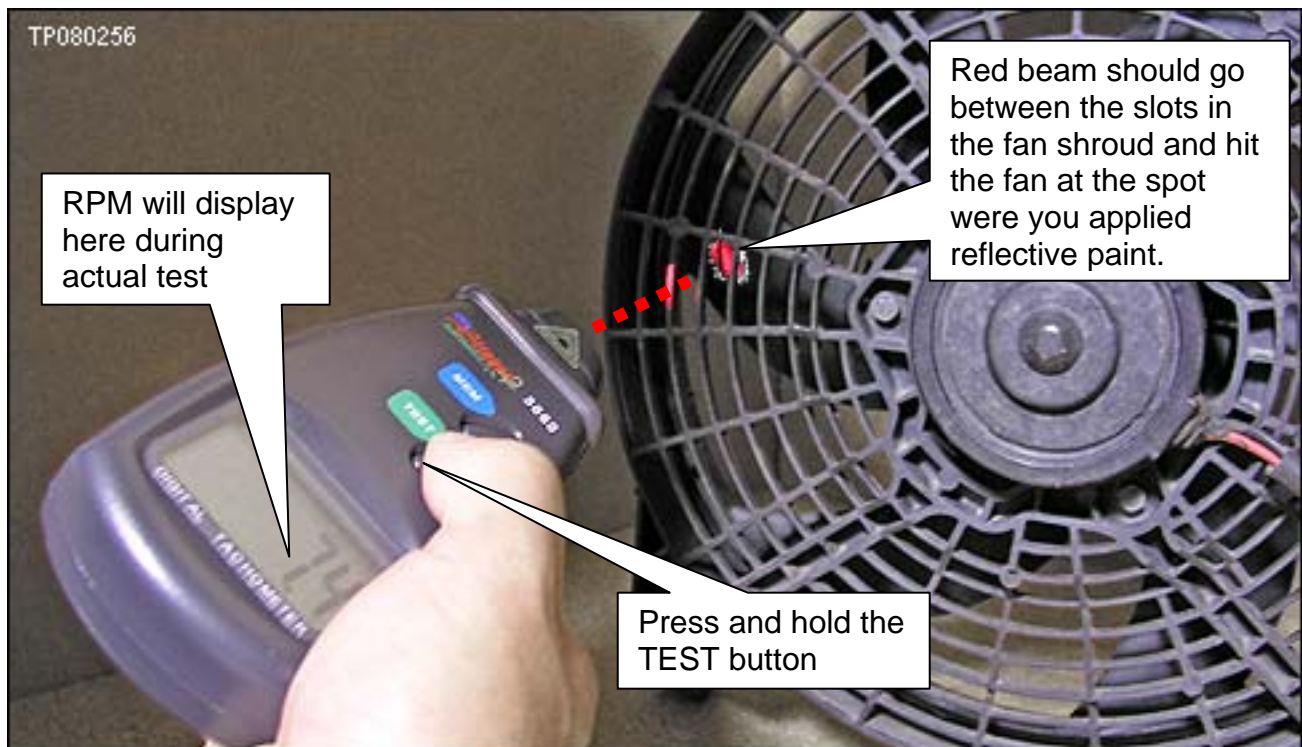
Figure B-7

3. Hold the digital tachometer about 4 inches away from the condenser fan.
4. Aim the red beam at the painted area on the fan blade.
  - The beam should be aimed between / through the slots in the fan shroud.

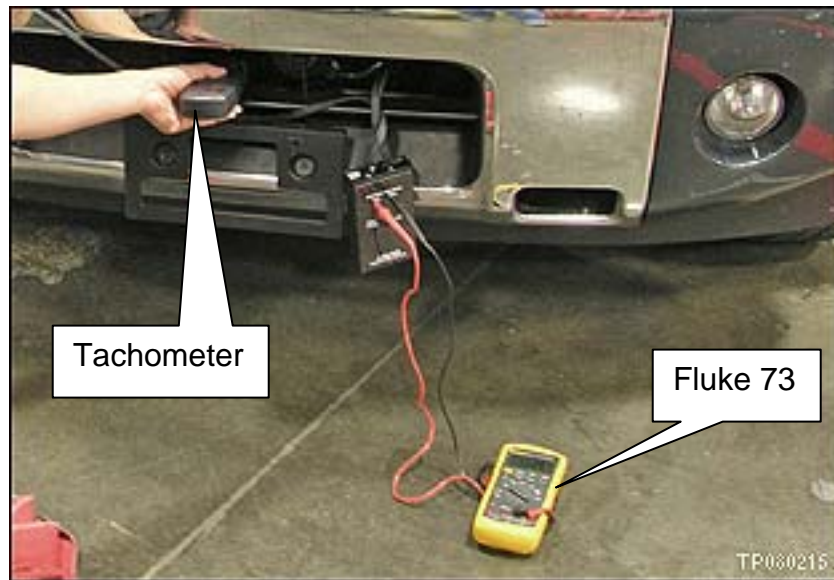
Figure B-5

9. Measure the fan motor speed (RPM) and the fan motor voltage as follows.
  - a. Turn the Fan Motor Tester ON.

- d. Observe the RPM reading on the tachometer and the volt reading on the Fluke 73 meter.

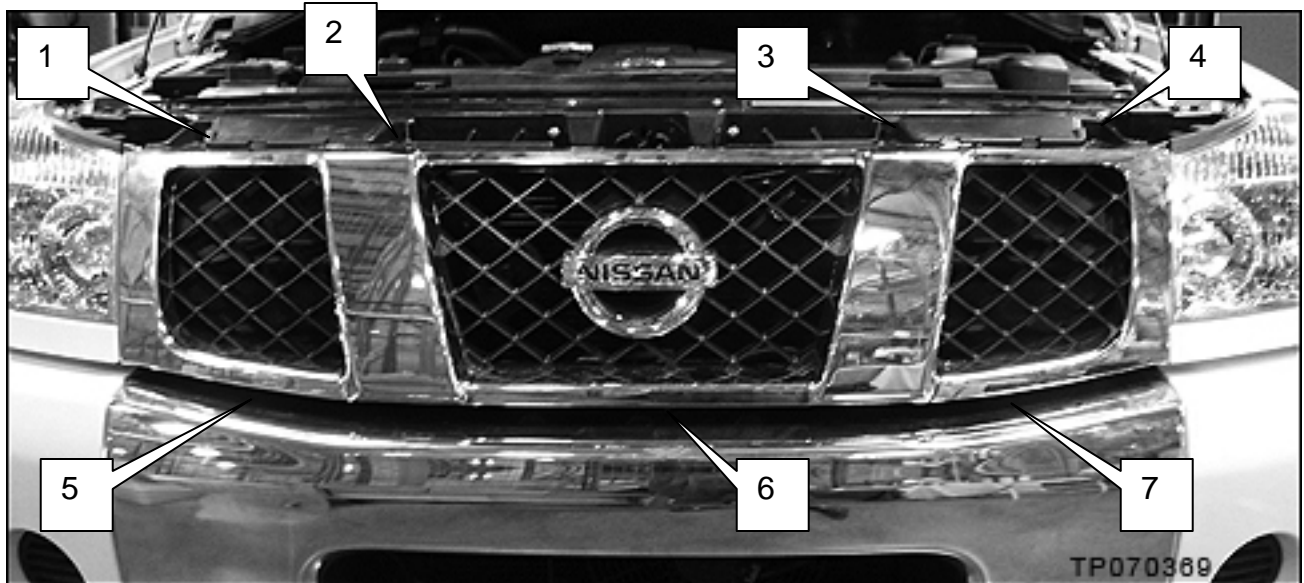
Figure C-1

- a. Use a long screwdriver to twist and release 7 clips shown in Figure C-1.

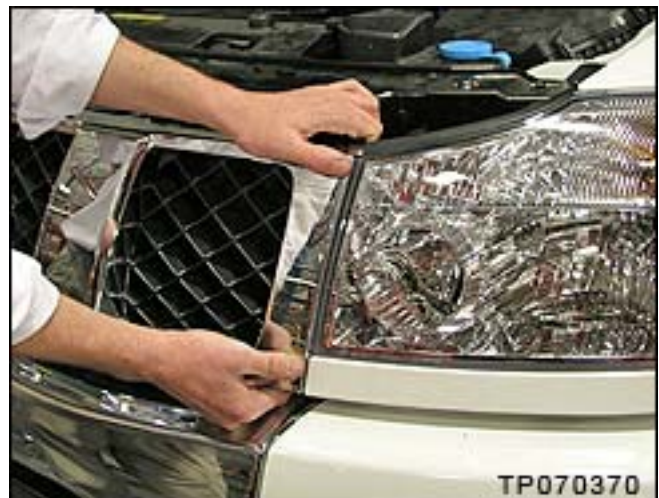
Figure C-2

- b. **IMPORTANT:** Make sure all 7 clips are released prior to the next step.
- c. Hold the grill as shown and give it a sharp pull.
- Do this for both sides.

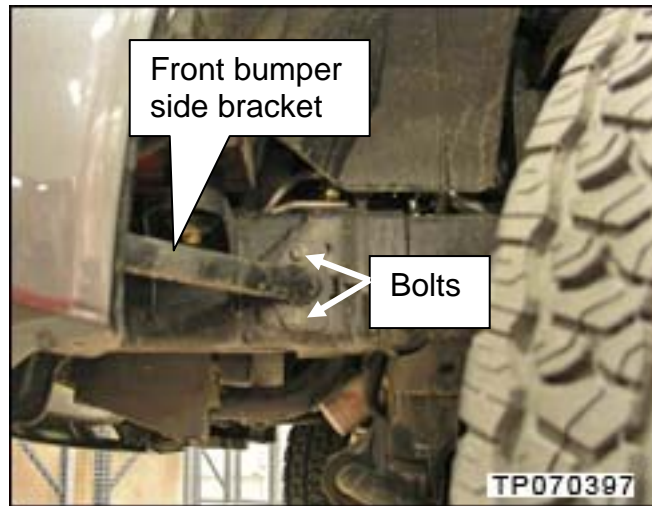
Figure C-3

4. Remove 2 bolts from the front bumper side bracket.

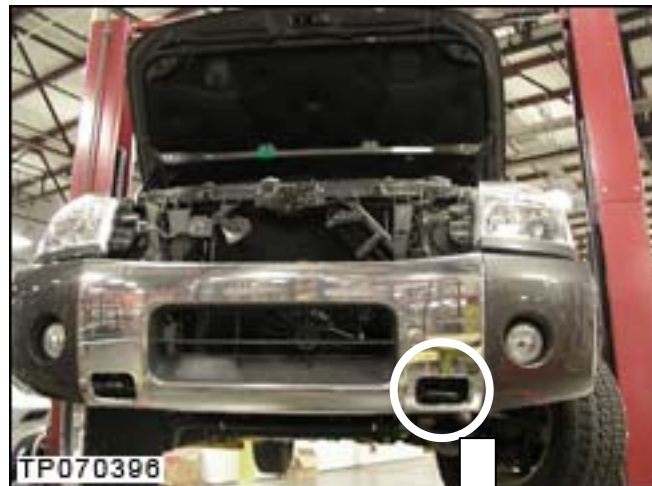
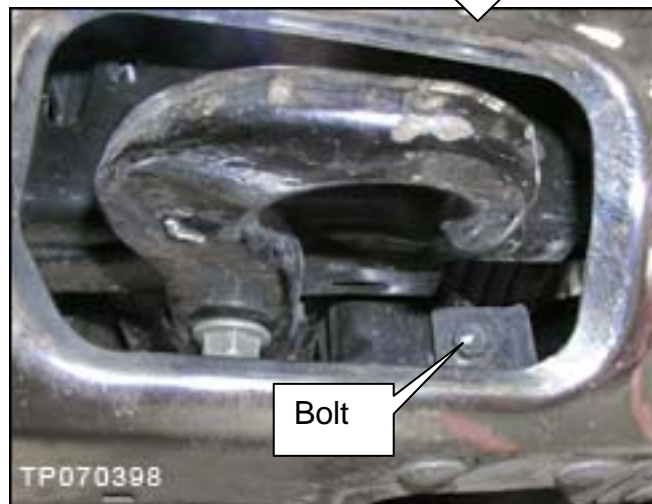
a. Remove 1 bumper bolt shown in Figures C-4 and C-5:

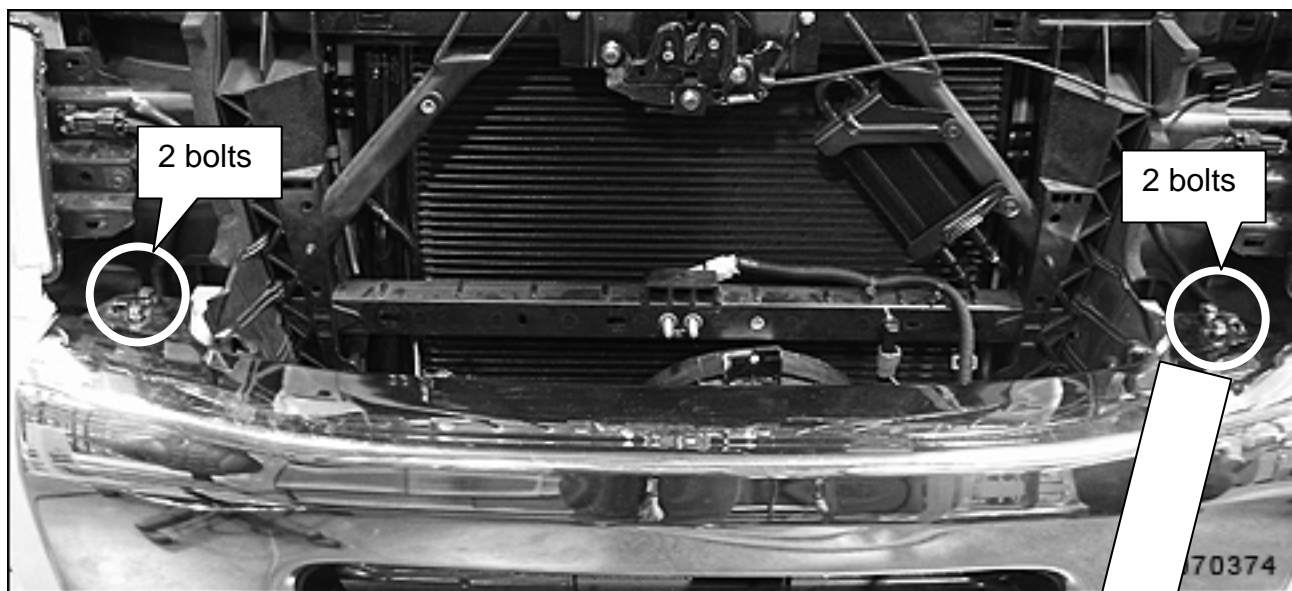
Figure C-6

b. Remove the 4 bumper bolts shown below.

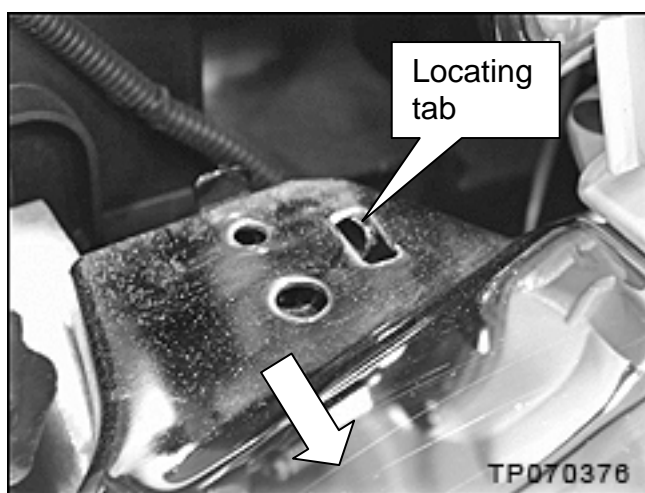
Figure C-7

c. Lift the bumper OFF of the locating tabs; both sides.

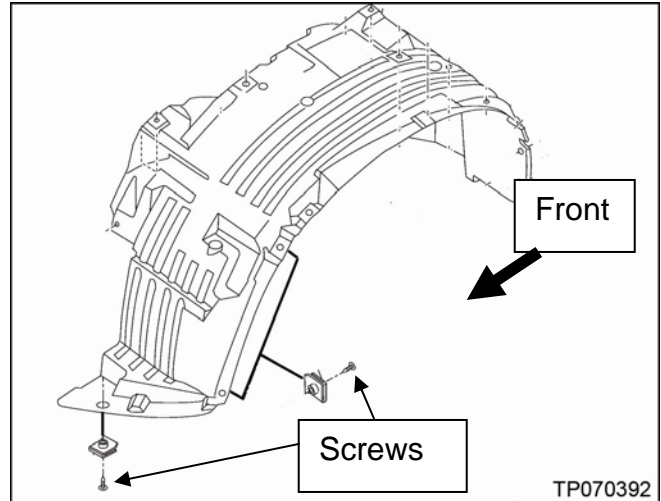
Figure C-8

- a. Remove 3 screws from the front of the fender protector.
  - Driver side only.

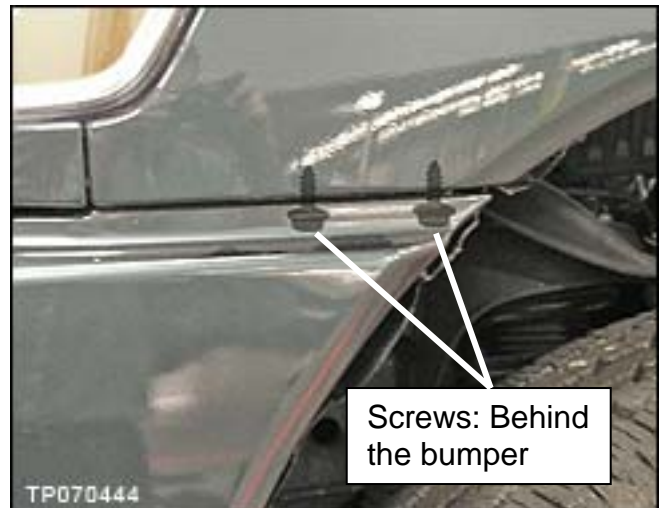
Figure C-9

- b. Remove 2 bumper to fender screws.
  - Driver side only.

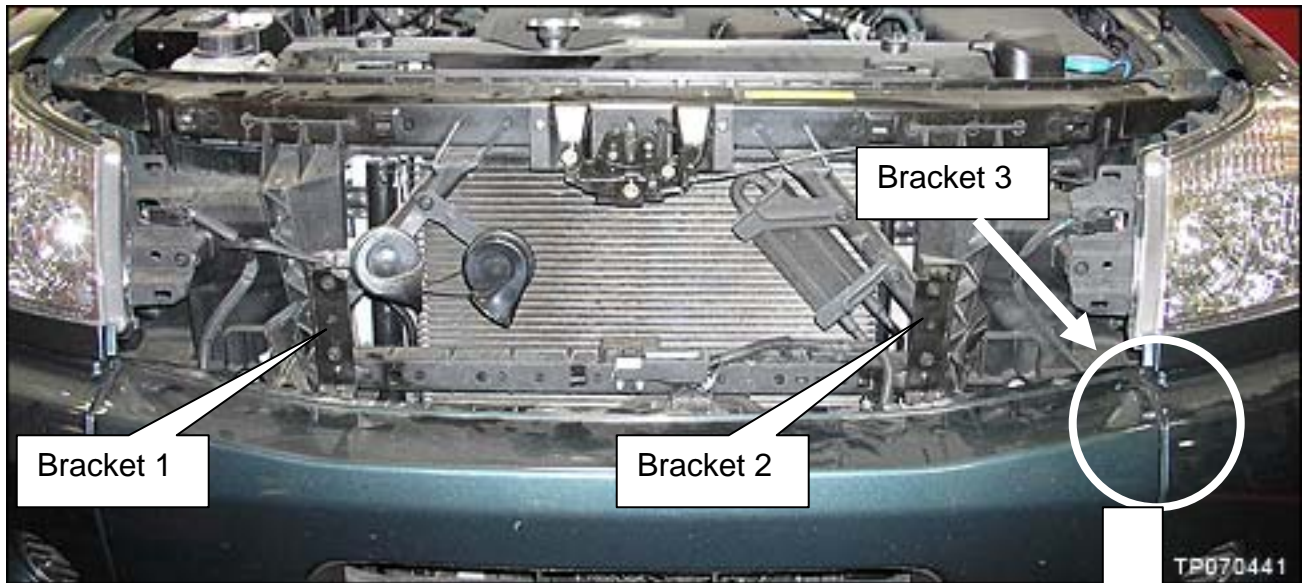
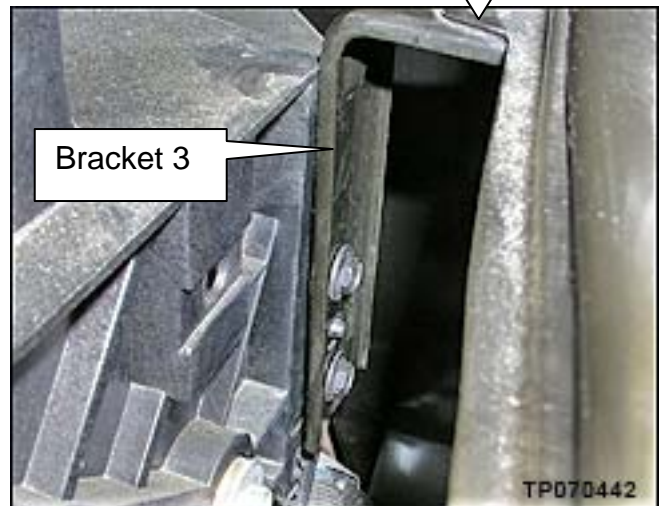
c. Remove 2 bolts from each of the 3 bumper brackets shown in Figures C-10 and C-11.

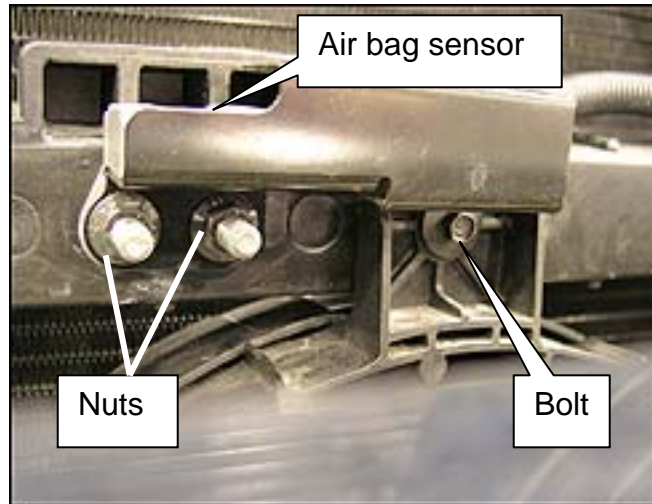
Figure C-12

8. Remove the condenser fan mounting bolt.

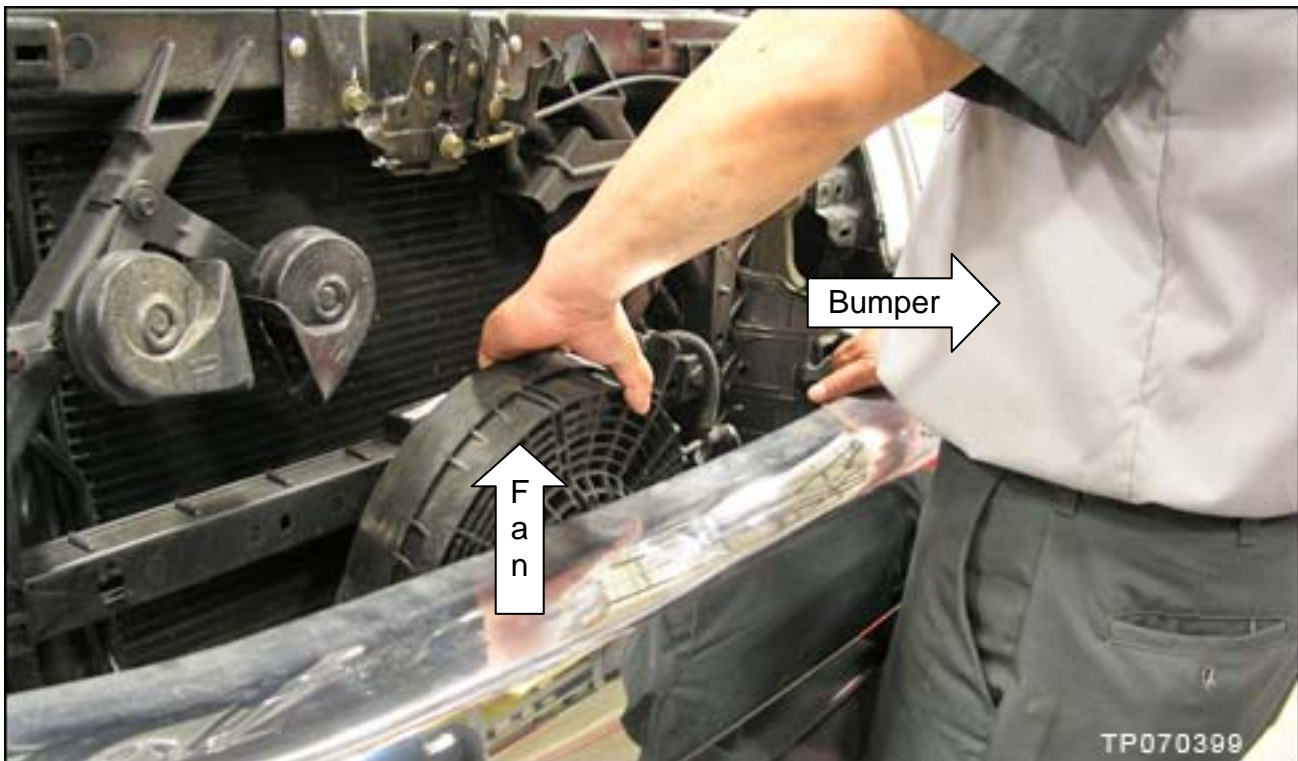
Figure C-13

9. Pull the bumper forward and remove the fan.

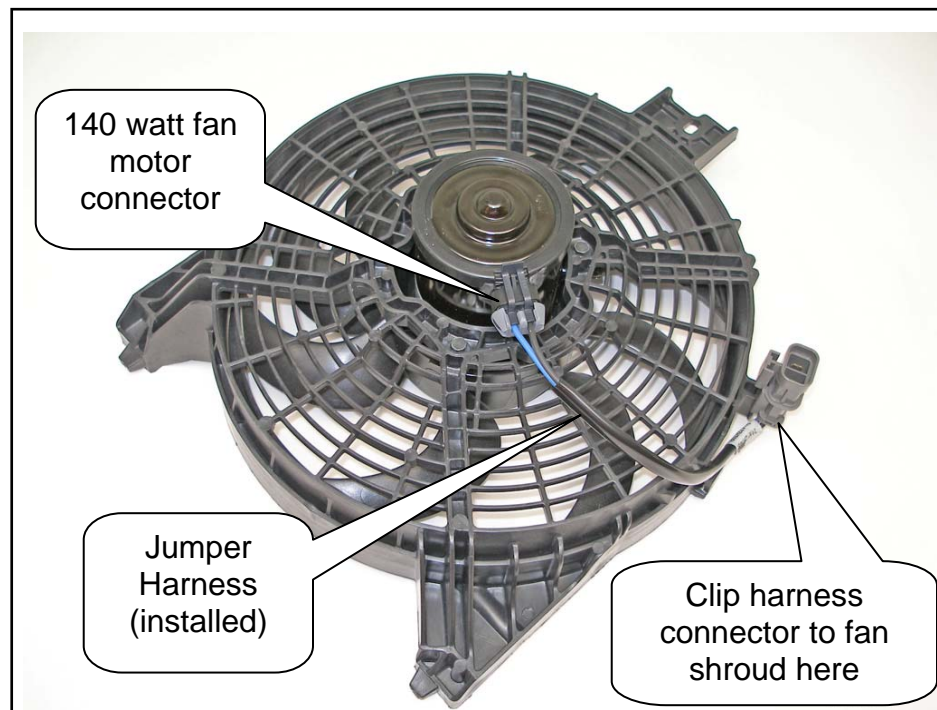
Figure C-14

- a. Install the jumper harness on the new fan motor as show below.
  - New fan assembly and harness kit are listed in the Parts Information.
- b. Go to the next page for installation of the fan assembly.

Jumper harness installation on NEW 140 watt fan assembly

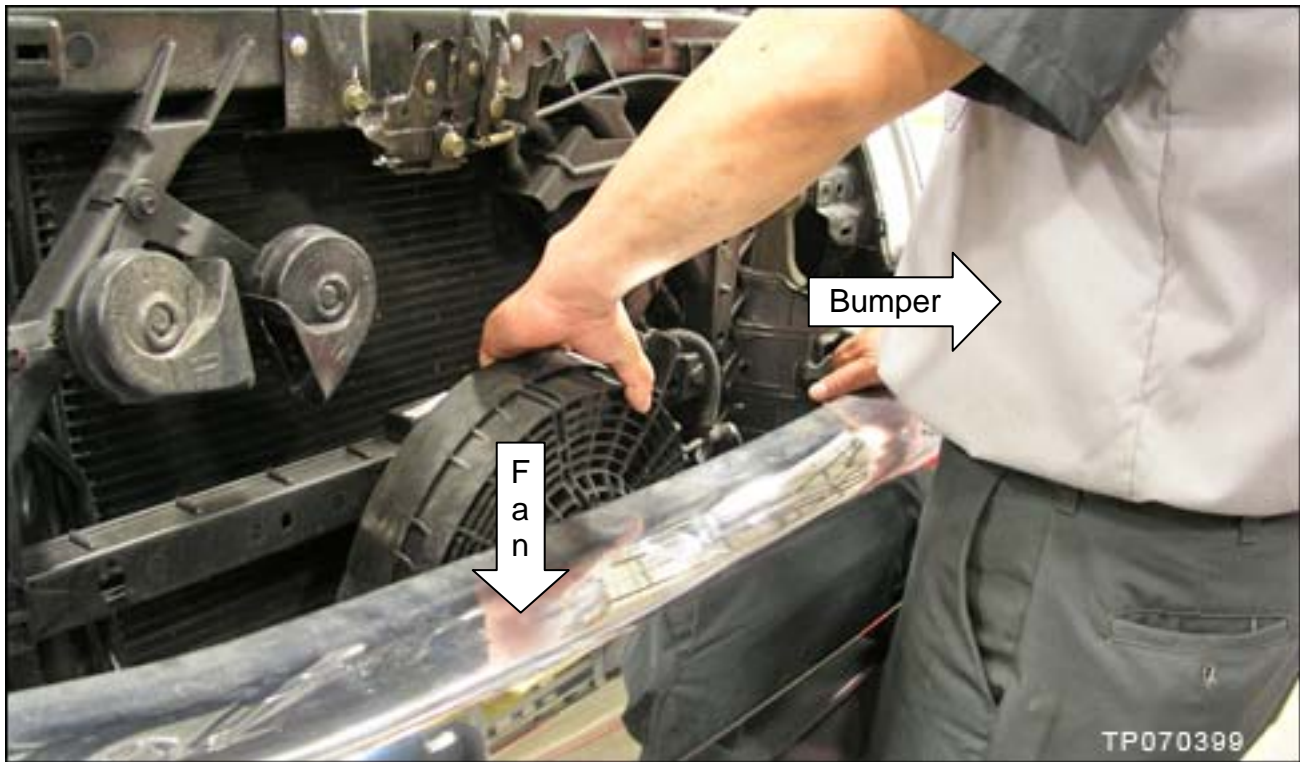
Figure C-15

10. Pull the bumper forward and Install the fan assembly.

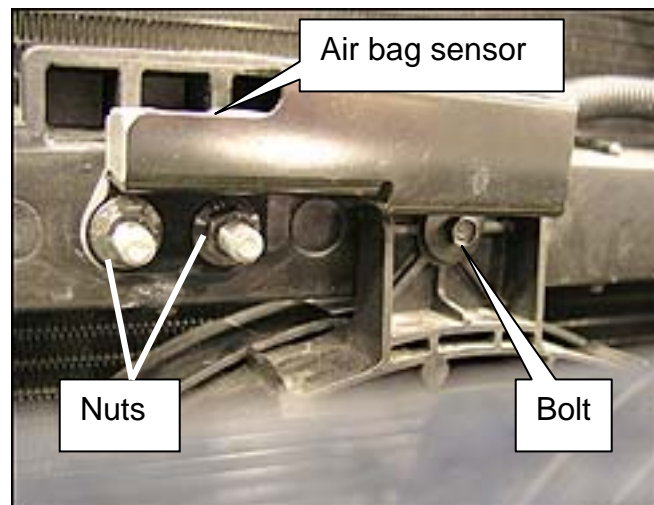
Figure C-16

12. Install and torque 2 nuts to the air bag sensor.

- Torque:  
15 N.m (1.52 Kg-m, **11 ft-lb**)
- Apply medium strength thread-locker to the studs (Nissan P/N 999MP-AM005P or equivalent).

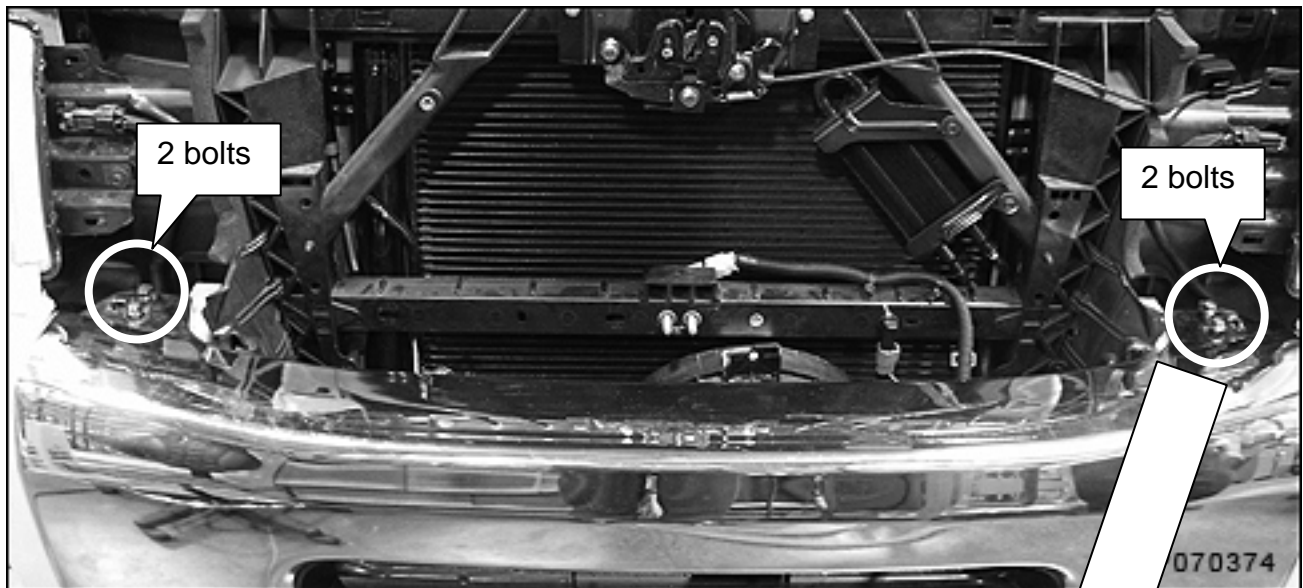
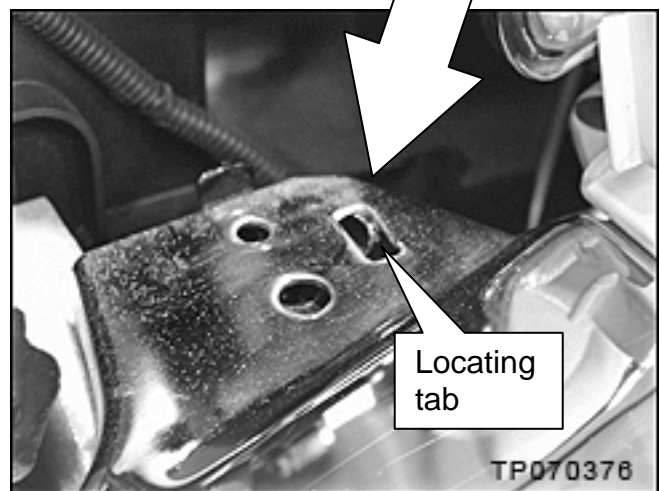
- a. Lift bumper ON the locating tabs; both sides (see Figure C-18).
- b. Install and Torque 4 bumper bolts (see Figure C-17).

Torque: 14.2 N.m (1.45 kg-m, **10 ft-lb**)

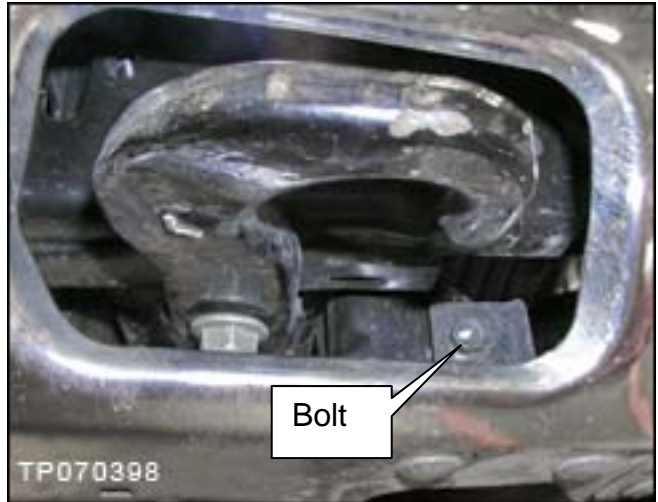
Figure C-19

c. Install and Torque the bumper bolt shown in Figure C-19.

Torque:  
14.2 N.m (1.45 kg-m, **10 ft-lb**)

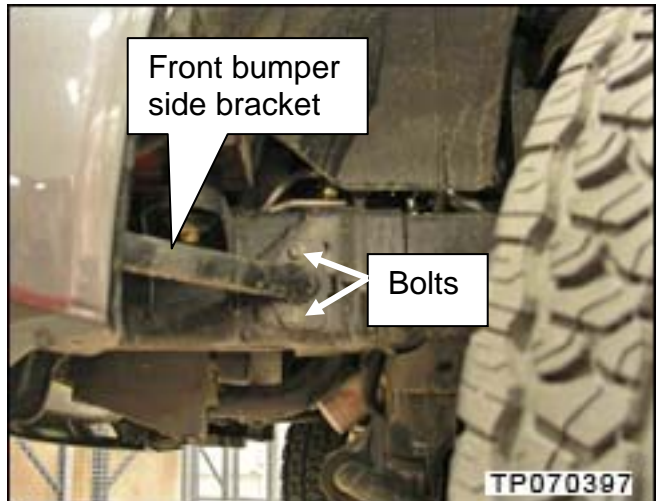
Figure C-20

d. Install and torque 2 bolts from the front bumper side bracket (see Figure C-20).

Torque:  
14.2 N.m (1.45 kg-m, **10 ft-lb**)

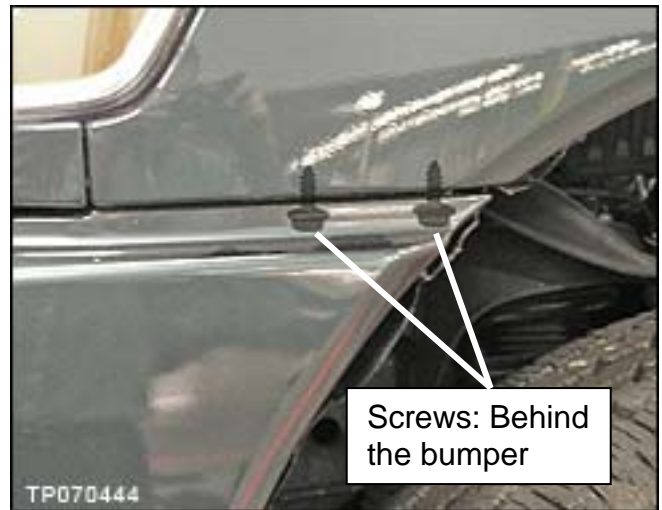
Figure C-21

- a. Install 2 bumper to fender screws.
  - Driver side only.

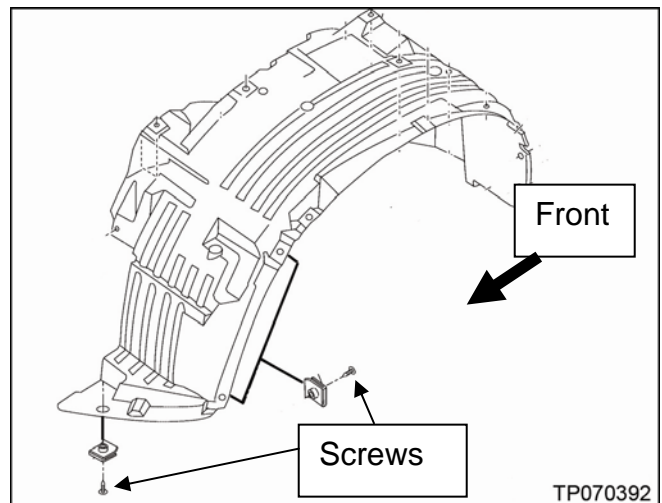
Figure C-22

- b. Install 3 screws at the front of the fender protector.
  - Driver side only.

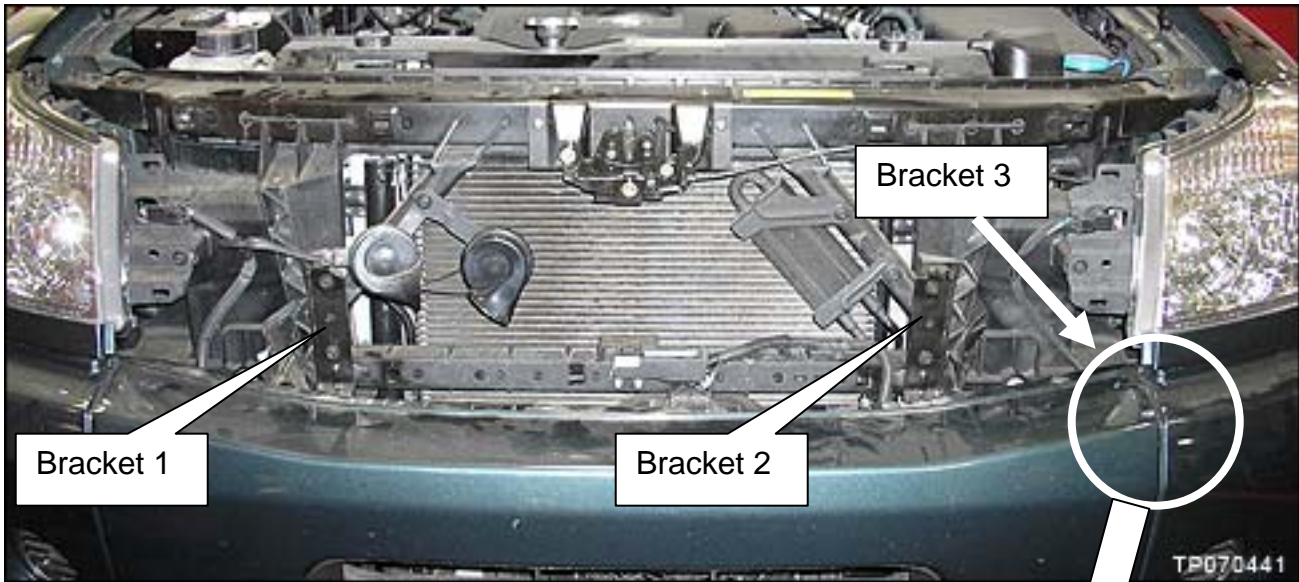
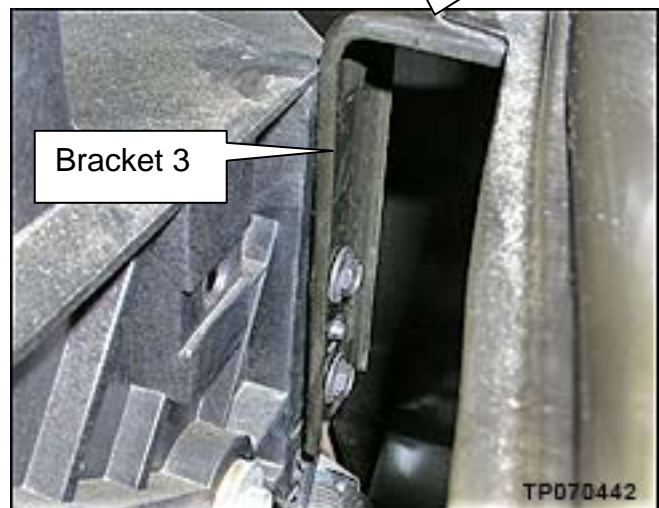
- c. Install and Torque 2 bolts at each of the 3 bumper brackets as shown (see Figures C-23 and C-24).

Torque for bolts on brackets 1, 2, & 3:  
9.6 N.m (0.97 kg-m, **85 in-lb**)

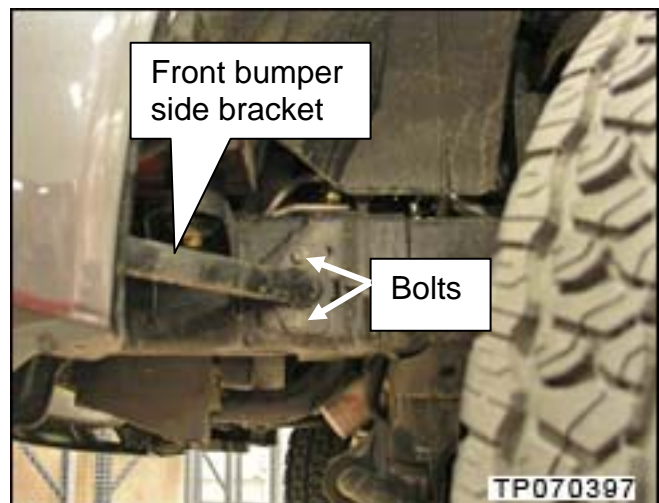
Figure C-25

- d. Install and torque 2 bolts for the front bumper side bracket.

Torque:  
14.2 N.m (1.45 kg-m, **10 ft-lb**)

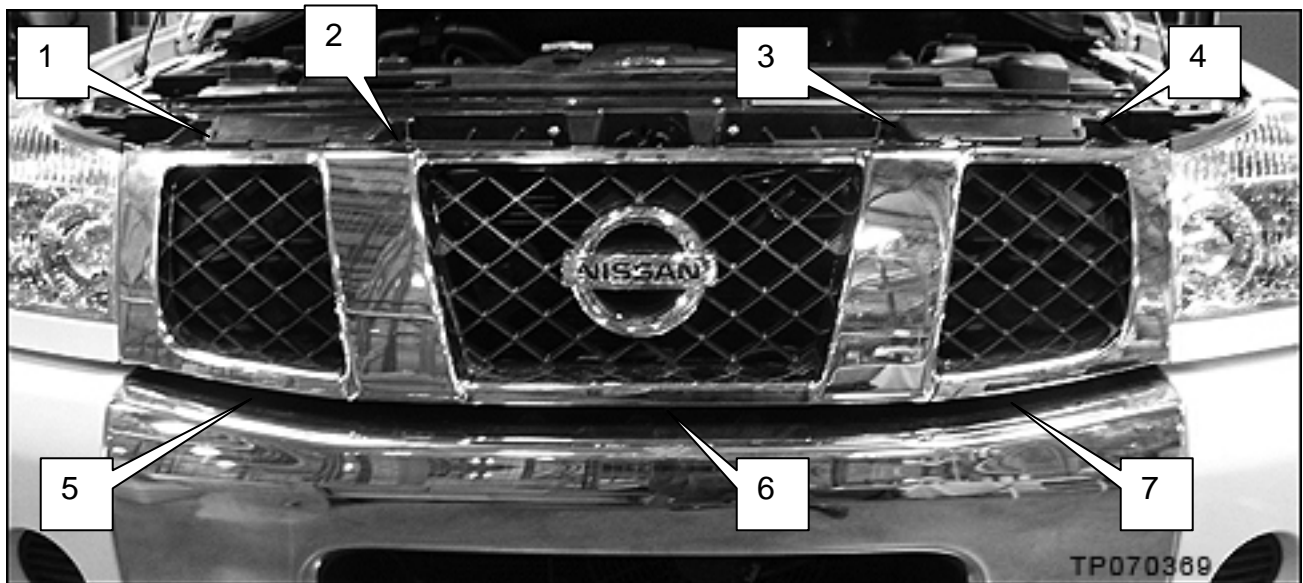
Figure C-26

15. Install the grill.

**IMPORTANT:** Make sure all 7 clips are properly located in the grill before installing.

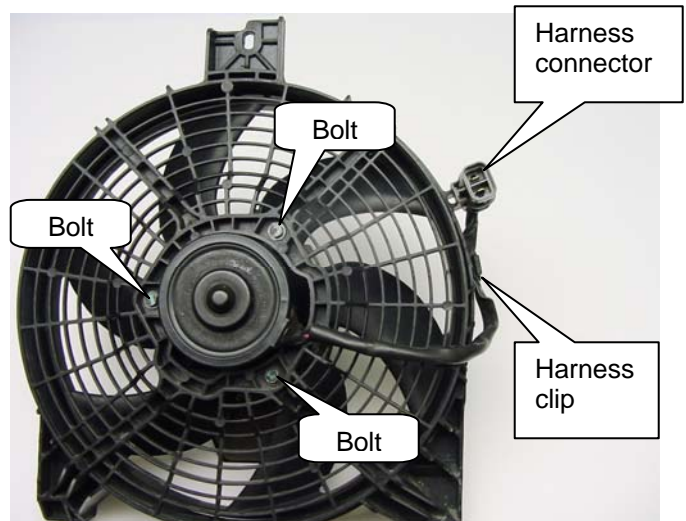
Figure D-1

1. Remove the fan motor from the shroud as follows:
  - a. Disconnect the harness connector from the shroud.
  - b. Disconnect the harness from the shroud clip.
  - c. Remove the fan motor bolts x 3.
    - Discard the bolts; they will not be reused.
  - d. Carefully separate the motor from the shroud:  
**Don't damage the fan harness.**

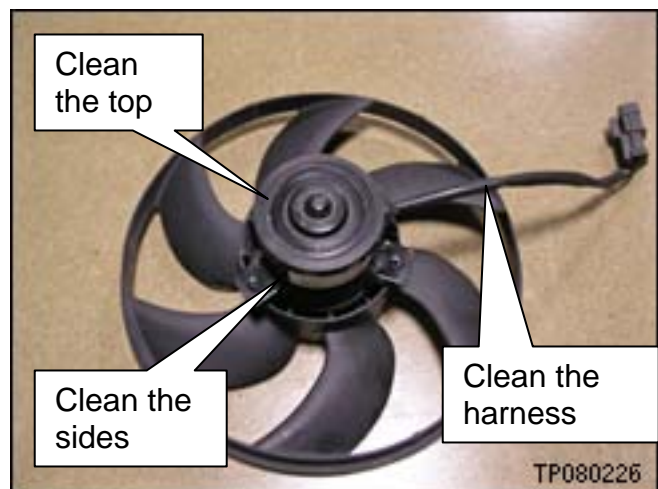
Figure D-2

2. Thoroughly clean all dirt and debris from the top and sides of the fan motor and the fan motor harness.
  - Use a locally approved brake cleaner and a clean rag.
  - The areas indicated must be completely clean to insure proper adhesion of the self adhesive protectors.

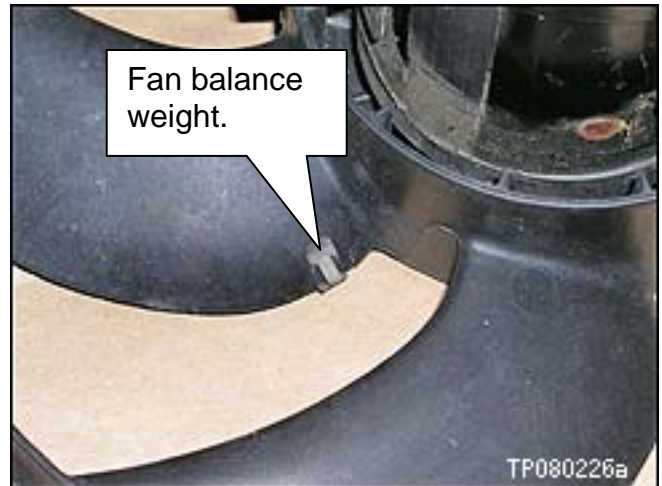
Figure D-2A

**NOTE:** You may see clips (fan balance weights) on the fan blades. **DO NOT** move or remove the fan balance weights.

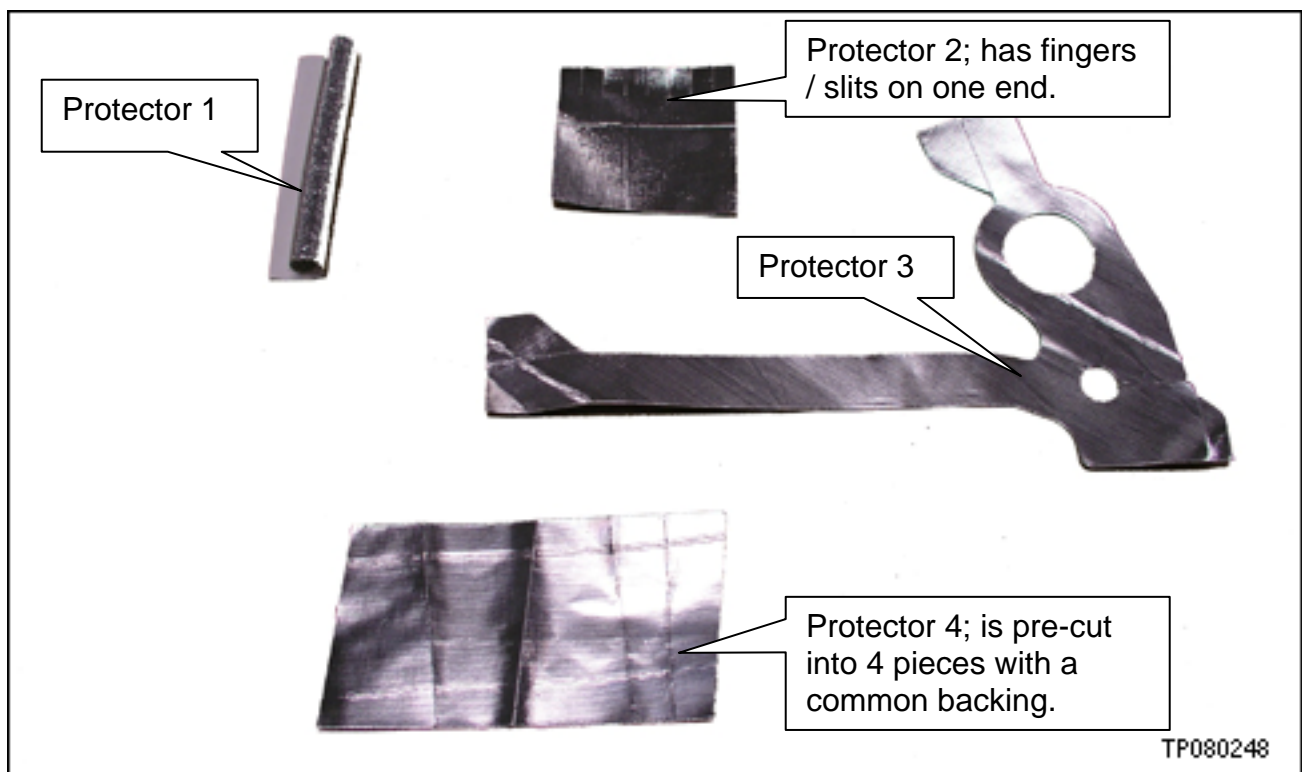
Figure D-3

In the next few steps you will be installing these four self adhesive protectors.

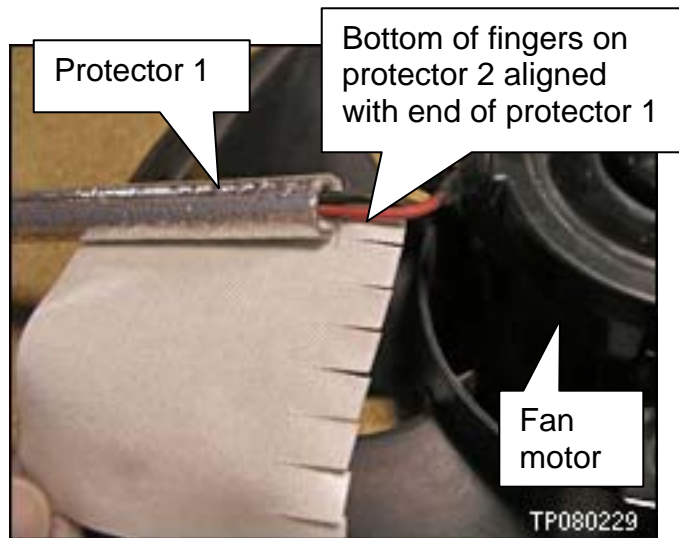
Figure D-5

4. Remove the adhesive backing from **Protector 2** and install it around protector 1:

- Fingers / slits on protector 2 must be facing the fan motor.
- Align the bottom of protector 2 fingers with the end of protector 1.
