# RECALL CAMPAIGN BULLETIN

NTB08-068a

## VOLUNTARY RECALL CAMPAIGN 2004 - 2006 NISSAN TITAN AND ARMADA AIR CONDITIONER CONDENSER FAN

**NHTSA #:** 08V-284

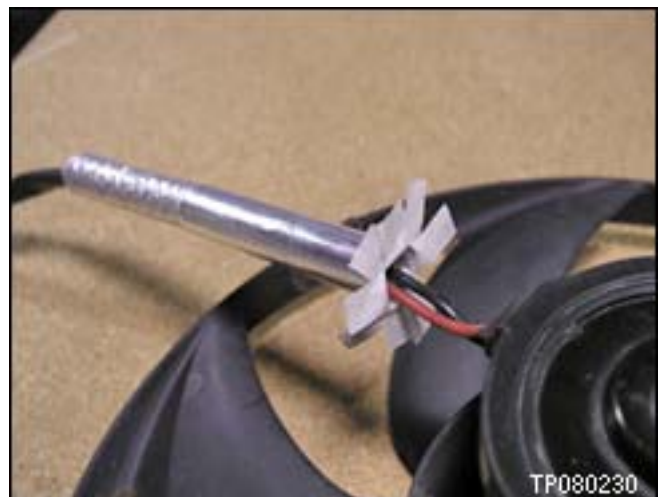
Figure D-6

- Wrap protector 2 around protector 1 and fold the fingers back as shown.

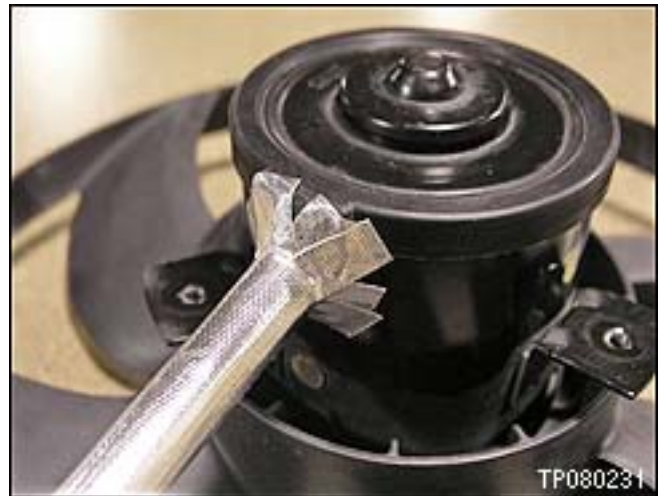
Figure D-7

5. Slide protector 2 against the fan motor and press / stick the fingers to the fan motor as shown.

- Make sure to press and smooth the fingers so they are completely stuck to the fan motor.

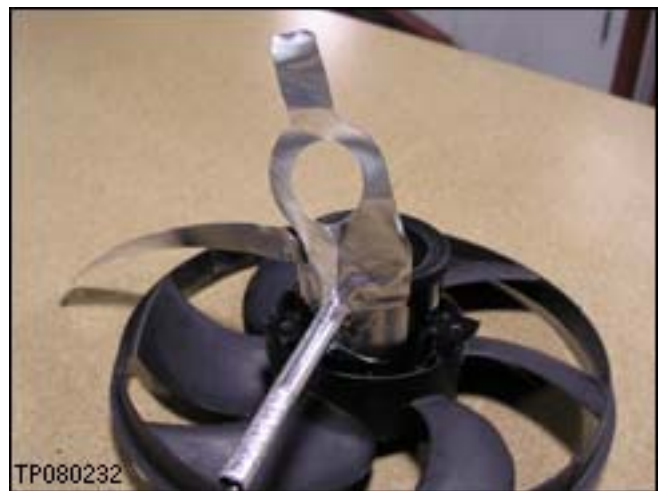
Figure D-8

6. Remove the adhesive backing from **Protector 3** and stick it to the fan motor as shown.

- Make sure the harness is routed through the harness hole in Protector 3 (refer to Figure D-8A).

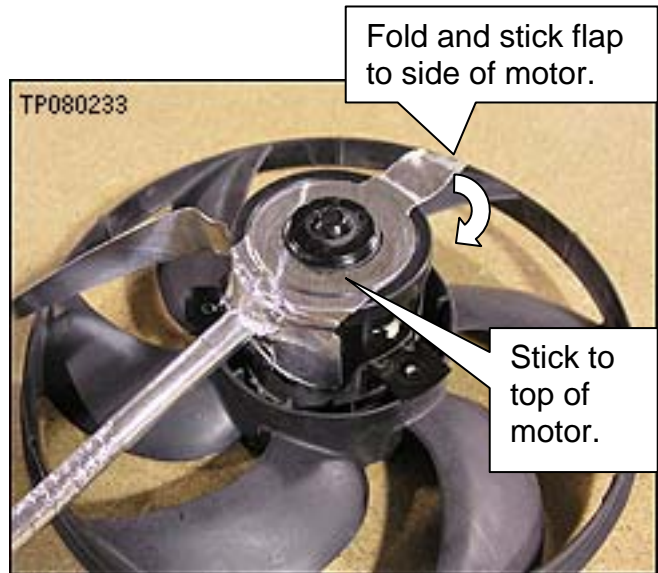
Fold and stick the flap shown in Figure D-9 to the side of the fan motor.

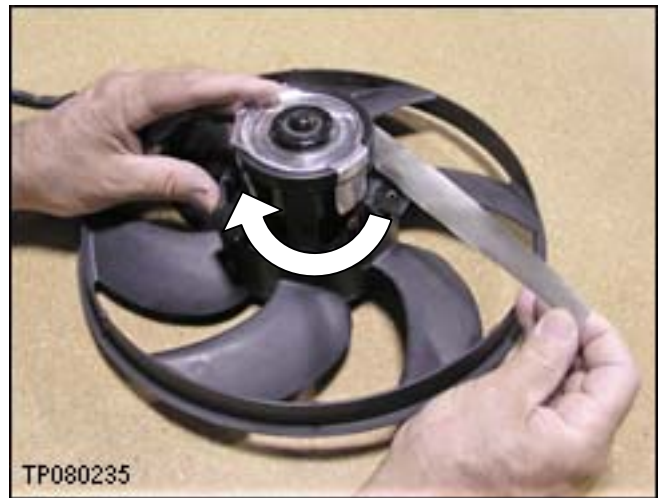
Figure D-10

8. Wrap the long strip of protector 3 completely around the motor.

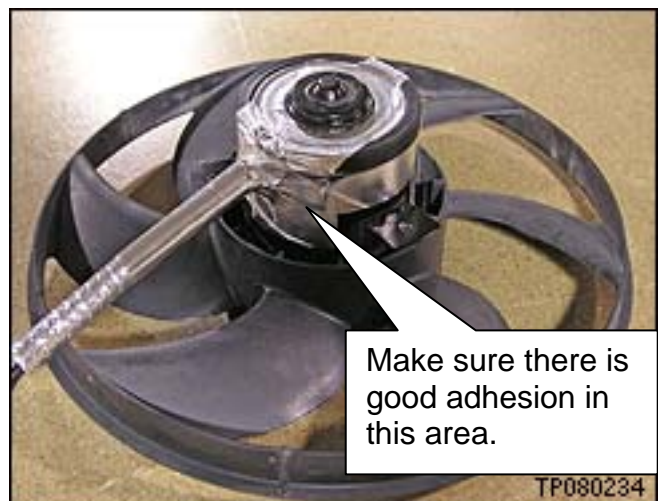
Figure D-11

9. Press and smooth all parts of protector 3. Make sure it is completely stuck to the fan motor.

- Pay special attention to the area shown in Figure D-11. Make sure there is good adhesion in this area.

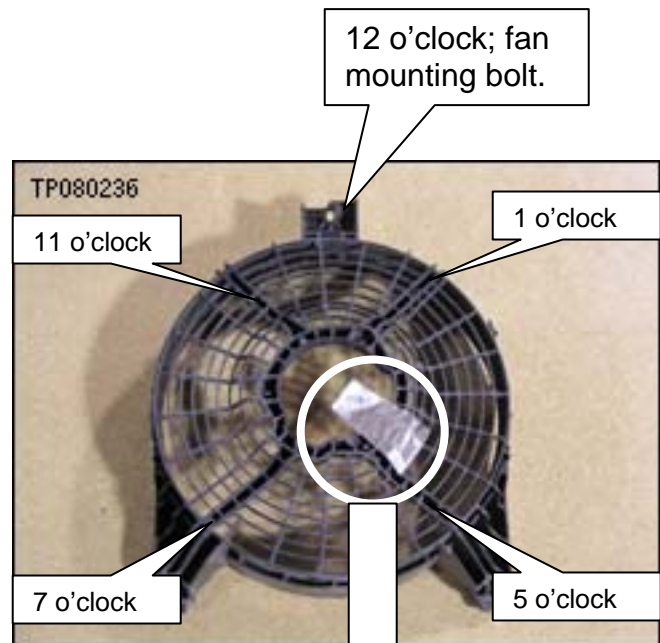
Figure D-12

- Remove 1 of the 4 sections from protector 4 adhesive backing.
- Stick the 1<sup>st</sup> section next to the 5 o'clock support rib.

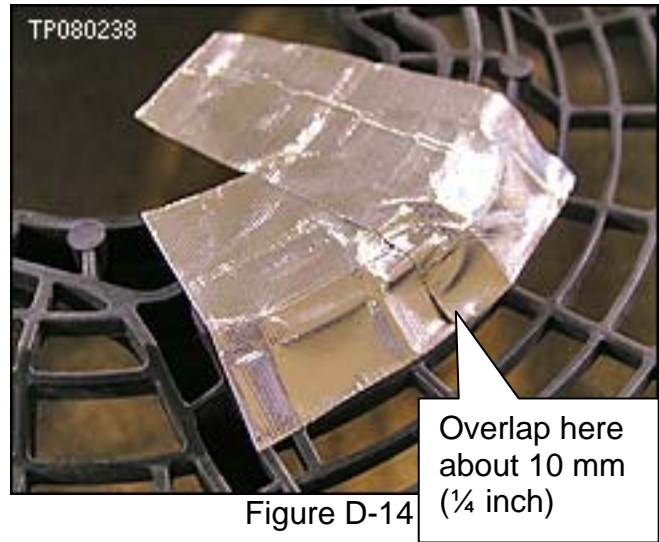
Figure D-14

- c. Stick the 2<sup>nd</sup> piece of protector 4 on the fan shroud as shown.
- Overlap the 2<sup>nd</sup> piece on top of the 1<sup>st</sup> piece at the spot shown.
  - Overlap about 10 mm (¼ inch) but not less than 5 mm (1/8 inch).
  - Fold and stick the protector under the shroud.

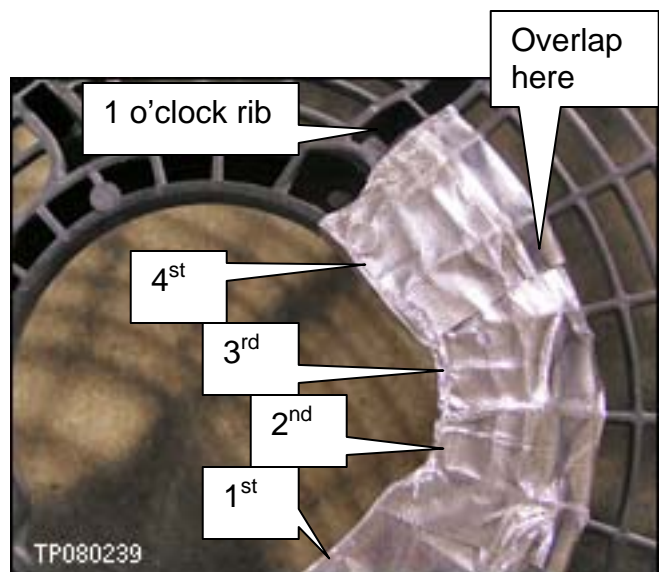
Figure D-15

- Align the protector along the 1 o'clock rib as shown.
- Don't cover up the bolt hole.
- Overlap the 4<sup>th</sup> piece on top of the 3<sup>rd</sup> piece at the spot shown.
- Overlap must be at least 5 mm (1/8 inch).
- Fold and stick the protector under the shroud.

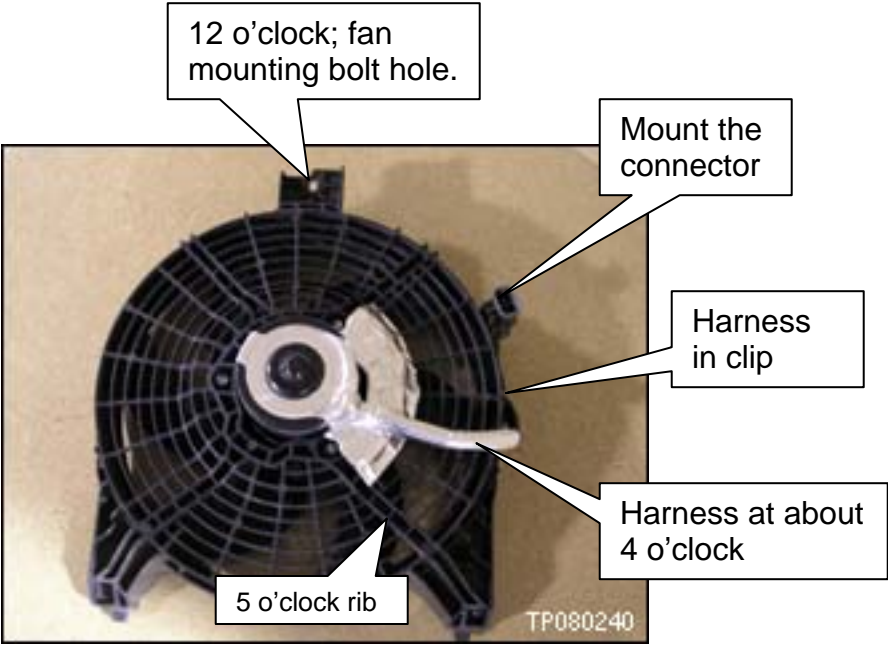
Figure D-16

- Use new bolts from the Fan Protector Kit. Bolt torque: 4.5 N.m (0.45, kg-m, **40 in-lb**)
- Mount the harness connector and clip the harness in place.

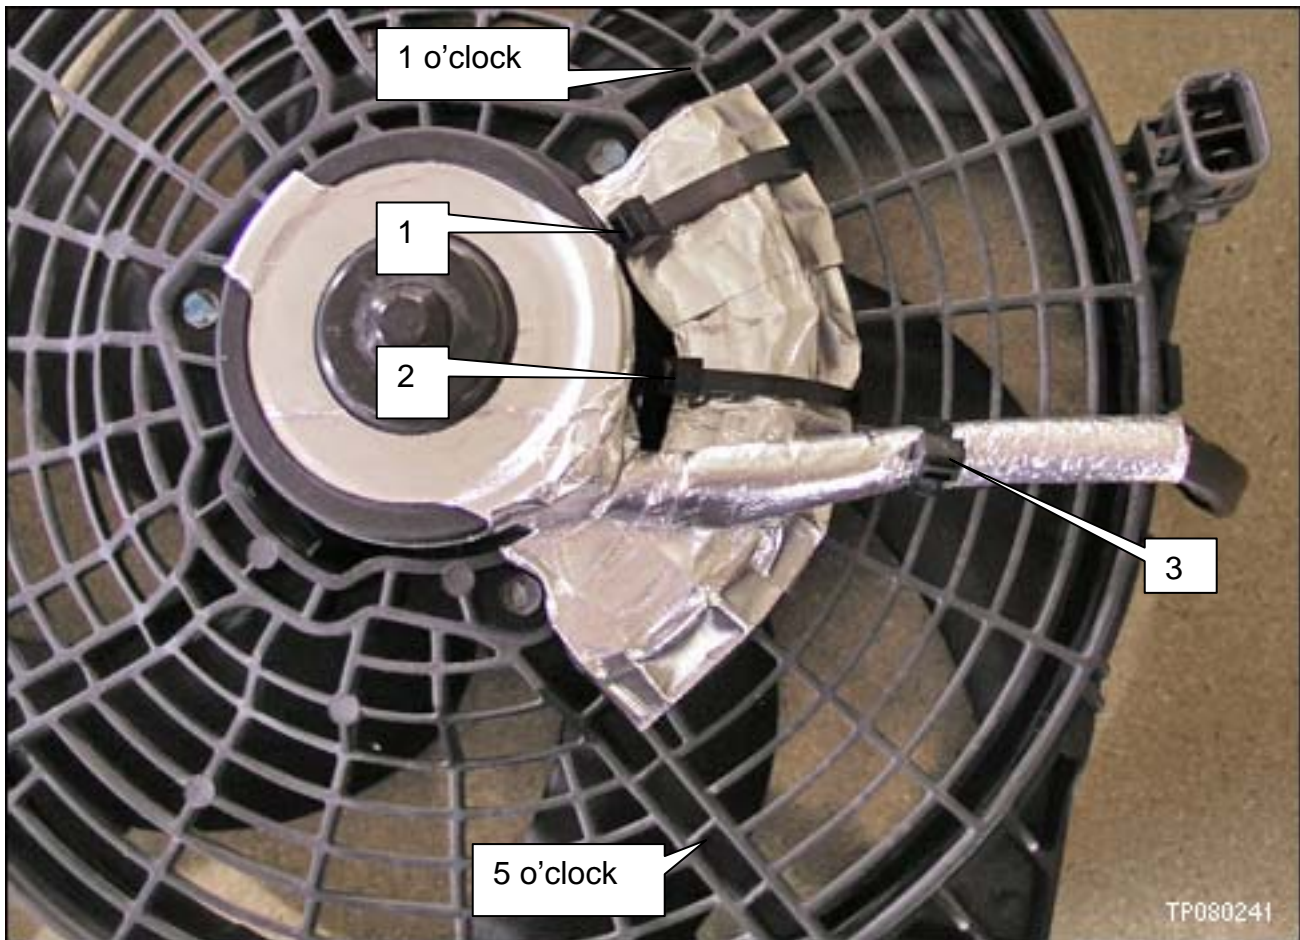
Figure D-17

14. Attach 3 tie-wraps as shown in Figure D-17.

- Use 7½ inch (19.5 cm) tie-wraps from the protector kit.
- Use the large 1 o'clock and 5 o'clock ribs for reference.
- **Pay close attention to the tie wrap locations.** Count the slots in the fan shroud to confirm correct tie-wrap locations.

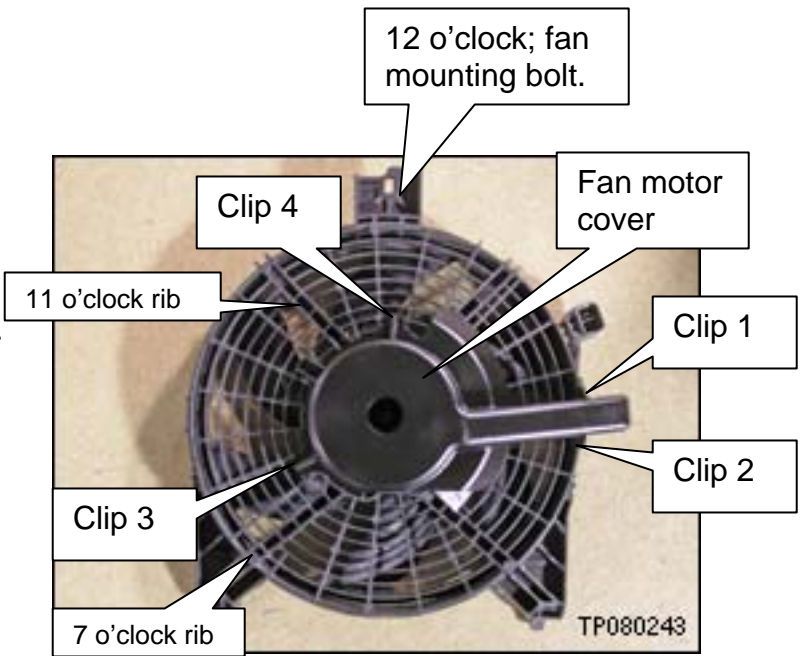
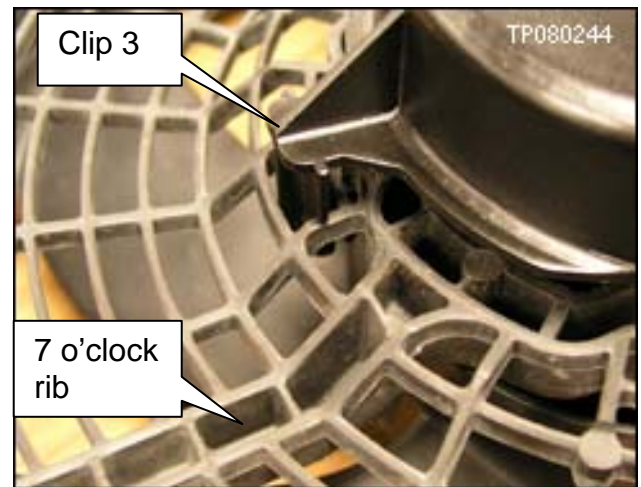
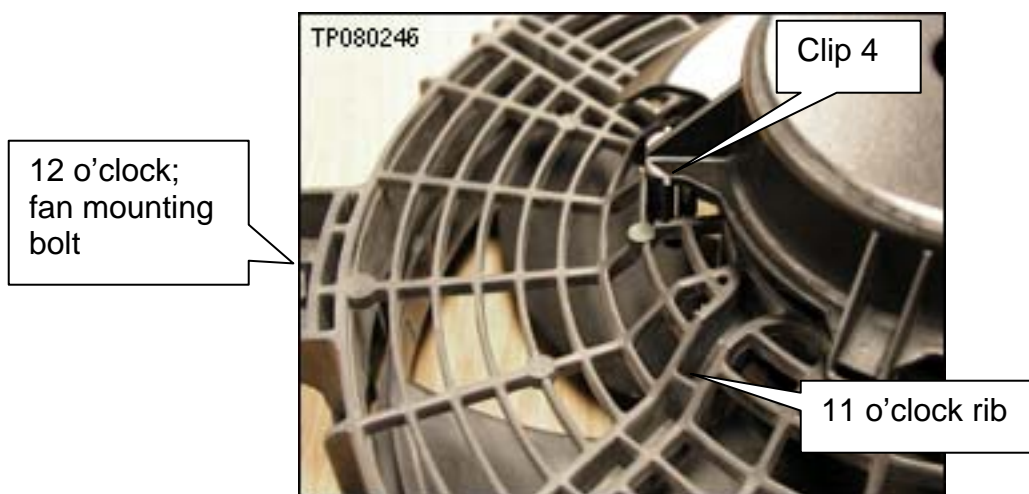
- Make sure the 4 clips are installed in the correct locations.
- Refer to Figures D-18 through D-21 for clip locations.
- Use the large 7 o'clock and 11 o'clock ribs for reference.
- Count the slots in the fan shroud to confirm locations for clips 3 and 4.

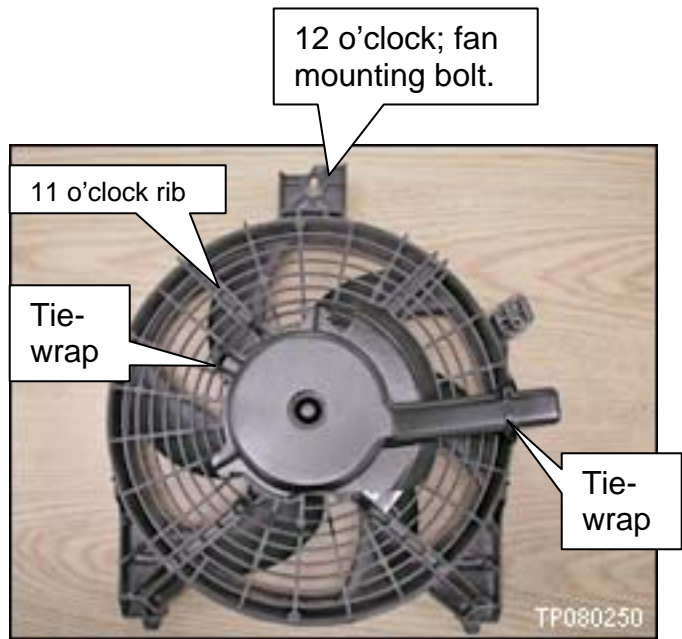
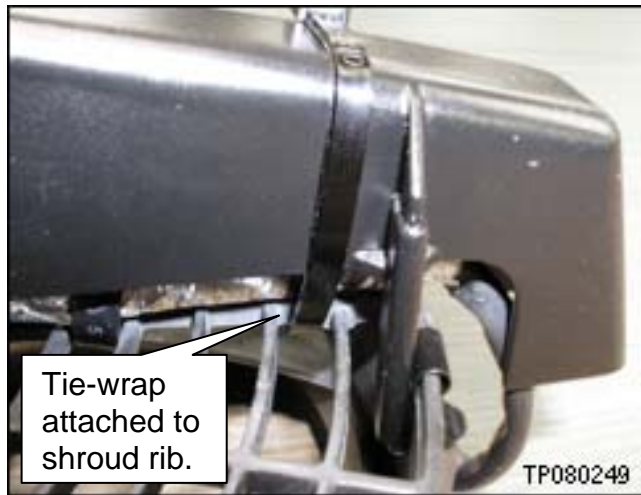
- Use 11 inch (28 cm) tie-wraps from the protector kit.
- Refer to Figures D-22 through D-24 for tie-wrap locations.
- Use the large 11 o'clock rib for reference.
- Count the slots in the fan shroud to confirm locations as needed.

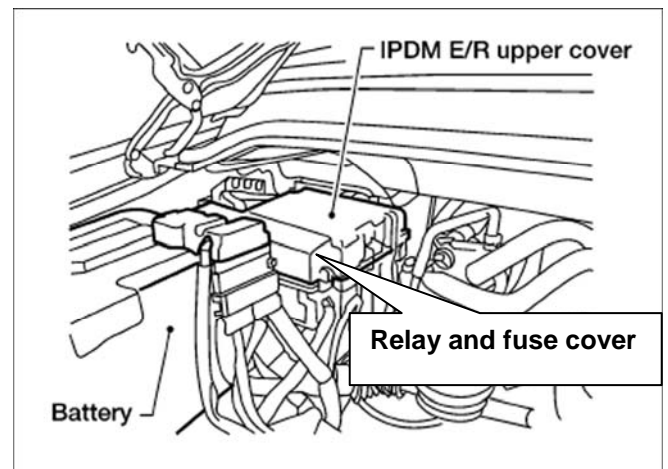
Figure E-2

2. Remove the relay and fuse cover.

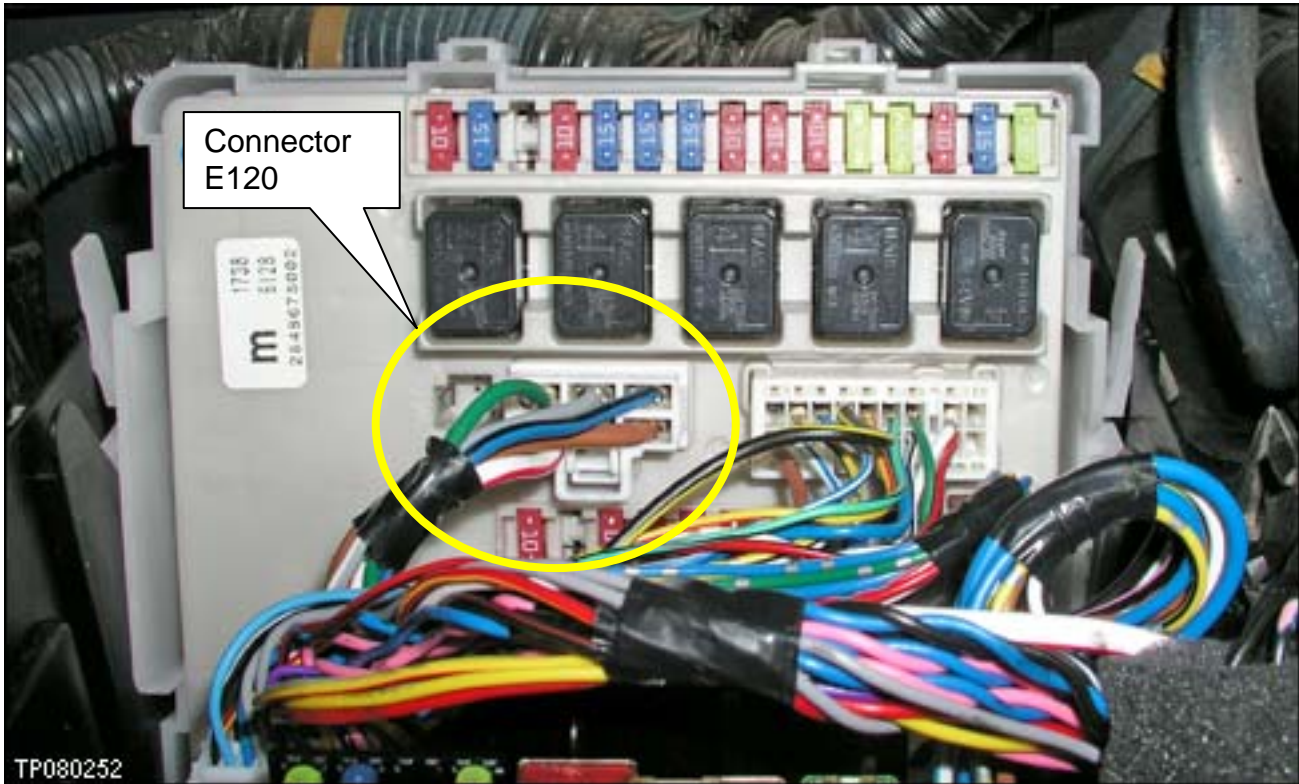
Figure E-3

- This is connector E120.
- This connector has 6 terminal slots with only 5 filled.

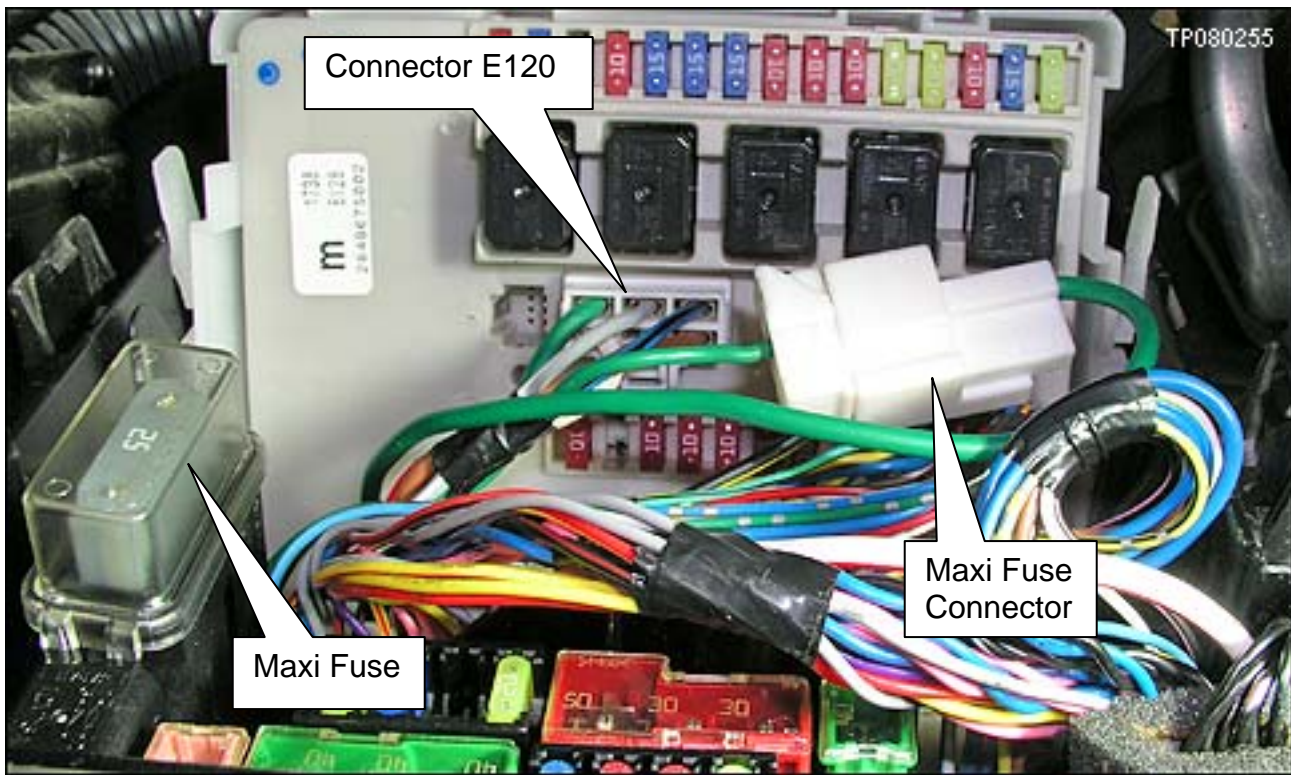
Figure E-6

7. Reconnect connector E120.
8. Connect the Maxi Fuse connector.
9. Position the Maxi Fuse, wires, and connector into the IPDM E/R box as shown in Figure E-6.
