# RECALL CAMPAIGN BULLETIN

NTB08-068

## VOLUNTARY RECALL CAMPAIGN 2004 - 2006 NISSAN TITAN AND ARMADA AIR CONDITIONER CONDENSER FAN

**NHTSA #:** 08V-284

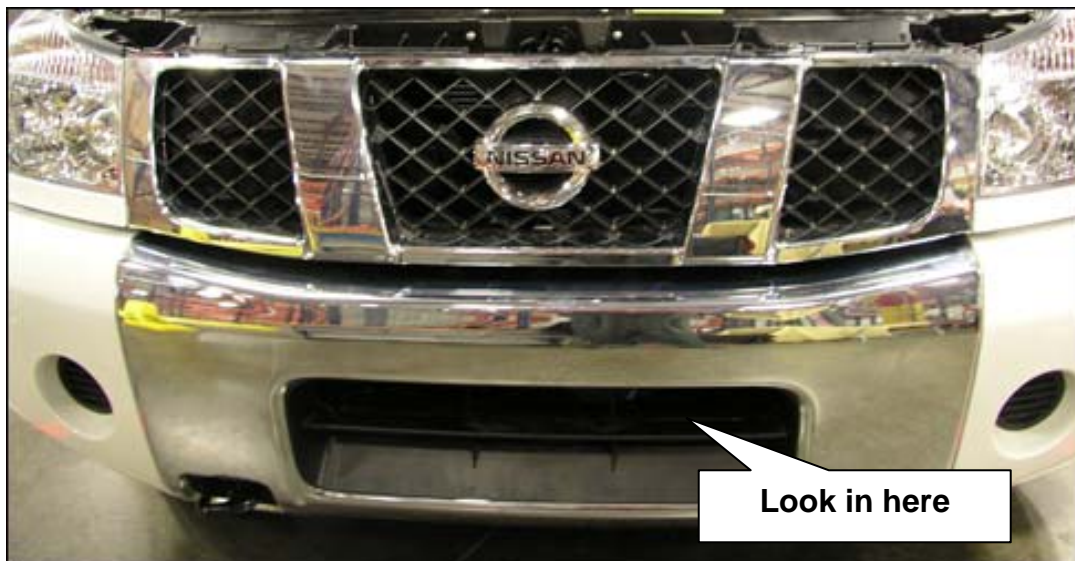
Figure A-1

1. Look in the lower bumper area and locate the condenser fan motor.

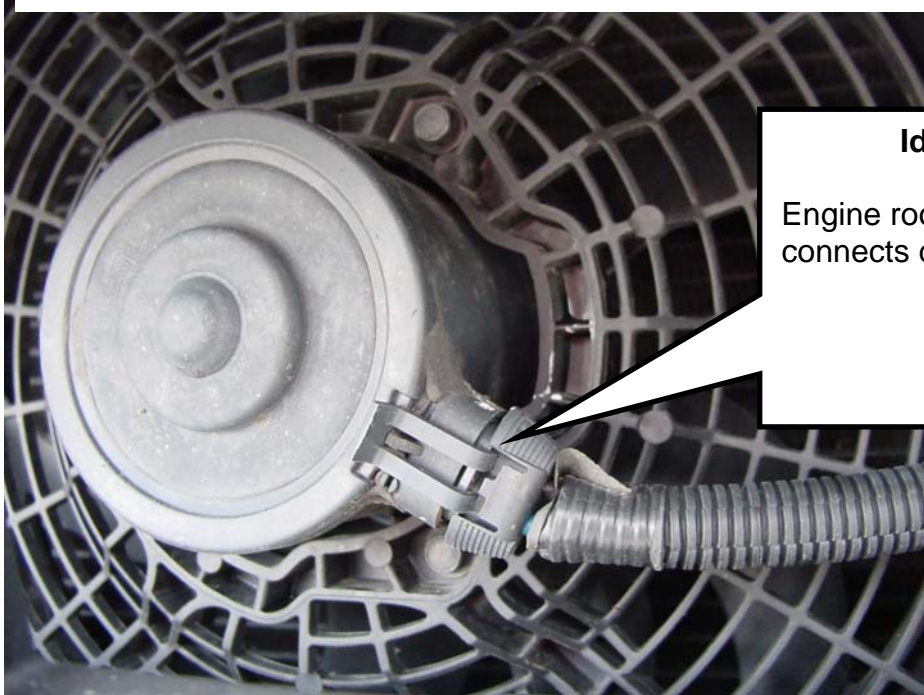
Figure A-2

**Type 3 Fan - 140 watt motor**

**Identification**  
Engine room harness  
connects directly to fan motor.

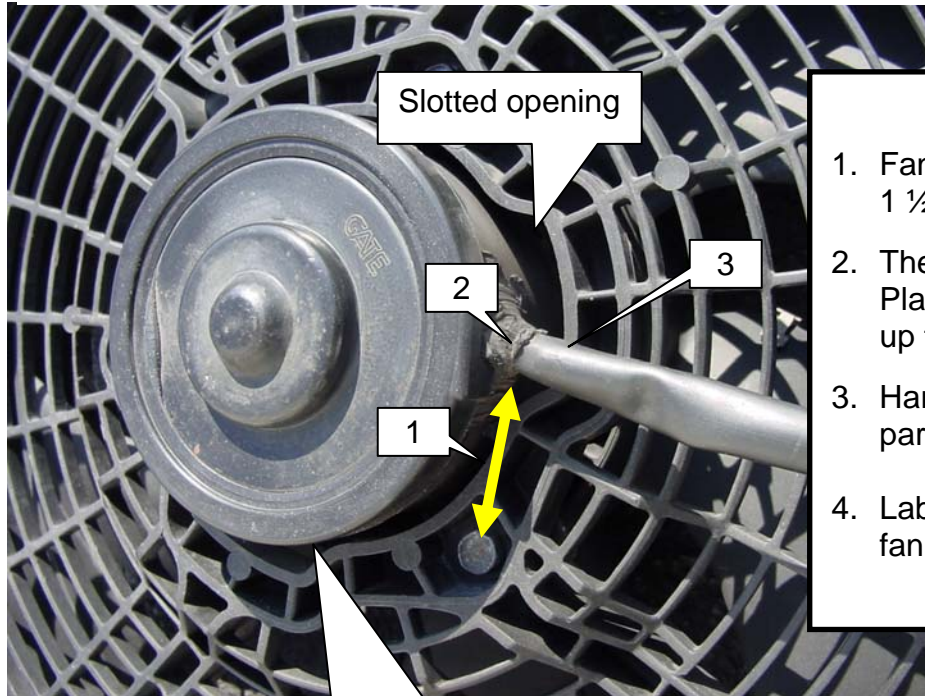
Figure A-3

## Type 1 Fan - 90 watt motor

1. Fan motor harness position is 1 ½" from mounting bolt.
2. There are no exposed wires. Plastic harness cover goes right up to the motor.
3. Harness goes across the lower part of the slotted opening.
4. Label on the lower side of the fan motor has the word "GATE".

4: Label has the word "GATE"

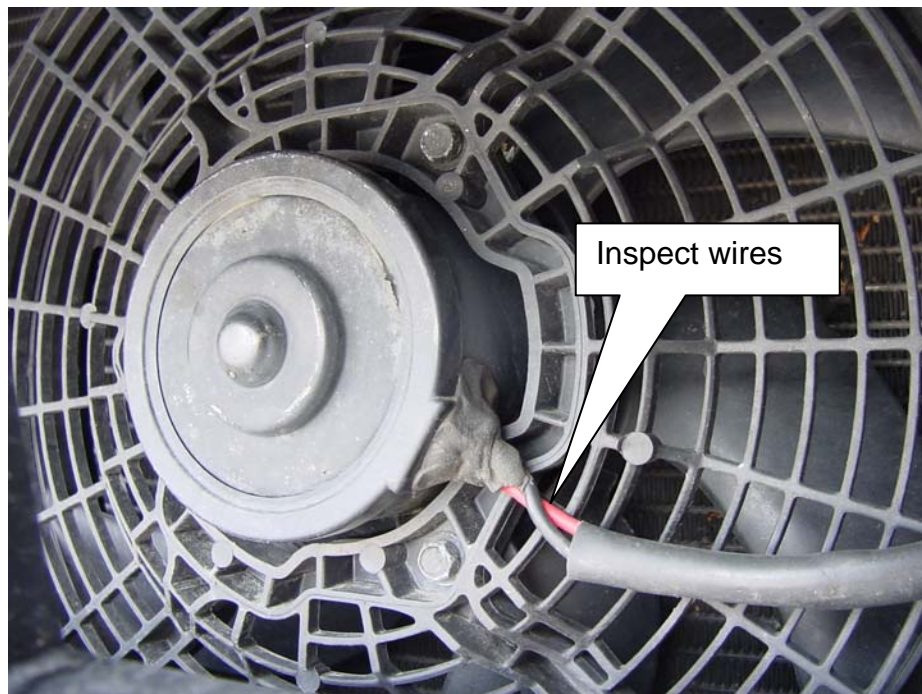
Figure B-1

### 1. Inspect the wires near the condenser fan motor:

- Make sure there is no damage to the wire insulation and the wires are in good condition.
- **If the wires are damaged** (cracked or missing insulation), STOP; no more testing is needed. Go to Procedure C on page 17 and replace the condenser fan assembly.

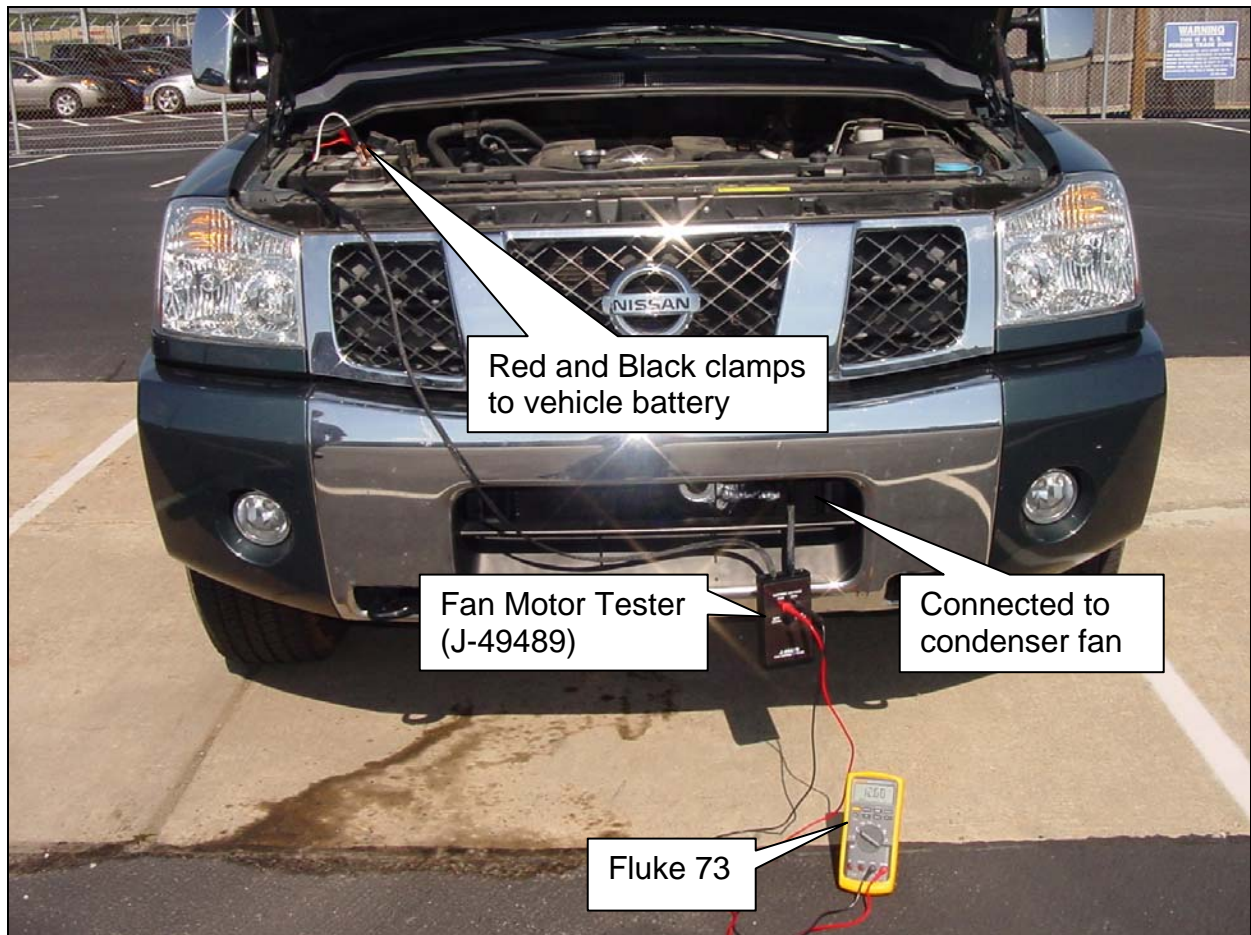
Figure B-4

6. Connect the Fan Motor Tester and the Fluke 73 Digital Multimeter (using the fluke meter test leads) as follows (see Figure B-4):
- Connect Fan Motor Tester harness connector to the condenser fan.
  - Connect Fan Motor Tester to the vehicle battery; Red clamp to + (positive) / Black clamp to – (negative).
  - Connect the Fluke 73 digital multimeter to the MOTOR VOLTAGE test ports on the Fan Motor Tester; V+ red probe to POS / COM black probe to NEG.

**NOTE:** When connected as above with the Fan Motor Tester switched OFF, the LED on the switch will illuminate green; this indicates the tester has battery power.

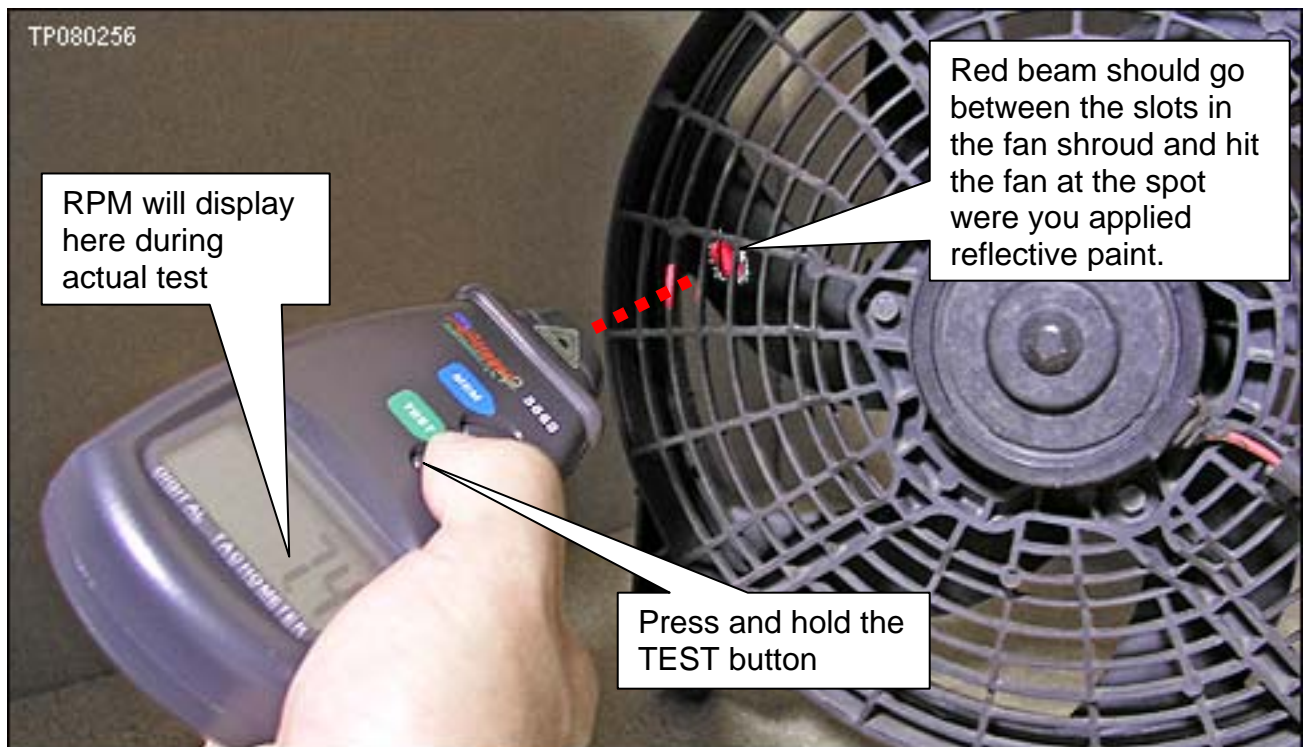
Figure B-7

3. Hold the digital tachometer about 4 inches away from the condenser fan.
4. Aim the red beam at the painted area on the fan blade.
  - The beam should be aimed between / through the slots in the fan shroud.

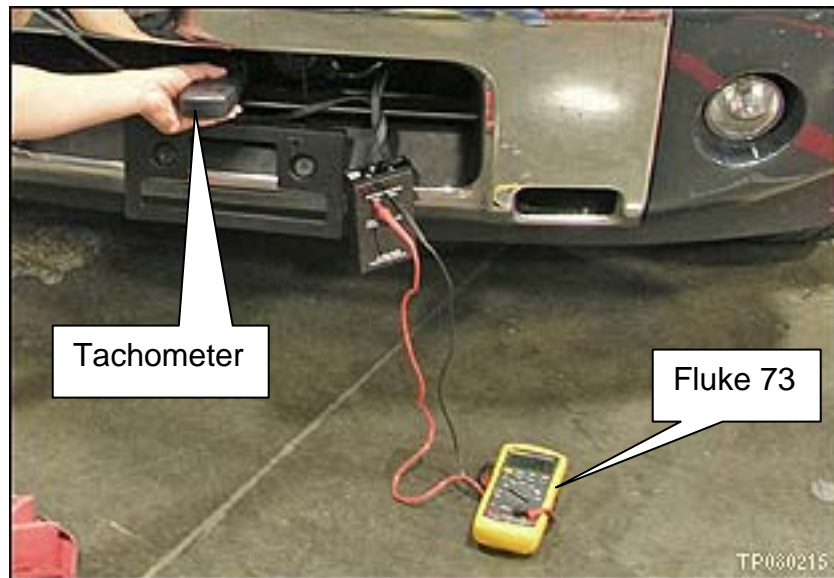
Figure B-5

**WARNING:** Do not shine or point the red light beam from the Phototach Digital Tachometer into anyone's eyes (including your own).
  - b. Hold the digital tachometer about 4 inches away from the condenser fan.
  - c. Aim the red beam at the painted area on the fan blade.
    - The beam should be aimed between / through the slots in the fan shroud.

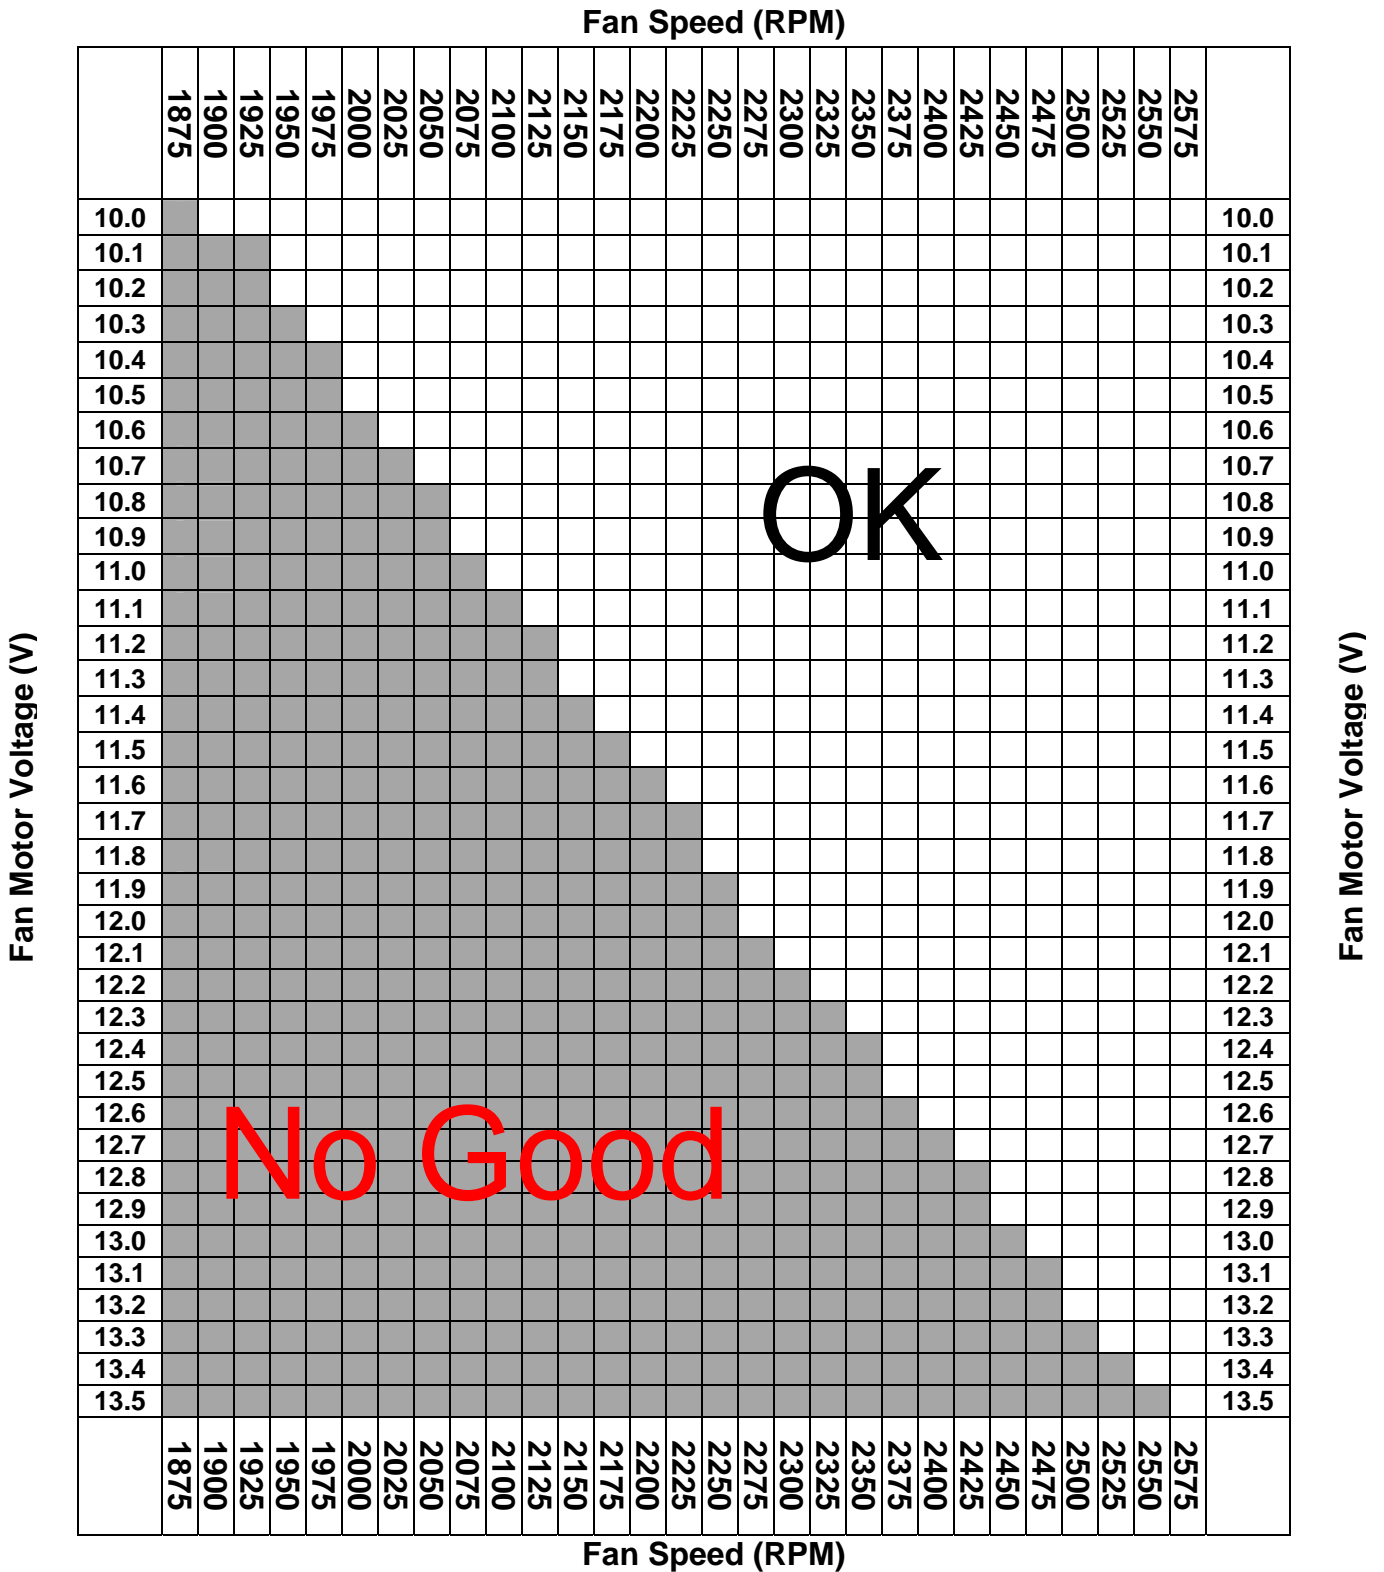
13. Use the chart below to determine if the fan motor is OK or No Good.

- Find the intersecting point of your RPM and Voltage readings that you wrote down in step 10.

**NOTE:** If voltage reading is less than 10.0 V, charge the vehicle battery and retest. Do not perform fan motor test with a charger attached to the battery.

15. Determine your next steps as follows:

**If the fan motor is OK:**

- a. **Remove** the Condenser Fan Motor Assembly – Procedure C steps 1 through 9.
- b. Install the Condenser Fan Motor Protective Coverings – Procedure D.
- c. Reinstall the Condenser Fan Motor Assembly – Procedure C steps 10 through 18.
- d. Confirm Condenser Fan Motor operation – Procedure F.

**If the fan motor is No Good:**

- a. **Replace** the Condenser Fan Motor Assembly – Procedure C.
- b. Install the Max Fuse – Procedure E.
- c. Confirm Condenser Fan Motor operation – Procedure F.

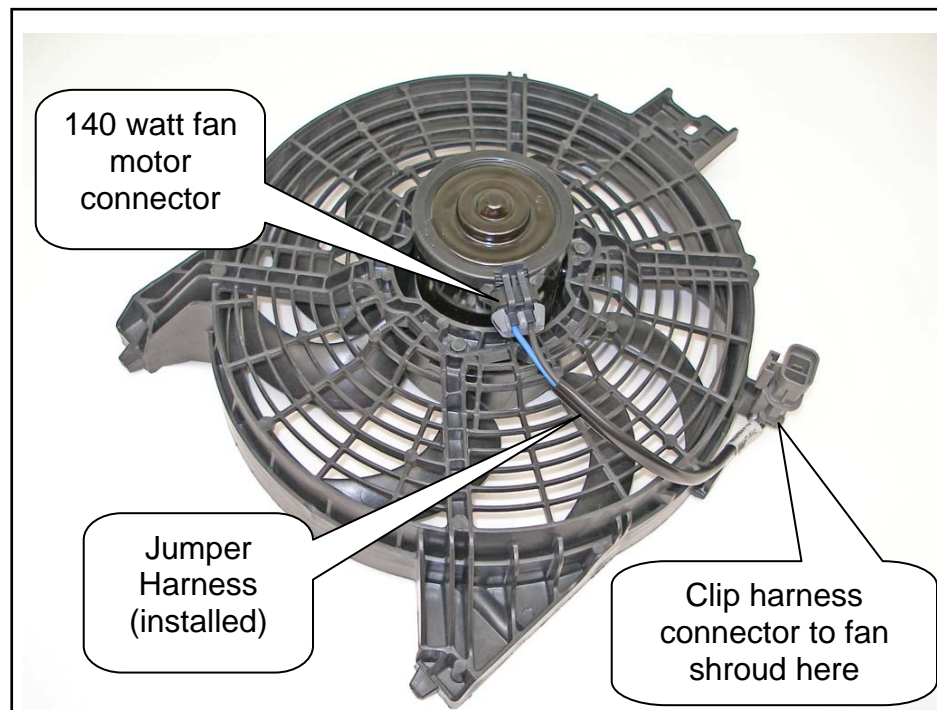
Figure C-14

- a. Install the jumper harness on the new fan motor as show below.
  - New fan assembly and harness kit are listed in the Parts Information.
- b. Go to the next page for installation of the fan assembly.

Jumper harness installation on NEW 140 watt fan assembly

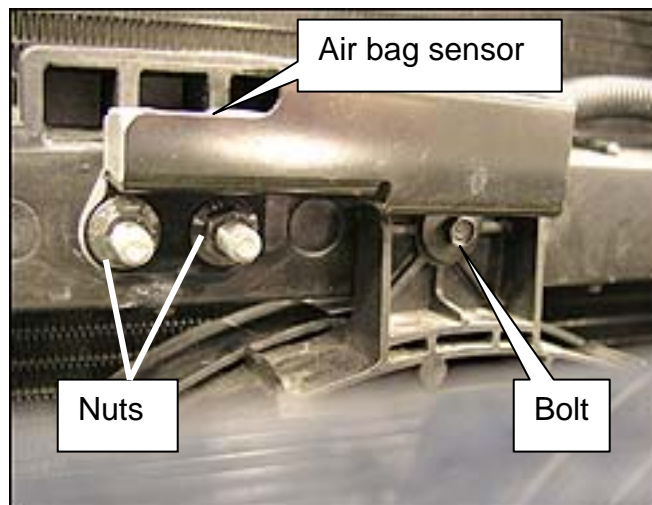
Figure C-16

12. Install and torque 2 nuts to the air bag sensor.

- Torque:  
15 N.m (1.52 Kg-m, **11 ft-lb**)
- Apply medium strength thread-locker to the studs (Nissan P/N 999MP-AM005P or equivalent).

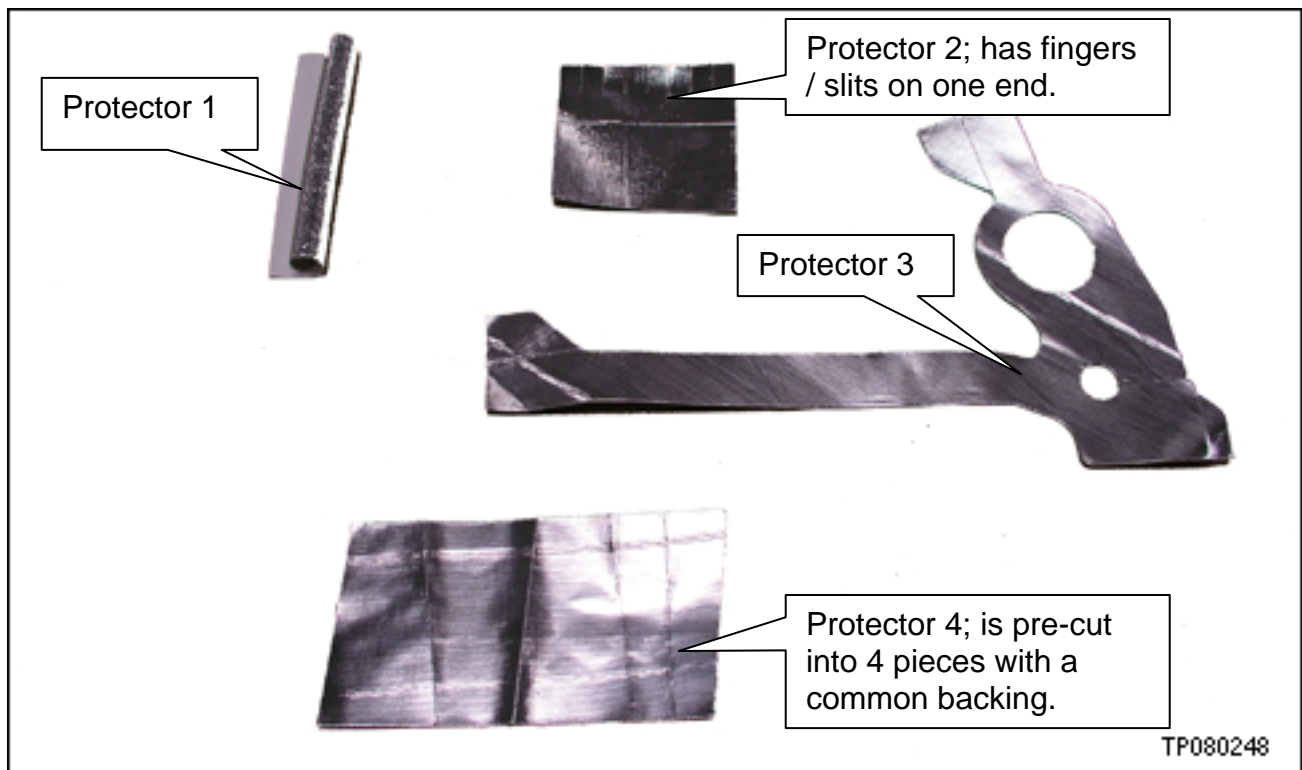
Figure D-3

In the next few steps you will be installing these four self adhesive protectors.

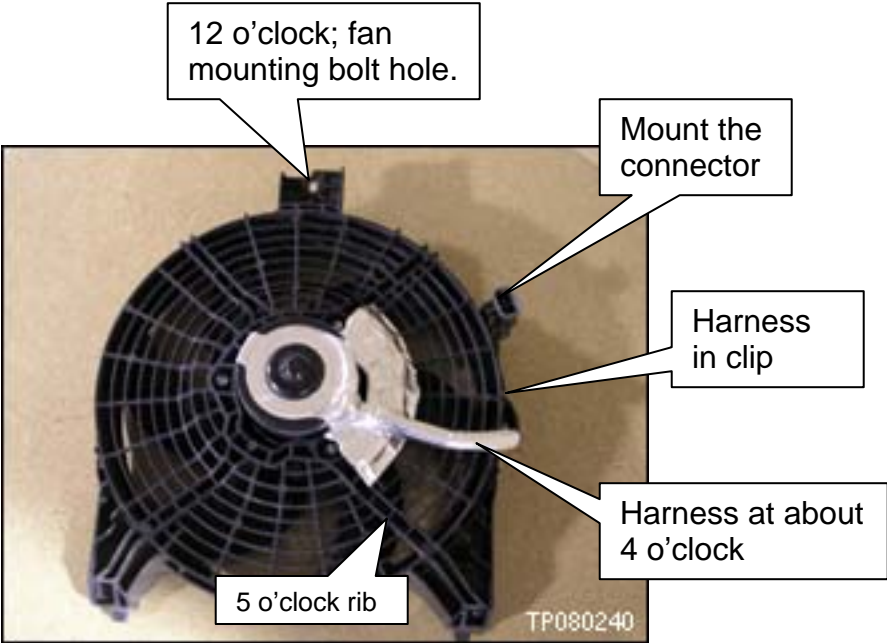
Figure D-16

- Use new bolts from the Fan Protector Kit. Bolt torque: 4.5 N.m (0.45, kg-m, **40 in-lb**)
- Mount the harness connector and clip the harness in place.

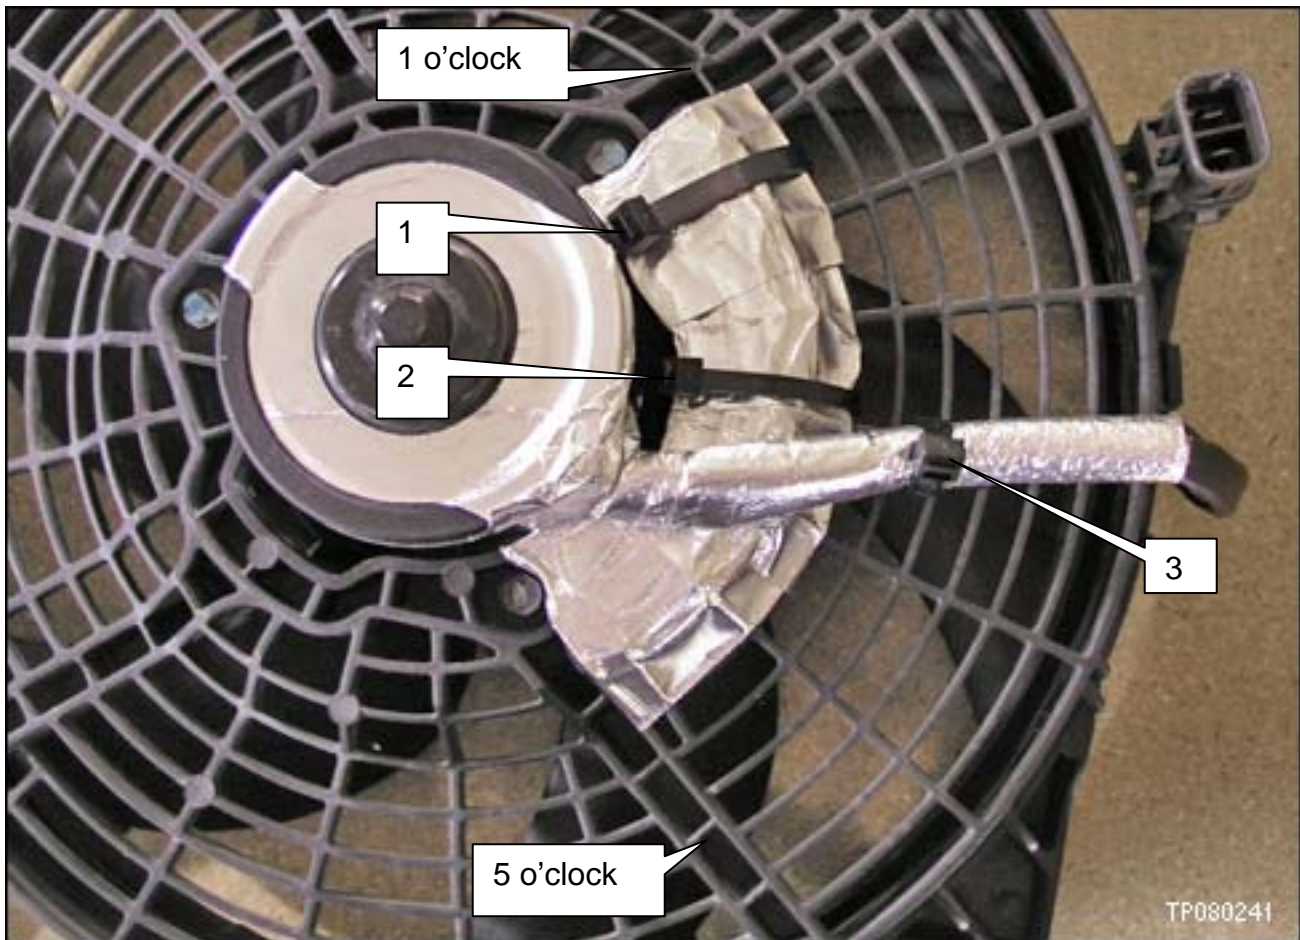
Figure D-17

- Use 7½ inch (19.5 cm) tie-wraps from the protector kit.
- Use the large 1 o'clock and 5 o'clock ribs for reference.
- **Pay close attention to the tie wrap locations.** Count the slots in the fan shroud to confirm correct tie-wrap locations.

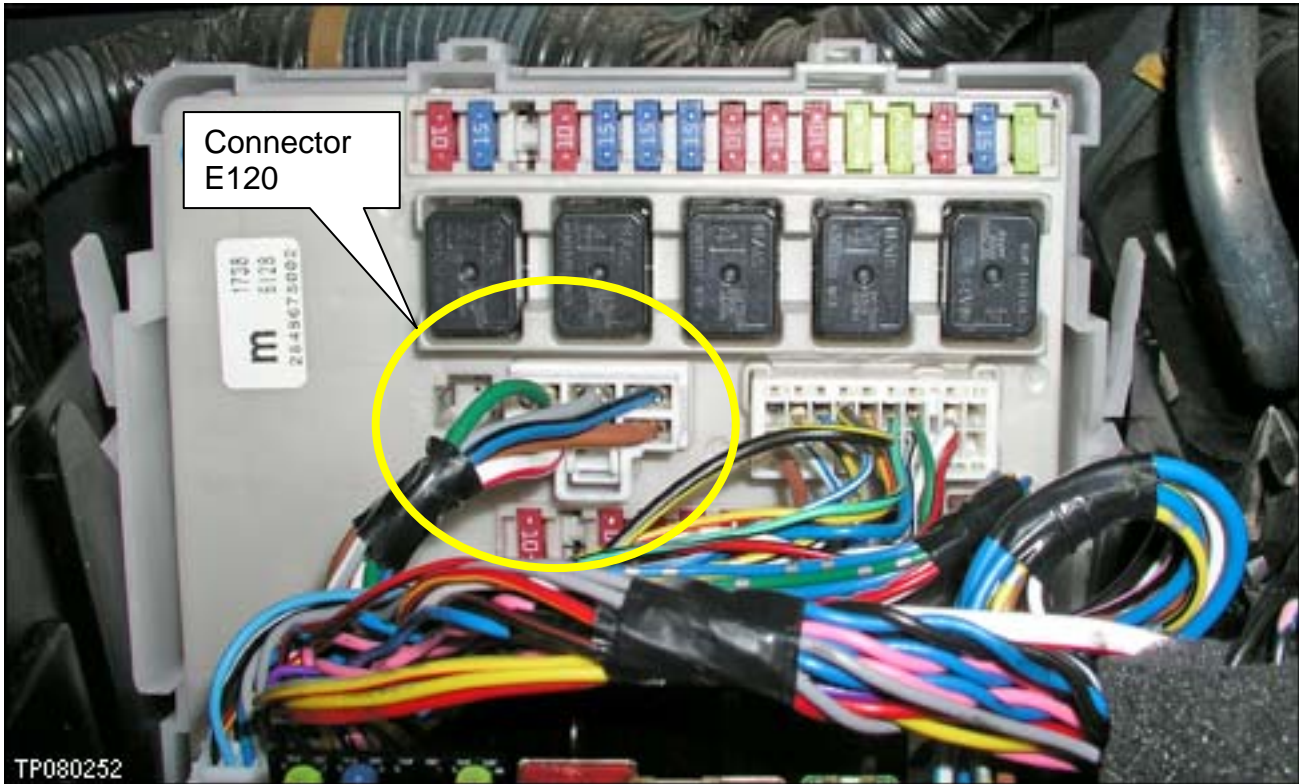
Figure E-3

- This is connector E120.
- This connector has 6 terminal slots with only 5 filled.

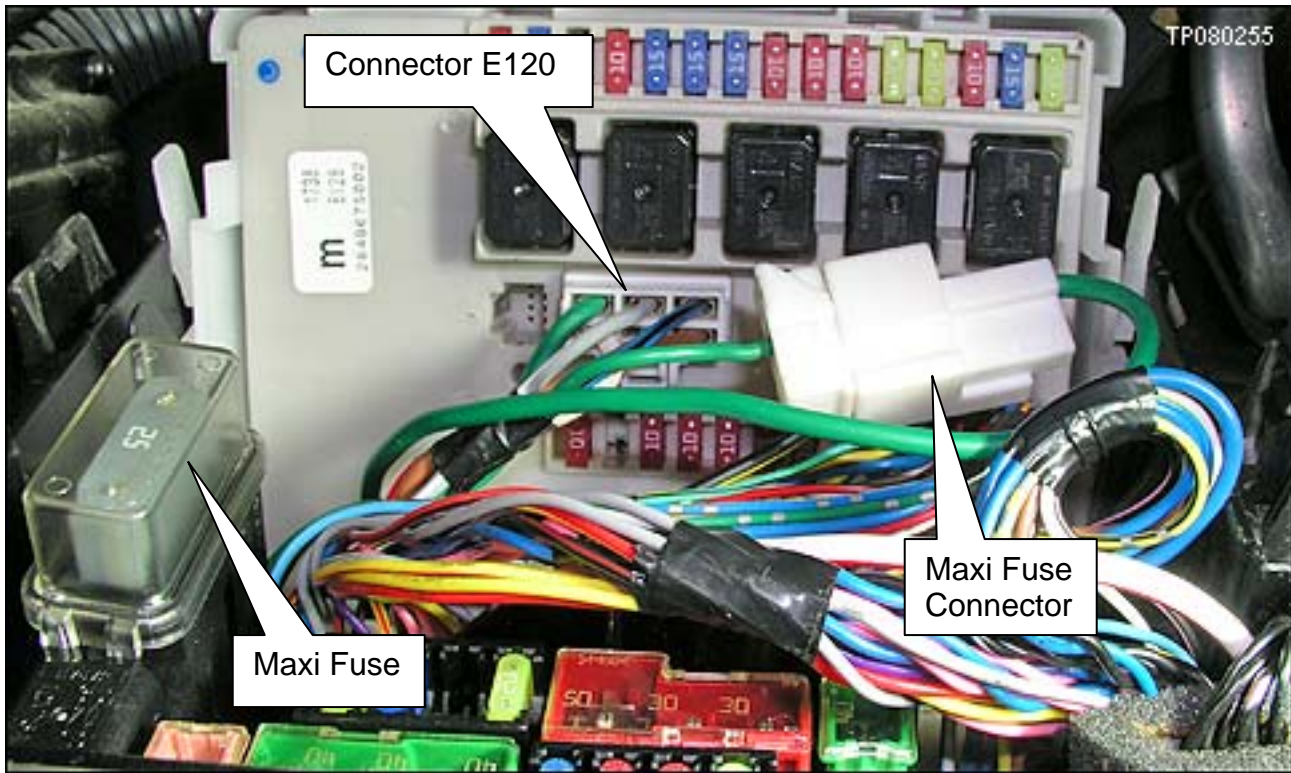
Figure E-6

7. Reconnect connector E120.
8. Connect the Maxi Fuse connector.
9. Position the Maxi Fuse, wires, and connector into the IPDM E/R box as shown in Figure E-6.
