SERVICE PROCEDURE

**G-08507
AUGUST 2008**

**SUBJECT: SAFETY RECALL (U.S.)
ENGINE HIGH PRESSURE OIL LINE ASSEMBLIES
on certain IC Bus RE models built 1/3/96 thru
3/22/04 with an INTERNATIONAL® T444E engine.**

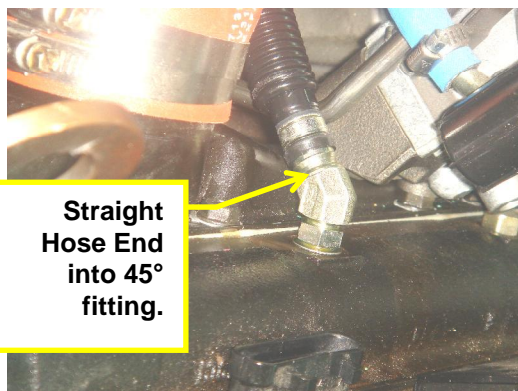
Figure A
8900200R91 – Older Style

Inspect the high pressure hose fitting located on the driver's side of the engine valley. Some vehicles may be equipped with an older style right bank hose assemblies.

If the hose assembly fitting looks like Figure A: use kit 8900200R91.
