Re: Monthly Notification of Bulletins and Notices

Safety Recall

Subject: NV8J Propeller Shaft Bolt Torque

Bulletin: R0026

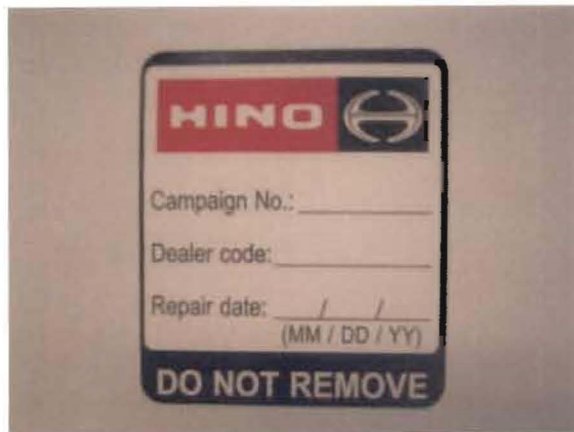
Fill out the Recall Completion sticker as shown in the picture to the left. This sticker should be attached to the left door jam above the V.I.N. decal.

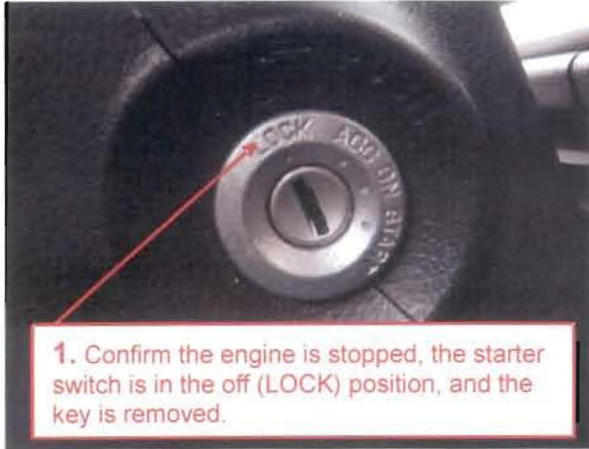
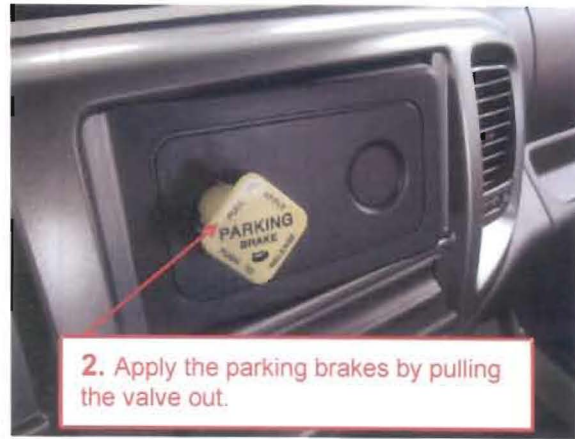
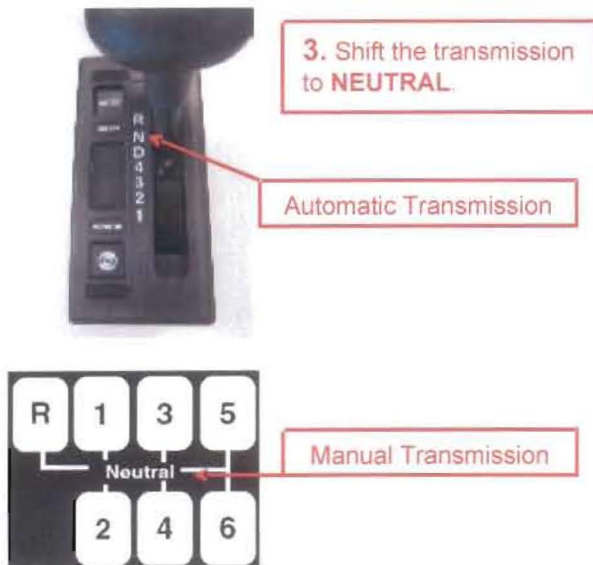
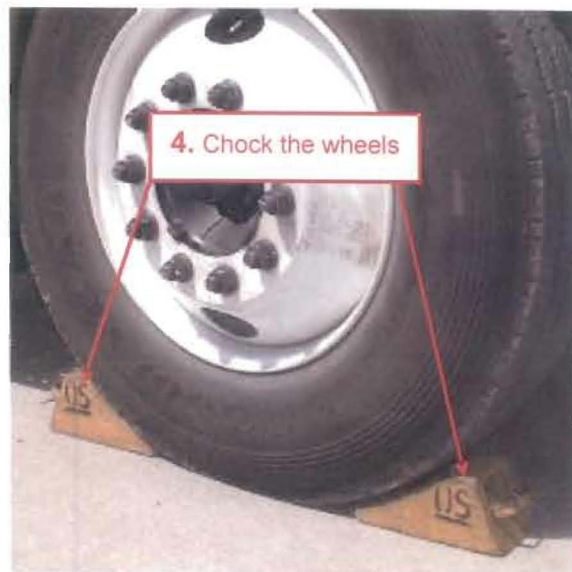
WARNING: It may be necessary to rotate the driveshaft to adequately access all of the propeller shaft strap bolts. Failure to do this may damage the strap bolts or cause injury if the socket is not properly seated on the strap bolt prior to applying torque.

Park the vehicle on a flat and level surface. Block the wheels to prevent the vehicle from moving.

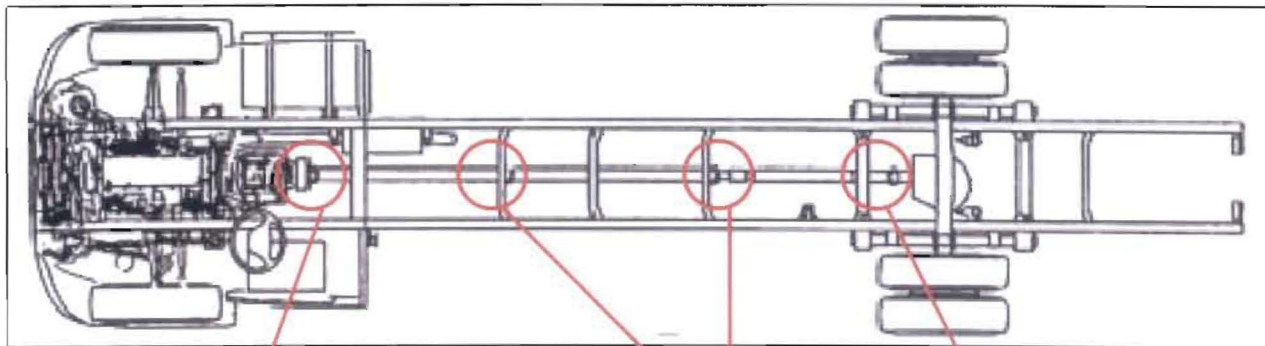
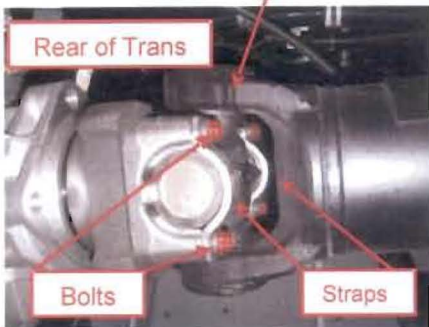
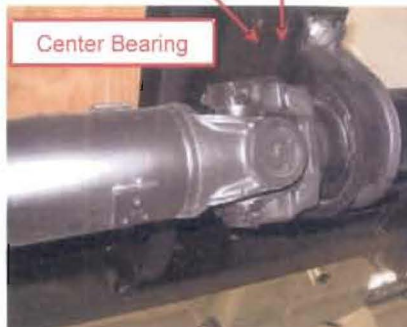
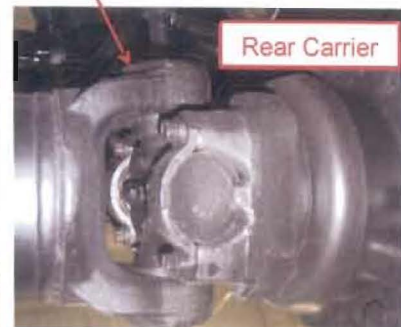
Torque all propeller shaft strap bolts.

Refer to the chart below for the number of bolts that must be torqued for each wheel base.

Note: The 8th digit of the V.I.N. indicates the wheel base of the vehicle.

5. Set the torque wrench to the specified torque.

Specified Torque 125 ft. lbs. (169Nm)
