**MC 08-14**

MODEL: **2008 KLR™ 650 (KL650E8F/L)**

TITLE: **TURN SIGNAL REPLACEMENT**

## RECALL

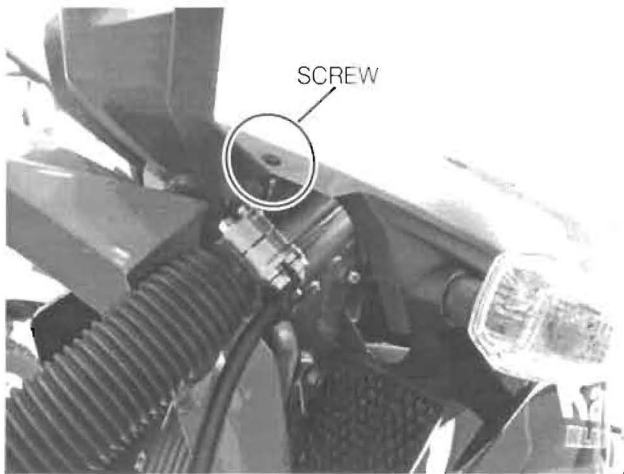
- Remove the upper fairing attachment screws (two per side) and support bracket bolts (one per side) and disconnect the turn signal lead wire connector.

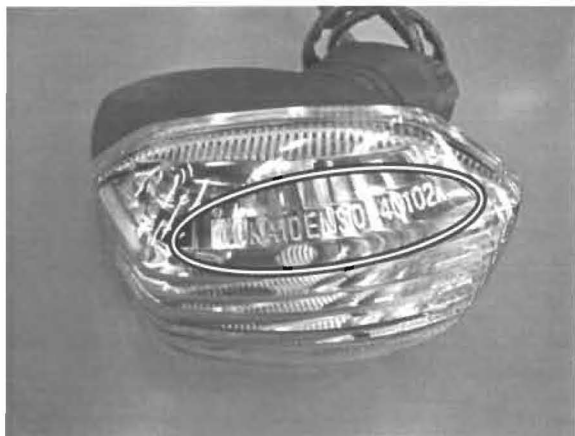
The name "TOKAIDENSO" that appears on the lens of each new turn signal will serve as repair verification.
