SERVICE

MC 09-01

MODEL: 2008 and 2009 Concours™ 14 (ZG1400A8F/L, B8F/L, A9F/L, B9F/L)

TITLE: BRAKE PEDAL COVER INSTALLATION

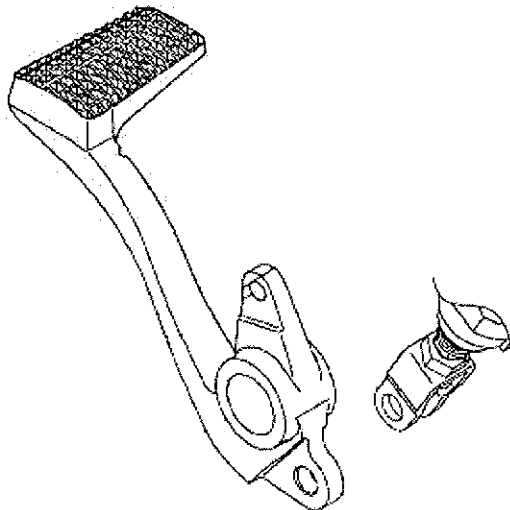
On eligible units, small stones or other road debris can become trapped between the brake pedal and the rear master cylinder actuating rod. This can prevent full release of the rear brake. Continuous activation of the rear brake can result in overheating, damage, rear wheel lockup, or failure of the rear brake, creating the potential for a crash resulting in injury or death.

Kawasaki has initiated a Recall campaign to repair all eligible units. The repair consists of installing a cover on the brake pedal.

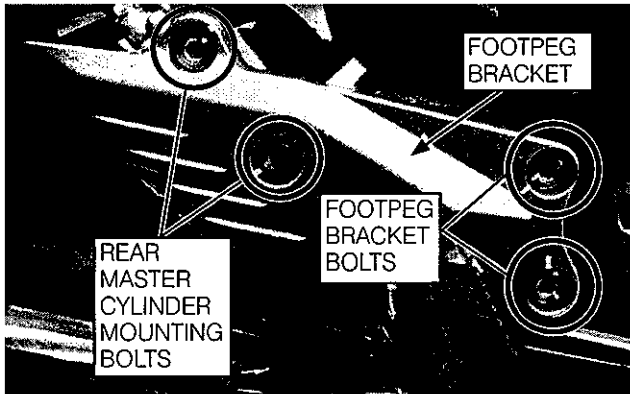
- Remove the right footpeg bracket bolts and rear master cylinder mounting bolts.

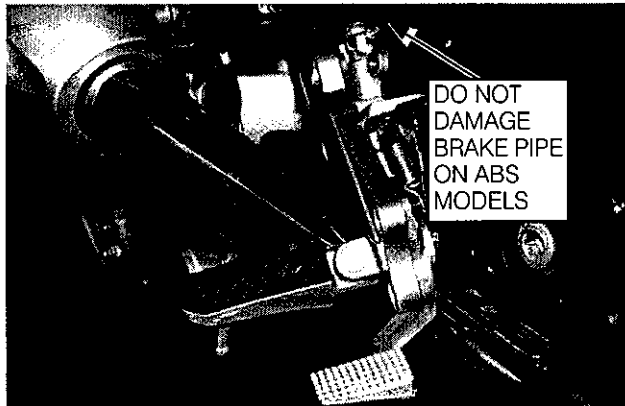
- o On ABS models, take care not to damage the brake pipe when installing the brake pedal cover.
- Rotate brake pedal and bracket away from frame as shown.

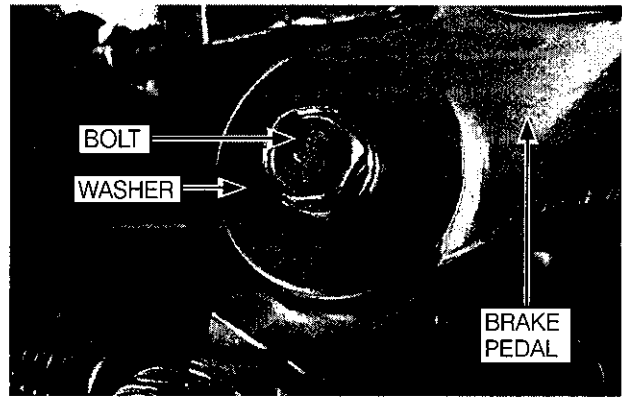
- Remove and discard the brake pedal pivot bolt and washer.

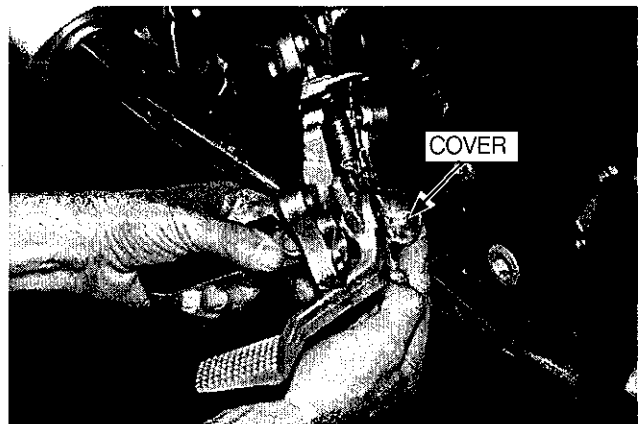
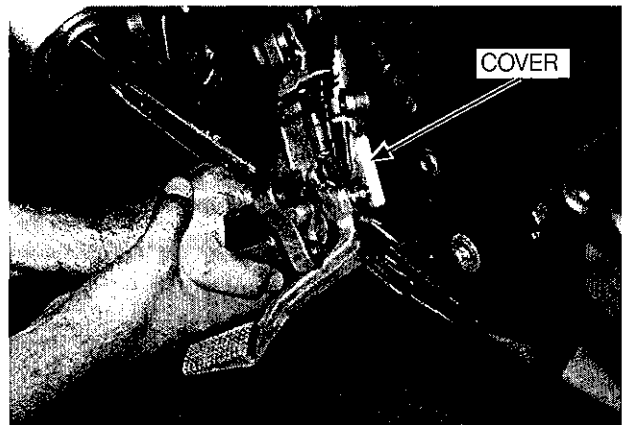
- Place the brake pedal cover into position as shown in the photographs below.

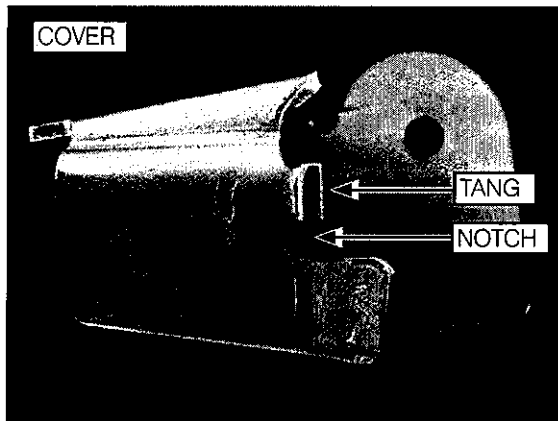
- When installed correctly, the tang and notch of the cover should be positioned against the footpeg bracket as shown below.

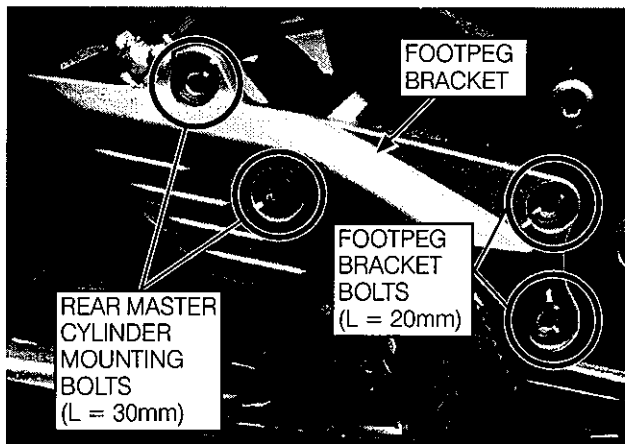
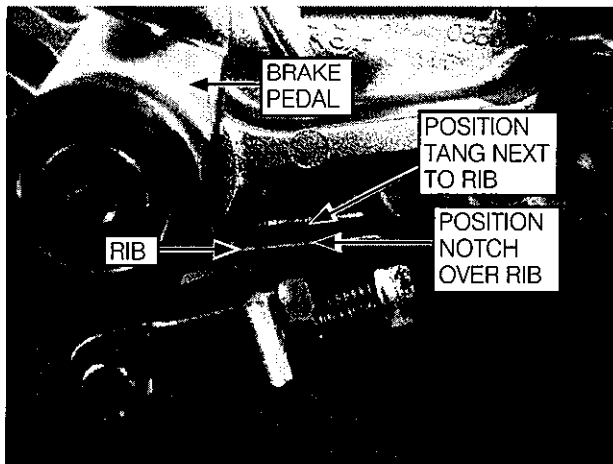
- Install the right footpeg bracket and rear master cylinder and tighten the bolts to 25 N-m (2.5 kgf-m, 18 ft-lb).

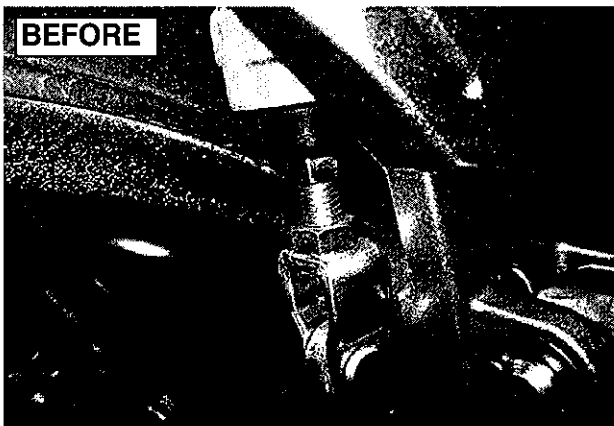
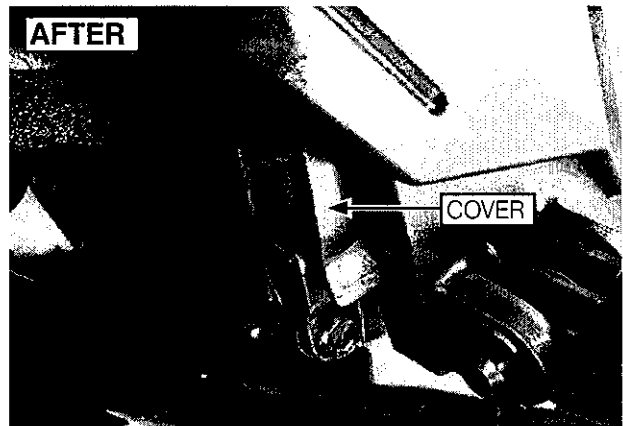
The brake pedal cover will serve as repair verification.
