Applies To: **2009 Odyssey** – From VIN 5FNRL3...9B043589 thru 5FNRL3...9B045212

February 13, 2009

Safety Recall: Brake Hoses Rub On the Front Caliper Upper Pin Bolts

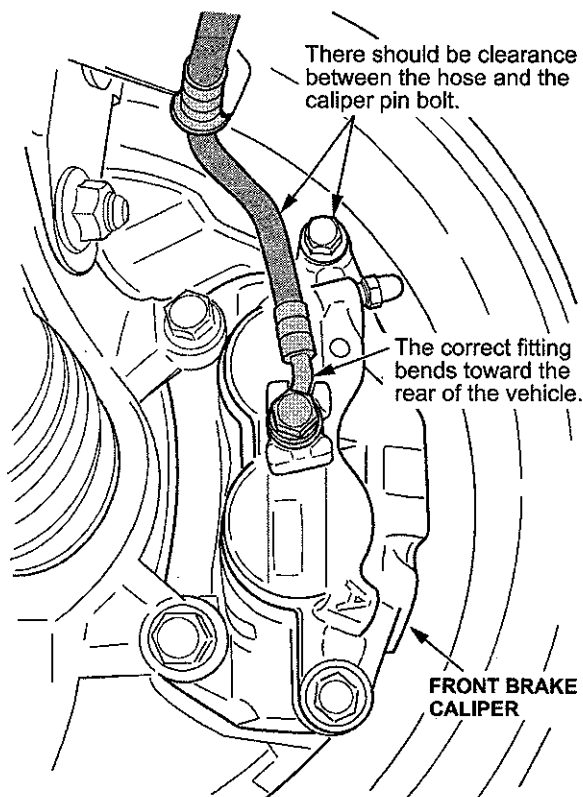
CORRECT

- Good hoses have a bend in the tubing at the caliper end, along with clearance between the hose and the caliper upper pin bolt. If both hoses are OK, go to step 2.
- Incorrect hoses have straight tubing at the caliper end, and little or no clearance between the hose and the caliper upper pin bolt. If either hose is incorrect, go to REPAIR PROCEDURE.

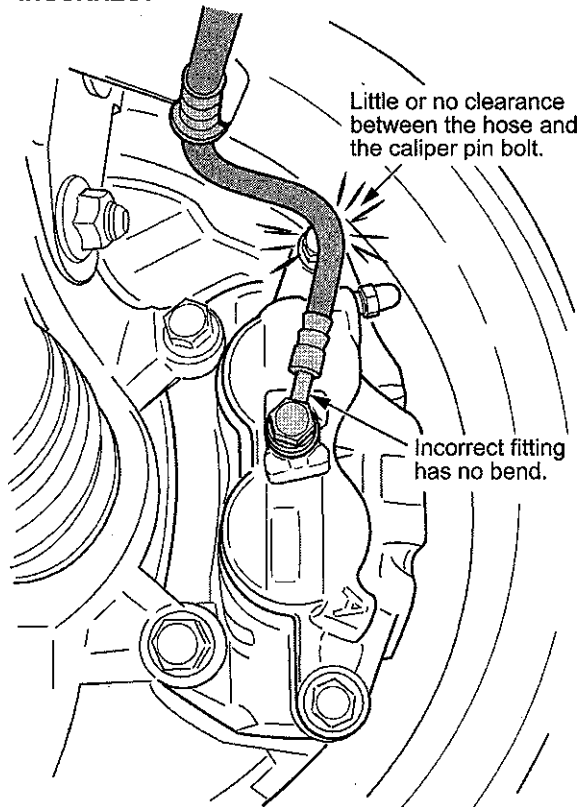
INCORRECT

During vehicle assembly, incorrect front brake hoses were installed on about 22 vehicles. These brake hoses can rub on the front brake caliper upper pin bolts. This could eventually cause a brake fluid leak and a loss of front braking.

1. Replace the front brake hose(s):
 - Refer to page 19-45 of the 2007–2009 Odyssey Service Manual, or
 - Online, enter keyword **HOSE**, and select **Brake Hose Replacement** from the list.
2. Center-punch a completion mark above the first character of the engine compartment VIN:
