Fuel Line Assembly Replacement

Models: M.Y. 2009 1198/ 1198 S/ 1098 R/ 848 and M.Y. 2010 F1098 Streetfighter/
Streetfighter S

Recall Bulletin RCL-09-003

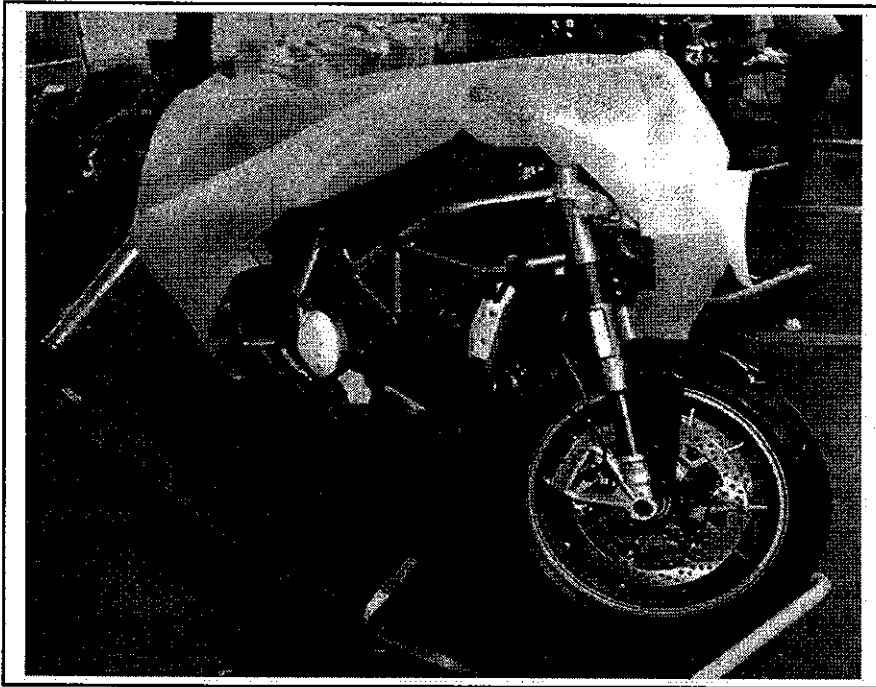
Working on the right-hand side of the motorcycle, remove the three (3) screws on the RH air intake and remove the intake.

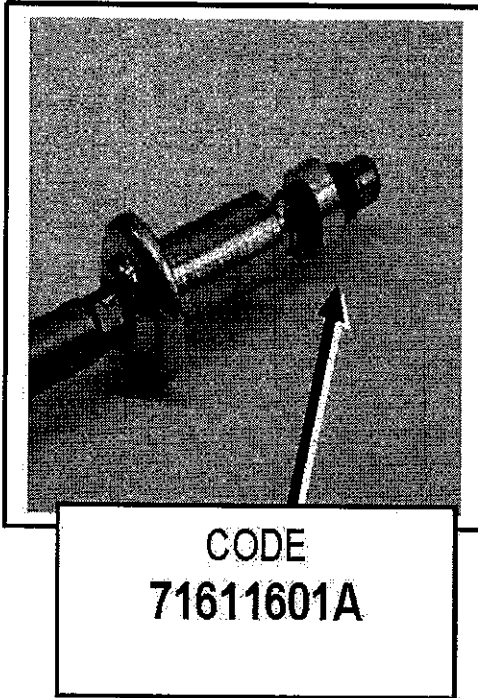
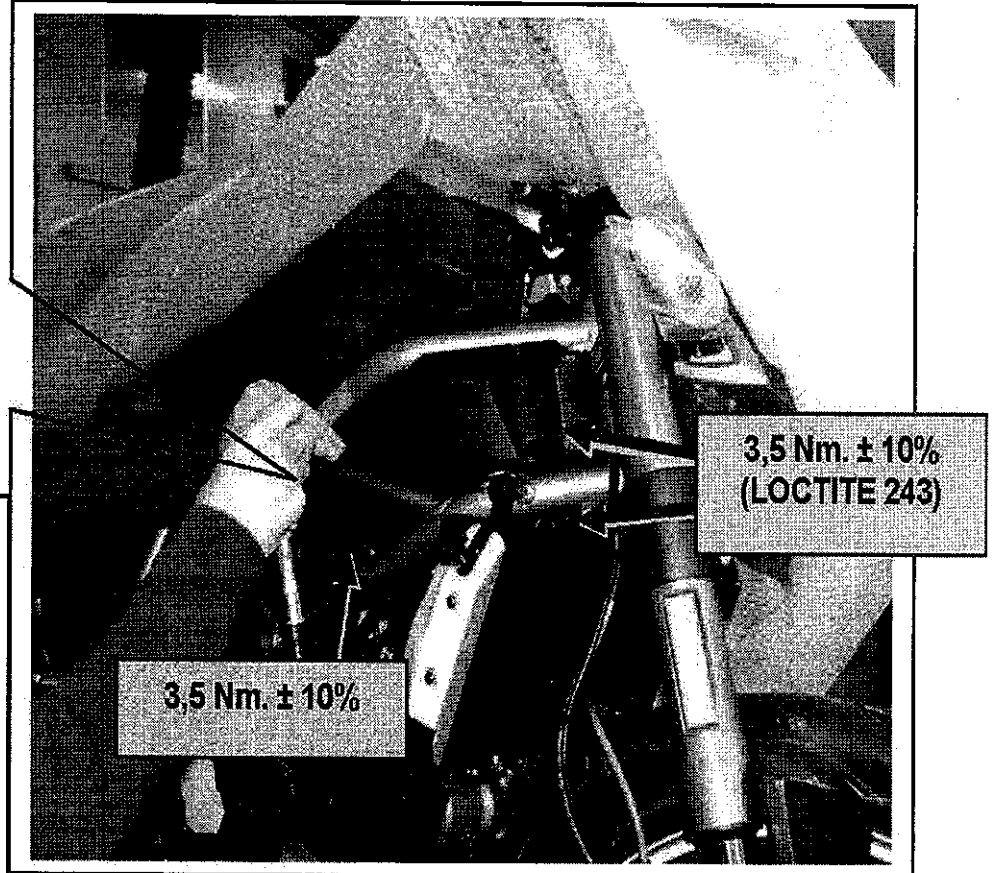
NOTE: It is possible on some motorcycles that spacers may not have been fitted to the rear screws of the air intake. If any of the spacers are missing please order spacers, part no. 71611601A - qty. 2. During reassembly install one spacer on both rear securing screws on the right-hand and left-hand side intakes.
