TOYOTA

Subject: Safety Recall – 90L
Certain 2007 – 2010 Model Year Camry and Camry Hybrid Vehicles
Potential Floor Mat Interference with Accelerator Pedal (January, 2010)
Phase 1 – Vehicles Equipped with Accelerator Pedals manufactured by Denso Corporation

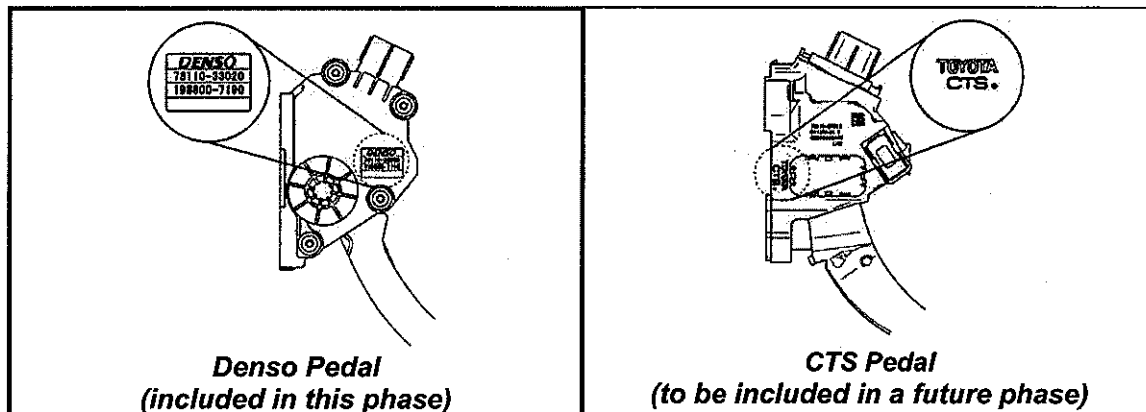
Note:

- ***The name of the pedal manufacturer is printed (Denso) or embossed (CTS) on the upper sensor housing on the brake pedal side.***
- ***This condition is separate from the Defect Information Report (DIR) filed on 1/21/2010 in reference to the possibility that certain CTS accelerator pedal mechanisms may, in rare instances, mechanically stick in a partially depressed position or return slowly to the idle position.***
