R09PX

FMVSS 110 Noncompliance Incorrect Spare Tire Pressure Data

RECALL

**Models Affected: Certain 2010 Model Year Micro Bird Single Rear Wheel Model Buses
Manufactured from August 31, 2005 through September 27, 2009**

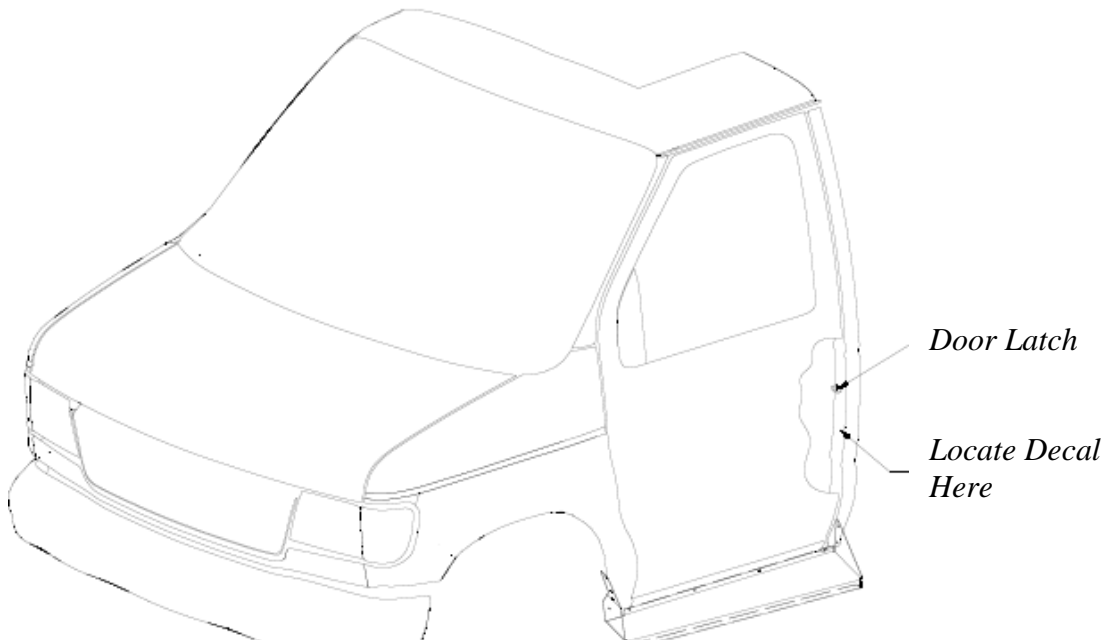
1. Park the vehicle on a level surface, apply parking brake, turn engine off, remove ignition key.
2. Open driver's door and locate tire pressure label as shown below.
3. Clean existing decal with damp cloth or paper towel and dry thoroughly.
4. Carefully place new tire pressure label on top of existing decal.
5. Return bus to service.

A replacement decal indicating appropriate spare tire pressure as required by FMVSS 110 S4.3.4c will be provided to owners to install.
