Safety Recall H36

Steering Drag Link inner Joint and Damper Bracket

2008-2009 (DH / D1) Dodge Truck

2008-2009 (DC) Dodge Truck

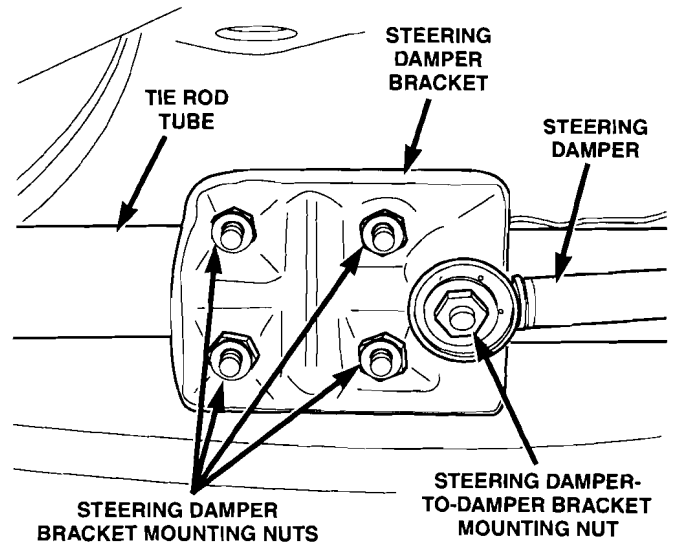
Figure 2

- a. Remove and save the steering damper-to-damper bracket mounting nut (Figure 2).
- b. Disconnect the steering damper from the steering damper bracket.
- c. Remove and discard the four steering bracket nuts, two u-bolts and the bracket (Figure 2).

- d. Place the new steering damper carriage bolt through the square hole in the new bracket.
- e. Place the new steering damper bracket assembly onto the tie rod tube at the flat spot area on the tube and install the new u-bolts and nuts. Lightly snug the nuts to hold the steering damper bracket in position.
- f. Center the new steering damper bracket on the flattened area of the tie rod tube.
- g. Evenly tighten the four steering damper bracket u-bolt nuts to 25 ft. lbs. (34 N·m). Then tighten the four u-bolt nuts to 45 ft. lbs. (61 N·m).
- h. Connect the steering damper to the steering damper carriage bolt.
- i. Install the steering damper mounting nut and tighten to 75 ft. lbs. (100 N·m).
- j. Continue with Step 4 of this procedure.

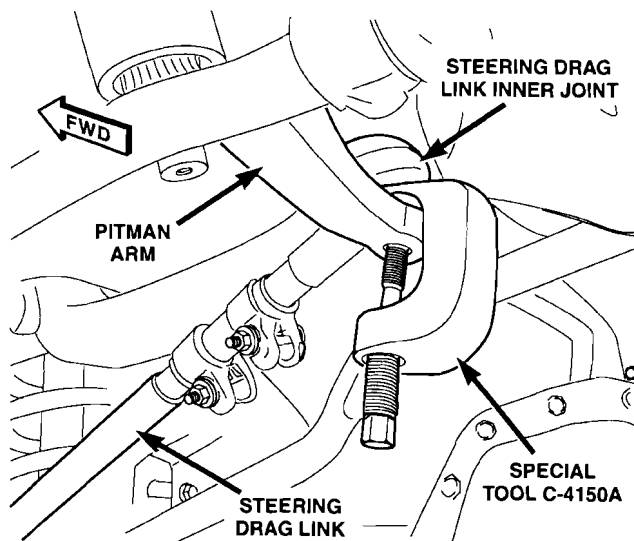
Figure 4

c. Using special tool C-4150A, separate the steering drag link inner joint from the pitman arm (Figure 4).

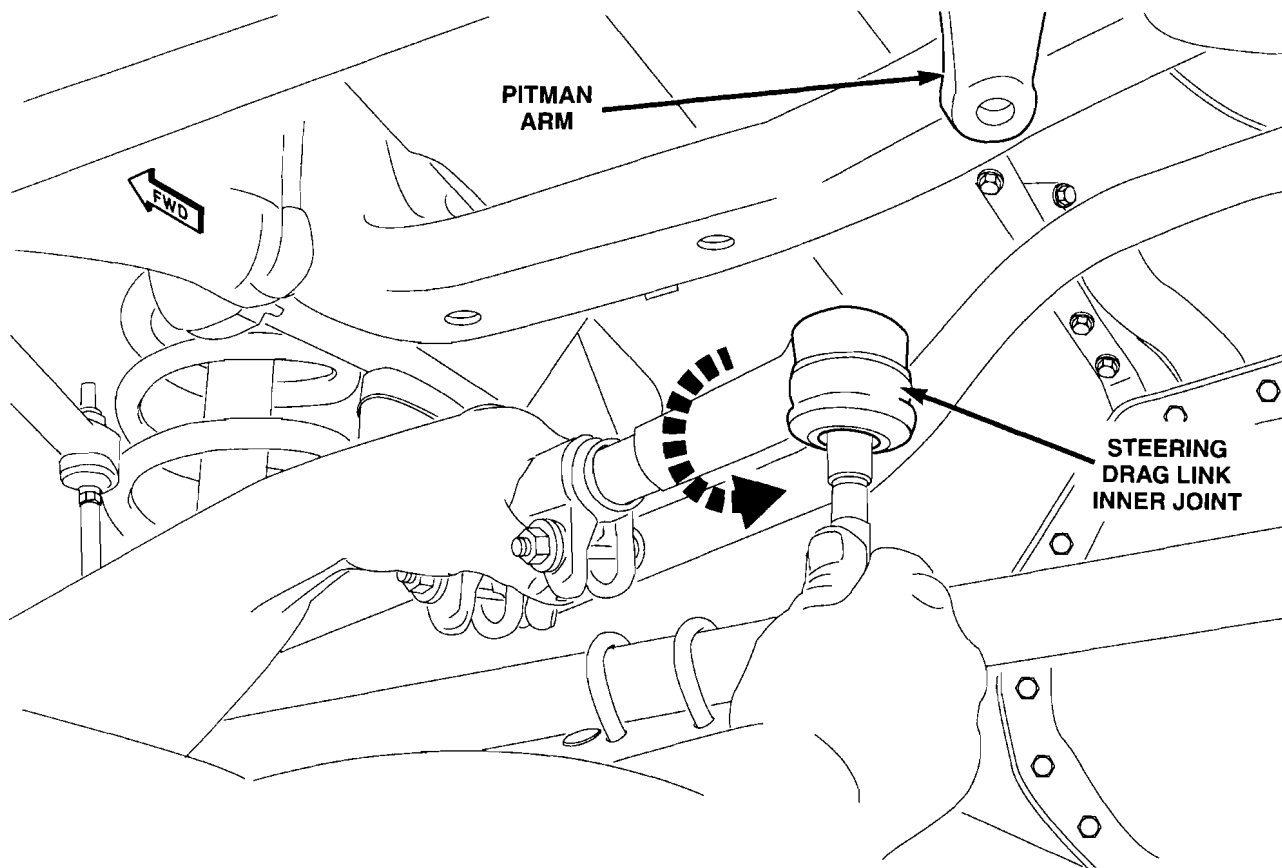
Figure 5

d. While counting the number of turns, unscrew the steering drag link inner joint from the drag link adjuster sleeve (right handed threads) (Figure 5).

CAUTION: Do not allow the drag link adjuster sleeve to turn while unscrewing the drag link inner joint.

e. Screw in the new steering drag link inner joint into the drag link adjuster sleeve the same number of turns counted in step 4d. of this procedure.
