# Technical Service Bulletin

Model	SONATA (EF)
	Group	BODY (INTERIOR & EXTERIOR)
	Number	91B032
Subject  CHROMIUM-PLATED DOOR INSIDE HANDLE REPAIR	Date	August, 2009
	Area	Puerto Rico
	Type	Safety Recall

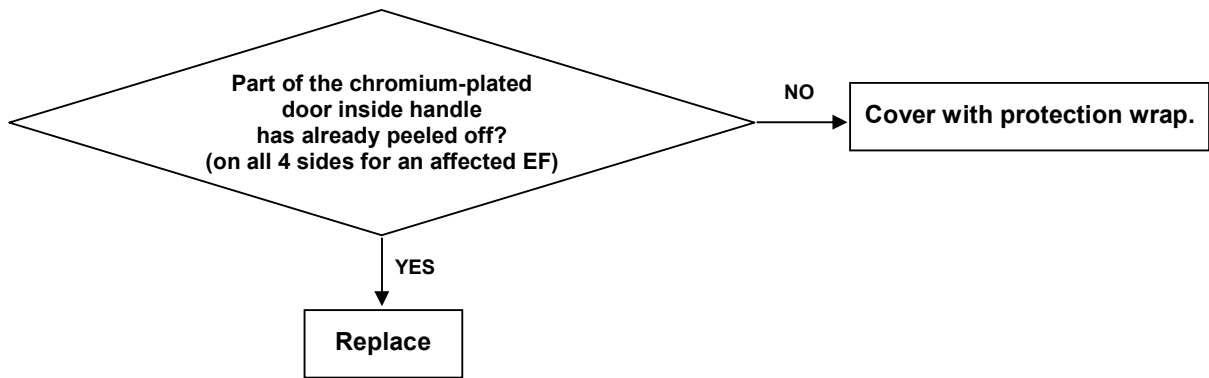
This bulletin provides the procedure for repairing SONATA (EF) door inside handle whose outer chromium plating may peel off.
