**SUBJECT:    RECALL R10RF    REAR INNER PANEL FMVSS 221 JOINT  
STRENGTH NONCOMPLIANCE**

# Adhesive Omitted on Rear Interior Panels

**Models Affected:** All American (D3FE) buses manufactured prior to October 24, 2009

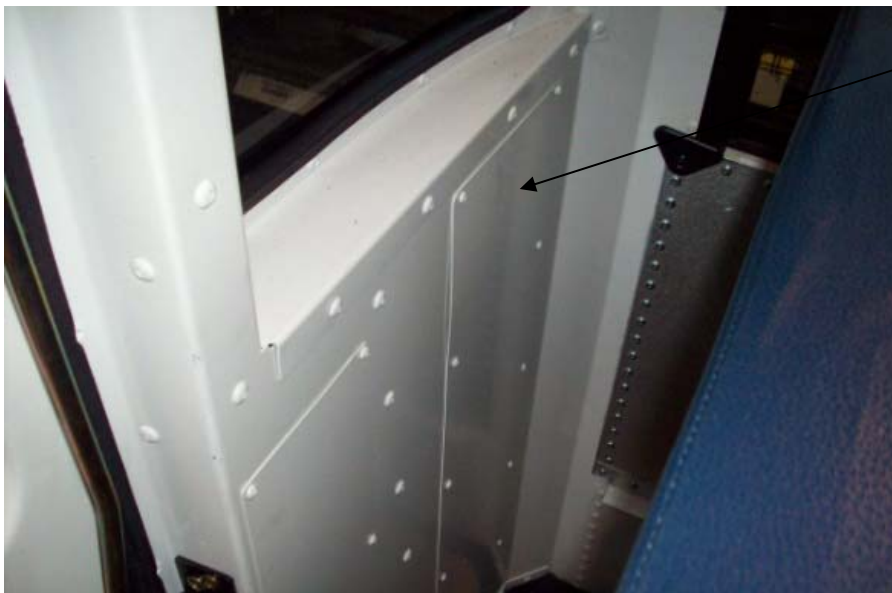
1. Read all instructions completely before proceeding with repair.
2. Park the bus on a level surface, apply parking brakes, turn off engine and remove ignition key. Chock wheels.
3. Locate the rear interior close-out panels **at both sides** of the rear emergency door.

This panel and same panel on opposite side of emergency door are to be inspected for adhesive

5. Inspect the close-out panels for the presence of adhesive by sliding a putty knife, or other slim object, behind the panel between the screws. Loosen a few screws as necessary to aid inspection. If adhesive is present, you will not be able to penetrate the space between the joined panels. If inspection determines that adhesive is present no repair is required.
6. If no adhesive is present, remove the close-out panel by first removing the screws (12 per panel) that hold it in place.
7. Apply a .25" bead of Magnobond adhesive in the center of the mating surfaces for the close-out panel along or near the screw lines.
8. Reinstall the close-out panel with the screws removed in step 6.
9. Clean off any excess adhesive.
10. Return bus to service.
