August 2010

SAFETY RECALL NOTICE

CLUB CAR VILLAGER 2+2 LSV

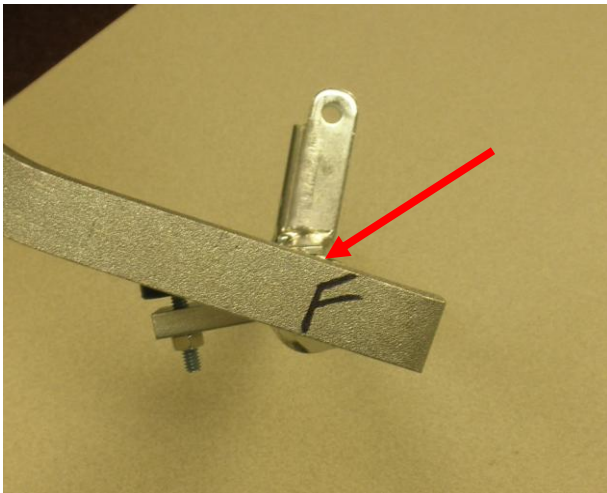
Figure 1

The following procedure outlines the inspection process that must be performed on all potentially affected vehicles. It isn't necessary to raise the vehicle in order to perform the inspection. The affected area of the brake pedal assembly can be viewed by looking beneath the front driver's side of the vehicle. A mechanic's inspection mirror on a telescoping handle and a flashlight may make inspecting this area easier.

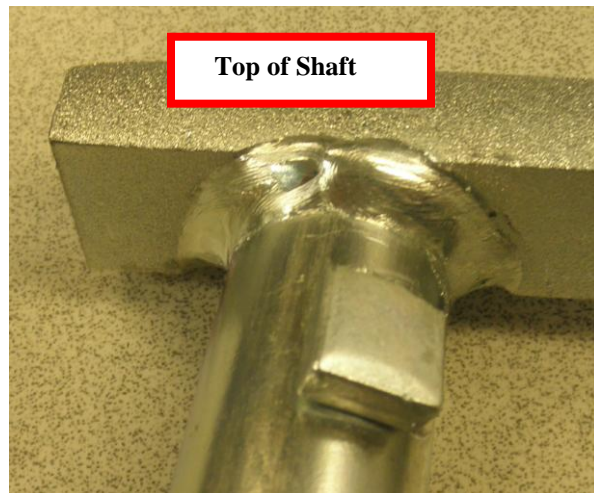
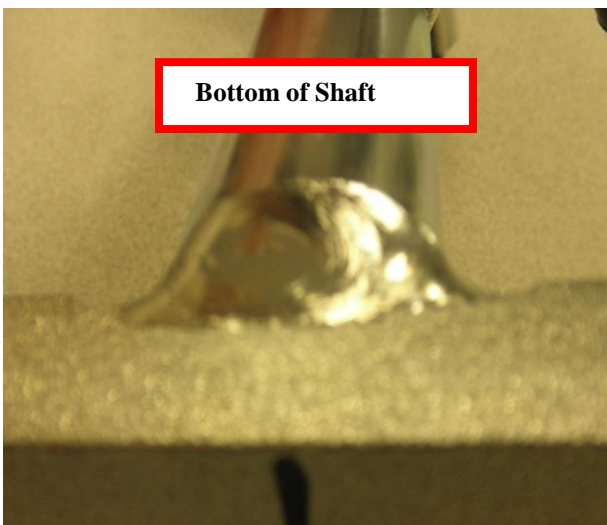
Figure 2

1. Inspect the area where the pedal arm is welded to the pedal cross shaft for a **full 360°** of weld (**Figures 2 and 3**) between the outside diameter of the shaft and the pedal arm.
2. An affected brake pedal assembly missing part of the weld will look like the example shown in **Figure 4**.
3. If the vehicle passes inspection of the welded joint, it must next be tested by apply force to the brake pedal by applying pressure to the brake pedal with both feet, pushing down as firmly as possible. If the vehicle passes both test criteria, place an “**F**” on the outside of the pedal arm (**Figure 5**) on the opposite side of the welded joint with a permanent ink marker and return the vehicle to service.

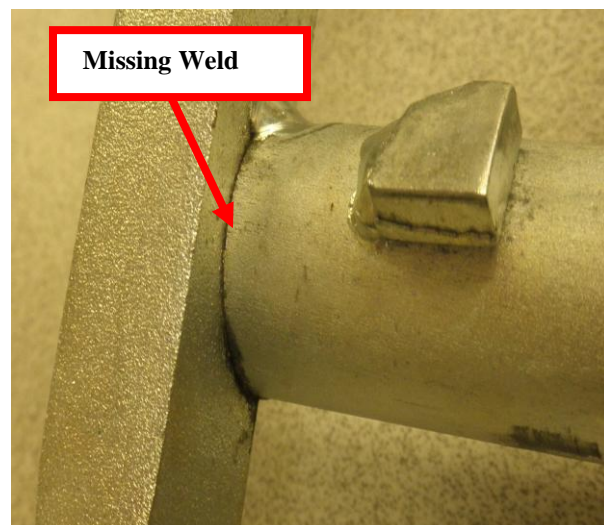
Figure 4

Club Car has determined that a defect which relates to motor vehicle safety may exist in certain 2010 Villager 2+2 LSV vehicles. The brake pedal may have been manufactured with a missing weld. This condition may lead to loss of brakes during operation without warning.

NOTE: Any vehicle found to have a missing weld on the Brake Pedal Assembly must be repaired immediately by replacing the pedal assembly with one Club Car part number 101878201 or 103370401 pedal kit, one 1010877 push nut and one 1013876 push nut. The 103370401 kit should be used on IQ Plus 4-Wheel Brake vehicles and Limo electric vehicles with manual brakes. The vehicle should immediately be removed from service until the repair can be made. Under no circumstances should the vehicle continue to be driven until repaired.
