Applies To: **2005 RL** – From VIN JH4KB16..5C000001 thru JH4KB16..5C021598
2006 RL – From VIN JH4KB16..6C000002 thru JH4KB16..6C012556
2007 RL – From VIN JH4KB16..7C000002 thru JH4KB16..7C003061

November 6, 2010

Safety Recall: Master Cylinder May Be Leaking

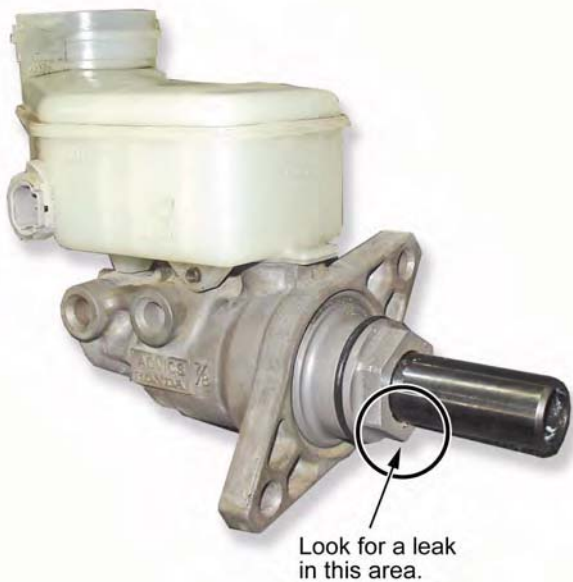
1. Remove the engine covers.
2. Remove the under-hood fuse/relay box, and move it aside.
3. Remove the strut brace.
4. Remove the brake fluid from the master cylinder reservoir with a syringe.
5. Remove the master cylinder. Be careful not to bend or damage the brake lines.
6. Check for brake fluid leaking from the installed end of the master cylinder:
 - If there is a leak, go to step 7.
 - If there is no leak, go to step 8.

7. Replace the brake booster. Replacement includes checking the adjustment of the brake pedal height and the brake pedal position switch. Torque the brake booster mounting nuts to **13 N·m (9.4 lb-ft)**.
NOTE: Be careful not to bend or damage the brake lines.

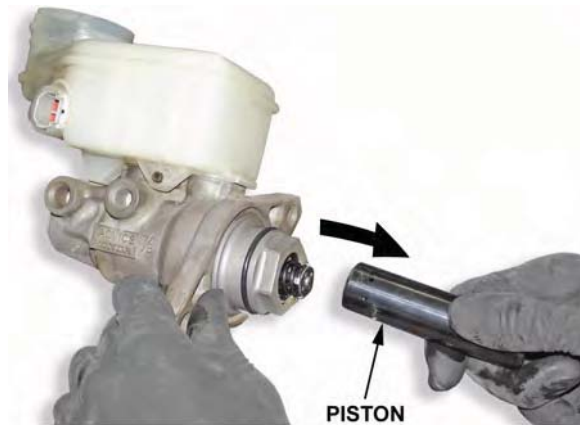
8. Place the master cylinder on clean shop towel on your work bench, then pull out the piston from the end of the master cylinder. A small amount of brake fluid will come out behind the piston; this is normal.

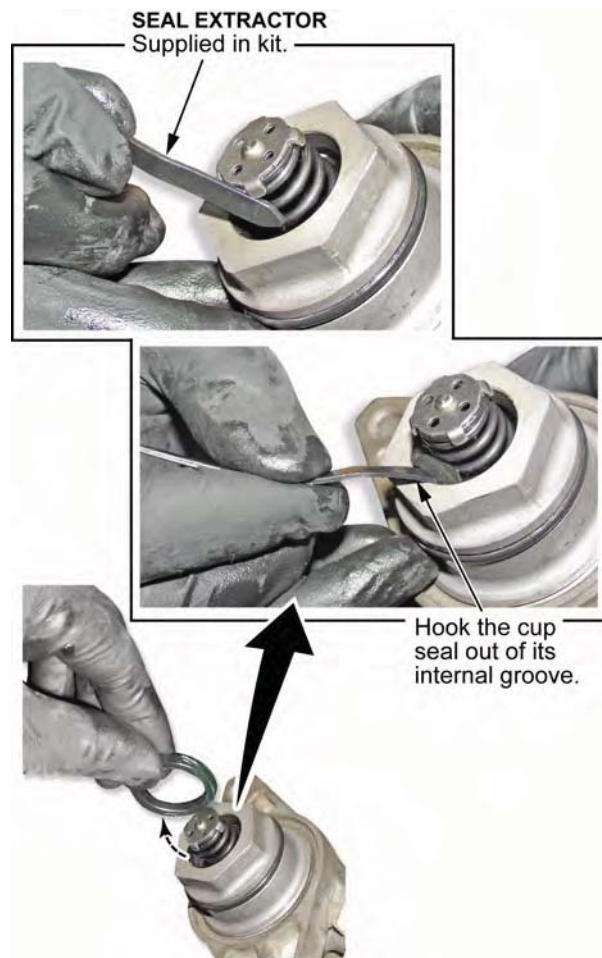
9. Remove the cup seal from the end of the master cylinder using the seal extractor (wire tie).
NOTE: To avoid damaging the cup seal retention groove in the master cylinder, do not use a pick seal or any other metal tool to remove the cup seal.

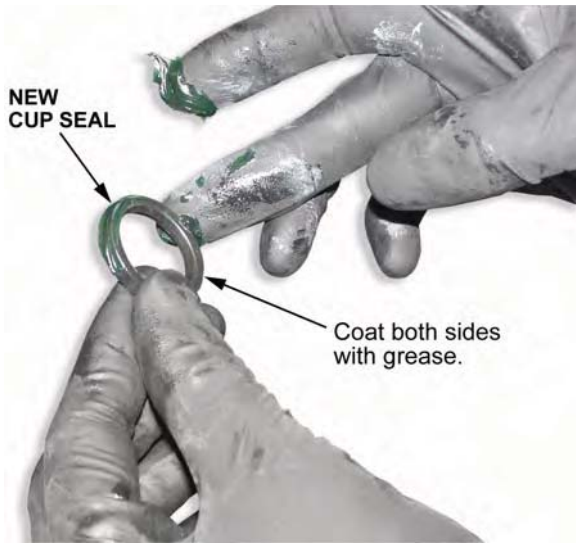
10. Coat the new cup seal with the grease supplied in the kit.

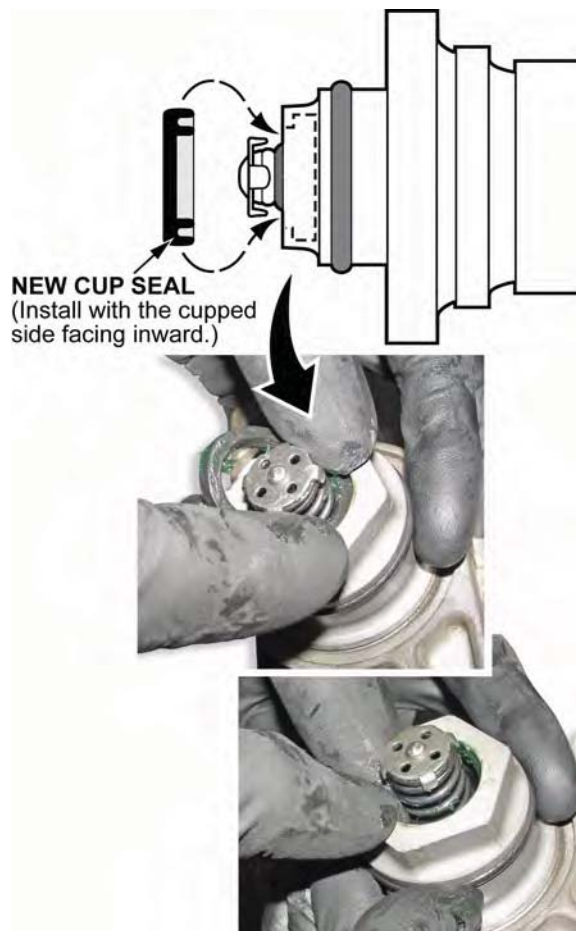
11. Install the new cup seal, by hand, into the seal groove at the end of the master cylinder. Install the seal with its cupped side facing the master cylinder.

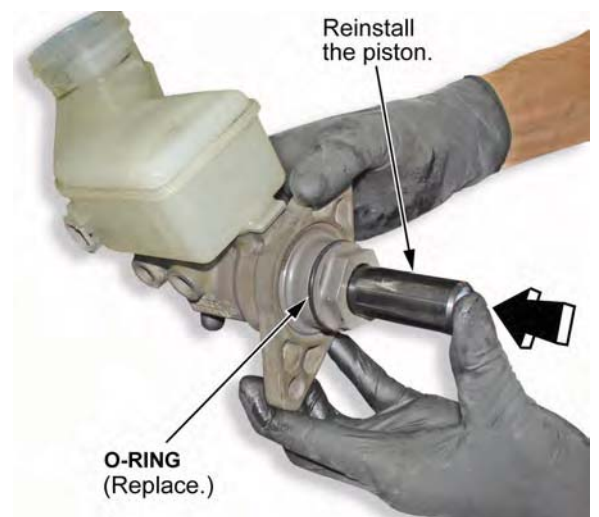
12. Reinstall the piston into the end of the master cylinder.
