Representative Letter - Customer letters are brand, model and model year specific, and personalized.

July 2010

- Your 2009 or 2010 model year Pontiac Vibe is involved in safety recall 10038.
- Schedule an appointment with your GM dealer.
- This service will be performed for you at no charge.

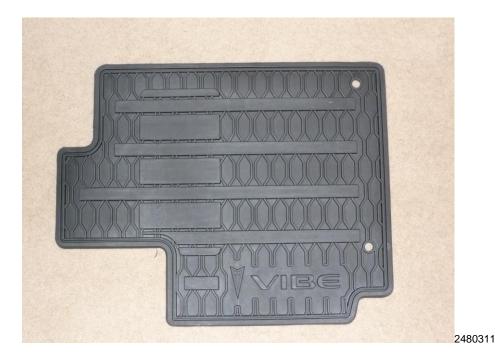
If your vehicle is equipped with a set of Pontiac Vibe All Weather Floor Mat (AWFM) (see above), the driver's side mat will be replaced. All this will be performed for you at no charge.

To make it less likely that an unsecured or incompatible driver's floor mat can interfere with the accelerator pedal on your vehicle, your GM dealer will modify the accelerator pedal and the floor surface in the driver's foot-well.
